# Manhole Inspection Report

Date:	<b>03/24/2018</b>	Weather:		Coding:	<b>RZMACP</b>
MH#:	<b>M-209-018</b>	Owner:	<b>NA</b>	Len. Surveyed:	<b>7.6</b>
P.O.#:		Surveyor:	<b>John Kuglmaier</b>	Rim to Invert:	<b>8.2</b>
Customer:		Cert. #:	<b>U-1215-07002349</b>	Wall Material:	<b>Concrete (reinforced)</b>

Street:	<b>North of 62nd Pl. 137' West of Califo</b>	Project:	<b>Hobart, IN</b>
City:	<b>Hobart, IN</b>	GPS Northing:	<b>0.0</b>
Location:		GPS Easting:	<b>0.0</b>
Drain Area:	<b>Southwest</b>	GPS Accuracy:	<b>Nearest Meter</b>
Cover Shape:	<b>Circular</b>	Evidence of Surcharge:	<b>No</b>
Cover Size:	<b>22.5</b>	Potential for Runoff:	<b>None</b>
Comments:

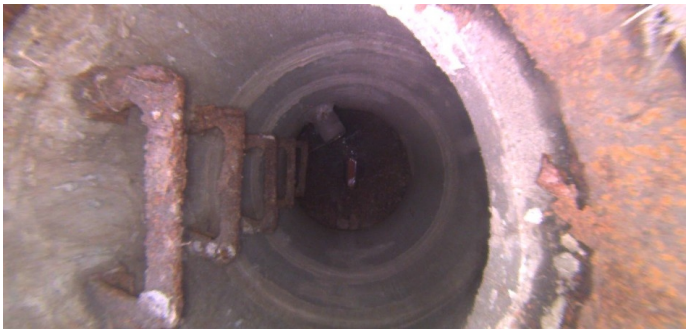
Code:	<b>MGP</b>
Description:	<b>General Photo</b>

Distance (ft):	.0
Structural Grade:	0
O&M Grade:	0
Clock Start/From:	
Clock To:	
1st Value:	
2nd Value:	
Value Percent:	
Step:	NO
Remarks:

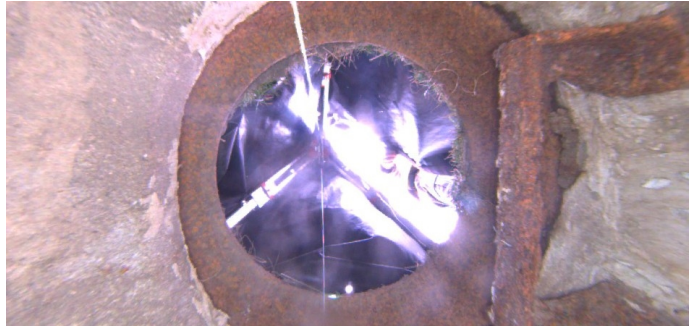
Code: **MGP**  
Description: **General Photo**

Distance (ft): **2.4**  
Structural Grade: **0**  
O&M Grade: **0**  
Clock Start/From:  
Clock To:  
1st Value:  
2nd Value:  
Value Percent:  
Step: **NO**  
Remarks:

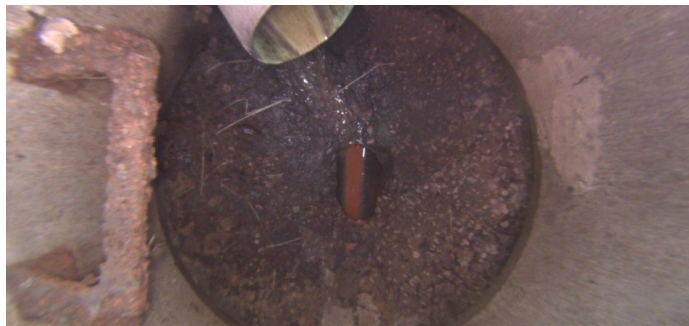
Code: **DAZ**  
Description: **Deposits Attached Other**

Distance (ft): **4.9**  
Structural Grade: **0**  
O&M Grade: **2**  
Clock Start/From: **12**  
Clock To: **12**  
1st Value:  
2nd Value:  
Value Percent: **5.000**  
Step: **NO**  
Remarks: **Mixed materials**

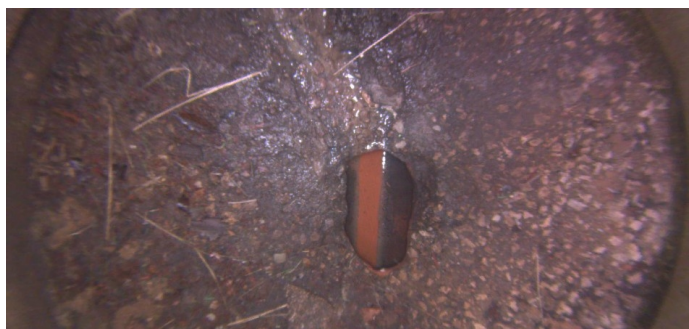
Code: **MGO**  
Description: **General Observation**

Distance (ft): **6.0**  
Structural Grade: **0**  
O&M Grade: **0**  
Clock Start/From:  
Clock To:  
1st Value:  
2nd Value:  
Value Percent:  
Step: **NO**  
Remarks: **Ins. Comp.**
