Manhole Inspection Report

Date:	03/24/2018	Weather:		Coding:	RZMACP
MH#:	M-209-019	Owner:	NA	Len. Surveyed:	11.6
P.O.#:		Surveyor:	John Kuglmaier	Rim to Invert:	11.5
Customer:		Cert. #:	U-1215-07002349	Wall Material:	Concrete (reinforced)

Street:	282' South of 61st Pl. West of Califor	Project:	Hobart, IN
City:	Hobart, IN	GPS Northing:	0.0
Location:		GPS Easting:	0.0
Drain Area:	Southwest	GPS Accuracy:	Nearest Meter
Cover Shape:	Circular	Evidence of Surcharge:	No
Cover Size:	22.5	Potential for Runoff:	None
Comments:

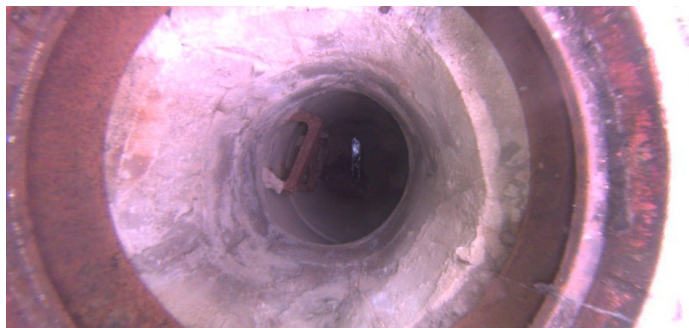
Code: **MGP**
Description: **General Photo**

Distance (ft): **.0**
Structural Grade: **0**
O&M Grade: **0**
Clock Start/From:
Clock To:
1st Value:
2nd Value:
Value Percent:
Step: **NO**
Remarks:

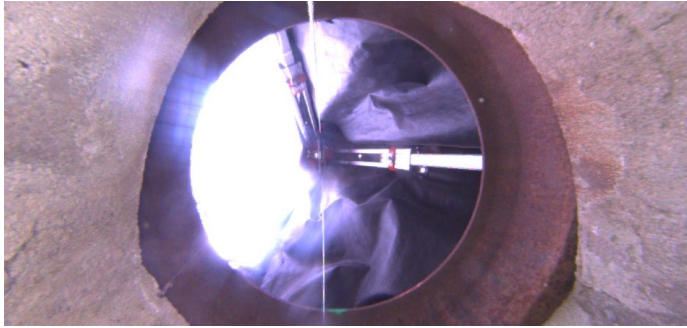
Code: **MGP**
Description: **General Photo**

Distance (ft): **2.7**
Structural Grade: **0**
O&M Grade: **0**
Clock Start/From:
Clock To:
1st Value:
2nd Value:
Value Percent:
Step: **NO**
Remarks:

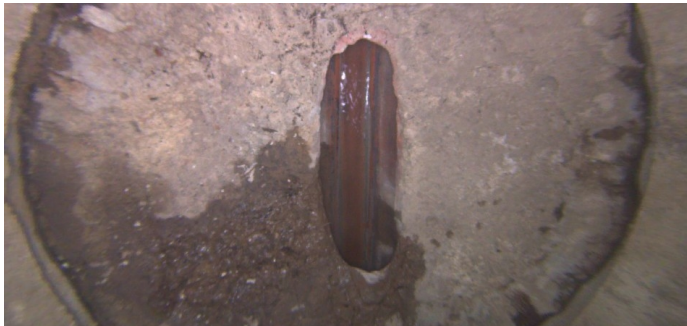
Code: **MGO**
Description: **General Observation**

Distance (ft): **9.9**
Structural Grade: **0**
O&M Grade: **0**
Clock Start/From:
Clock To:
1st Value:
2nd Value:
Value Percent:
Step: **NO**
Remarks: **Ins. Comp.**
