Manhole Inspection Report

Date:	03/22/2018	Weather:		Coding:	RZMACP
MH#:	M-209-020	Owner:	NA	Len. Surveyed:	11.9
P.O.#:		Surveyor:	John Kuglmaier	Rim to Invert:	12.2
Customer:		Cert. #:	U-1215-07002349	Wall Material:	Concrete (reinforced)

Street:	61st Pl. 137' West of California St.	Project:	Hobart, IN
City:	Hobart, IN	GPS Northing:	0.0
Location:		GPS Easting:	0.0
Drain Area:	Southwest	GPS Accuracy:	Nearest Meter
Cover Shape:	Circular	Evidence of Surcharge:	Yes
Cover Size:	22.5	Potential for Runoff:	None
Comments:

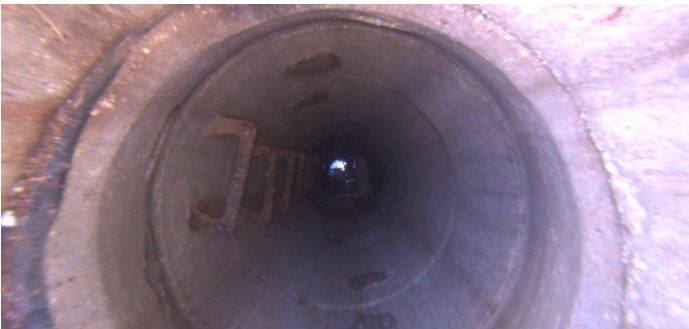
Code: **MGP**
Description: **General Photo**

Distance (ft): **.0**
Structural Grade: **0**
O&M Grade: **0**
Clock Start/From:
Clock To:
1st Value:
2nd Value:
Value Percent:
Step: **NO**
Remarks:

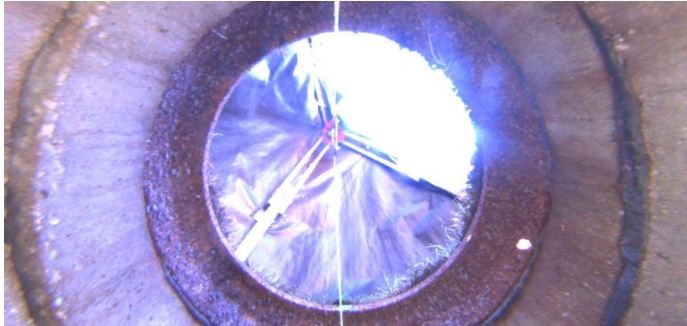
Code: **MGP**
Description: **General Photo**

Distance (ft): **2.0**
Structural Grade: **0**
O&M Grade: **0**
Clock Start/From:
Clock To:
1st Value:
2nd Value:
Value Percent:
Step: **NO**
Remarks:

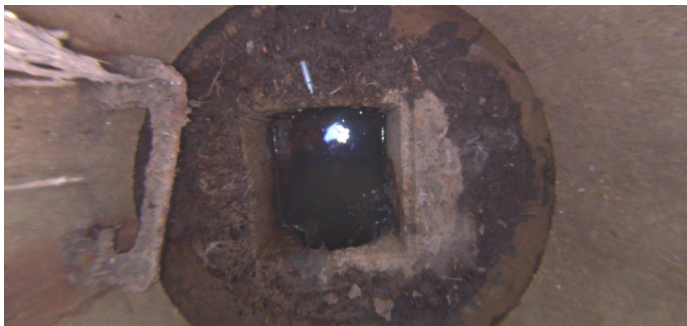
Code: **DAZ**
Description: **Deposits Attached Other**

Distance (ft): **8.8**
Structural Grade: **0**
O&M Grade: **2**
Clock Start/From: **12**
Clock To: **12**
1st Value:
2nd Value:
Value Percent: **10.000**
Step: **NO**
Remarks: **Mixed materials**

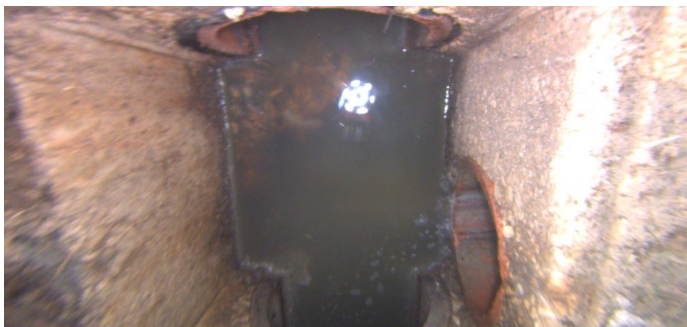
Code: **MGO**
Description: **General Observation**

Distance (ft): **10.5**
Structural Grade: **0**
O&M Grade: **0**
Clock Start/From:
Clock To:
1st Value:
2nd Value:
Value Percent:
Step: **NO**
Remarks: **Ins. Comp.**
