Manhole Inspection Report

Date:	03/24/2018	Weather:		Coding:	RZMACP
MH#:	M-209-027	Owner:	NA	Len. Surveyed:	10.8
P.O.#:		Surveyor:	John Kuglmaier	Rim to Invert:	11.1
Customer:		Cert. #:	U-1215-07002349	Wall Material:	Concrete (reinforced)

Street:	South of 62nd Pl. 175' East of Liverp	Project:	Hobart, IN
City:	Hobart, IN	GPS Northing:	0.0
Location:		GPS Easting:	0.0
Drain Area:	Southwest	GPS Accuracy:	Nearest Meter
Cover Shape:	Circular	Evidence of Surcharge:	Yes
Cover Size:	22.5	Potential for Runoff:	None
Comments:

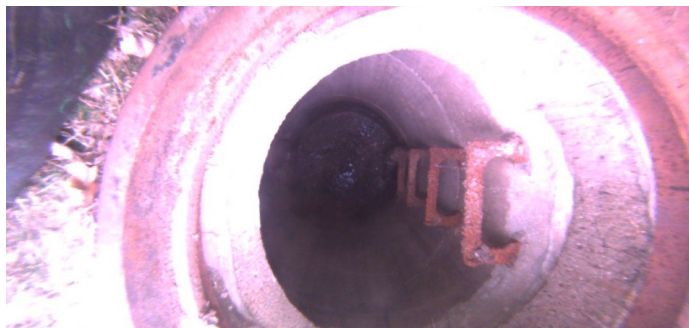
Code: **MGP**
Description: **General Photo**

Distance (ft): **.0**
Structural Grade: **0**
O&M Grade: **0**
Clock Start/From:
Clock To:
1st Value:
2nd Value:
Value Percent:
Step: **NO**
Remarks:

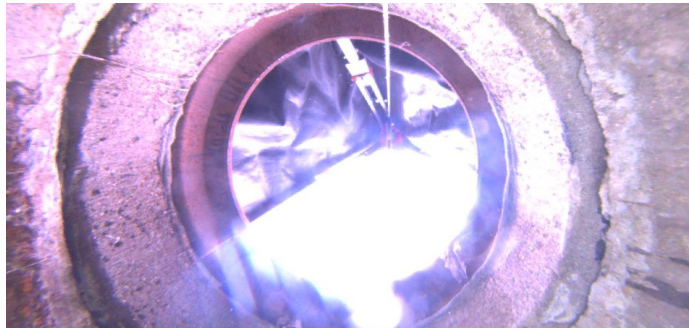
Code: **MGP**
Description: **General Photo**

Distance (ft): **2.9**
Structural Grade: **0**
O&M Grade: **0**
Clock Start/From:
Clock To:
1st Value:
2nd Value:
Value Percent:
Step: **NO**
Remarks:

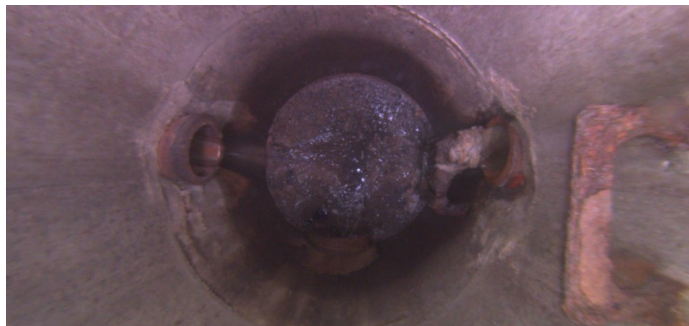
Code: **IS**
Description: **Infil Stain**

Distance (ft): **4.9**
Structural Grade: **0**
O&M Grade: **0**
Clock Start/From: **12**
Clock To: **12**
1st Value:
2nd Value:
Value Percent:
Step: **NO**
Remarks:

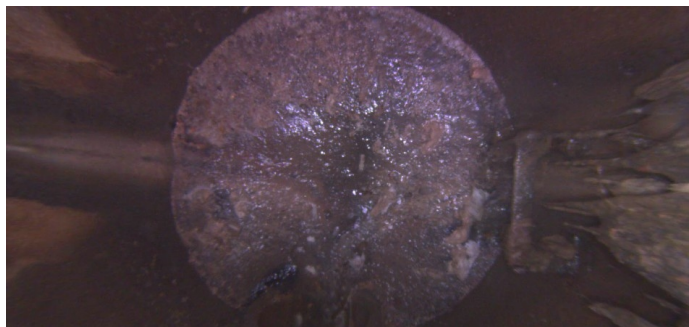
Code: **DAZ**
Description: **Deposits Attached Other**

Distance (ft): **8.3**
Structural Grade: **0**
O&M Grade: **2**
Clock Start/From: **12**
Clock To: **12**
1st Value:
2nd Value:
Value Percent: **10.000**
Step: **NO**
Remarks: **Mixed materials**

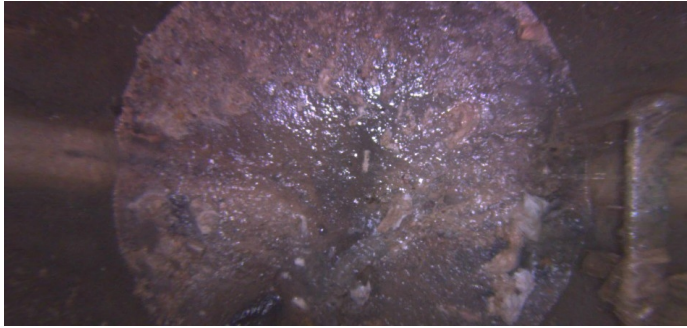
Code:	MGO
Description:	General Observation
Distance (ft):	9.1
Structural Grade:	0
O&M Grade:	0
Clock Start/From:	
Clock To:	
1st Value:	
2nd Value:	
Value Percent:	
Step:	NO
Remarks:	Ins. Comp.
