Manhole Inspection Report

Date:	03/24/2018	Weather:		Coding:	RZMACP
MH#:	M-209-028	Owner:	NA	Len. Surveyed:	6.9
P.O.#:		Surveyor:	John Kuglmaier	Rim to Invert:	8.0
Customer:		Cert. #:	U-1215-07002349	Wall Material:	Concrete (reinforced)

Street:	Colorado St. 435' North of 62nd Pl.	Project:	Hobart, IN
City:	Hobart, IN	GPS Northing:	0.0
Location:		GPS Easting:	0.0
Drain Area:	Southwest	GPS Accuracy:	Nearest Meter
Cover Shape:	Circular	Evidence of Surcharge:	No
Cover Size:	22.5	Potential for Runoff:	None
Comments:

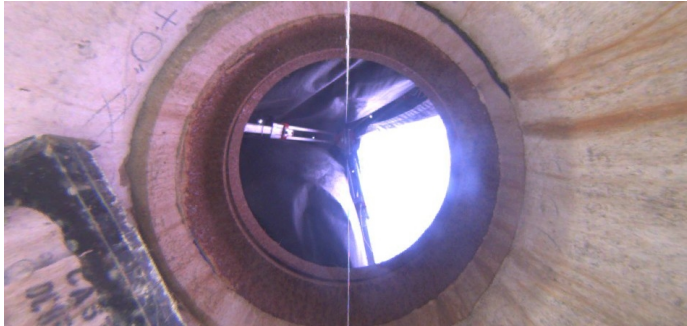
Code: **MGP**
Description: **General Photo**

Distance (ft): **2.6**
Structural Grade: **0**
O&M Grade: **0**
Clock Start/From:
Clock To:
1st Value:
2nd Value:
Value Percent:
Step: **NO**
Remarks:

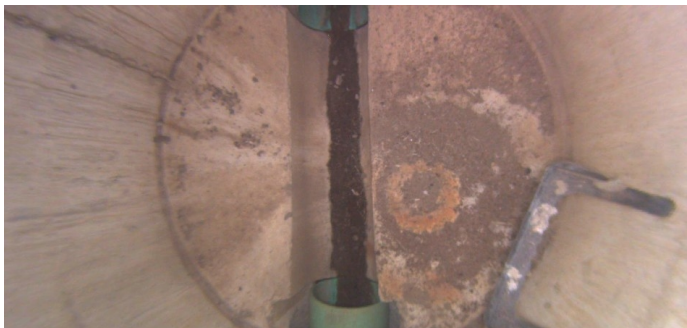
Code: **MGO**
Description: **General Observation**

Distance (ft): **4.8**
Structural Grade: **0**
O&M Grade: **0**
Clock Start/From:
Clock To:
1st Value:
2nd Value:
Value Percent:
Step: **NO**
Remarks: **Ins. Comp.**
