Manhole Inspection Report

Date:	03/24/2018	Weather:		Coding:	RZMACP
MH#:	M-209-029	Owner:	NA	Len. Surveyed:	10.1
P.O.#:		Surveyor:	John Kuglmaier	Rim to Invert:	10.8
Customer:		Cert. #:	U-1215-07002349	Wall Material:	Concrete (reinforced)

Street:	Colorado St. 332' South of 61st Ave.	Project:	Hobart, IN
City:	Hobart, IN	GPS Northing:	0.0
Location:		GPS Easting:	0.0
Drain Area:	Southwest	GPS Accuracy:	Nearest Meter
Cover Shape:	Circular	Evidence of Surcharge:	No
Cover Size:	22.5	Potential for Runoff:	None
Comments:

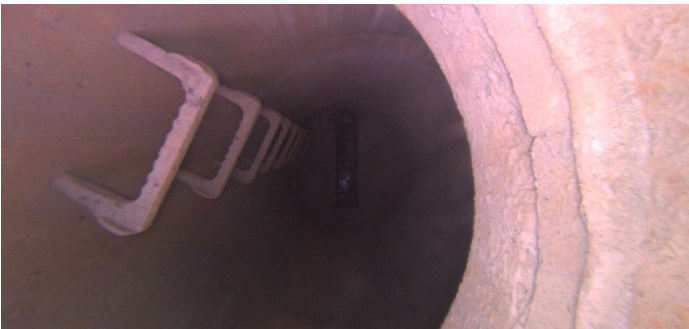
Code: **MGP**
 Description: **General Photo**

Distance (ft): **.0**
 Structural Grade: **0**
 O&M Grade: **0**
 Clock Start/From:
 Clock To:
 1st Value:
 2nd Value:
 Value Percent:
 Step: **NO**
 Remarks:

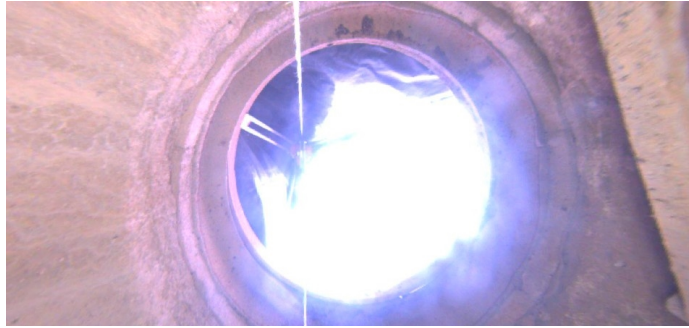
Code: **MGP**
Description: **General Photo**

Distance (ft): **2.2**
Structural Grade: **0**
O&M Grade: **0**
Clock Start/From:
Clock To:
1st Value:
2nd Value:
Value Percent:
Step: **NO**
Remarks:

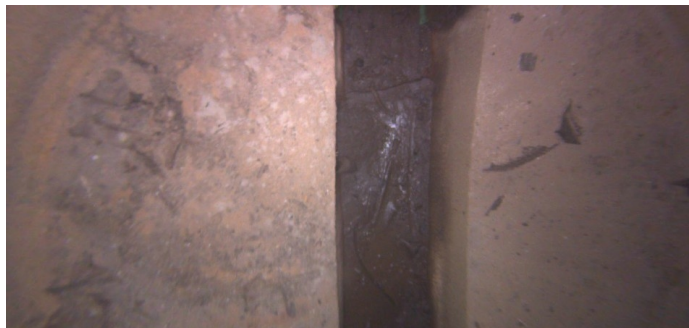
Code: **MGO**
Description: **General Observation**

Distance (ft): **8.8**
Structural Grade: **0**
O&M Grade: **0**
Clock Start/From:
Clock To:
1st Value:
2nd Value:
Value Percent:
Step: **NO**
Remarks: **Ins. Comp.**
