# Manhole Inspection Report

Date:	<b>04/12/2018</b>	Weather:		Coding:	<b>RZMACP</b>
MH#:	<b>M-303-001</b>	Owner:	<b>NA</b>	Len. Surveyed:	<b>8.4</b>
P.O.#:		Surveyor:	<b>John Kuglmaier</b>	Rim to Invert:	<b>10.0</b>
Customer:		Cert. #:	<b>U-1215-07002349</b>	Wall Material:	<b>Concrete (reinforced)</b>

Street:	<b>Intersection of Ridge Rd. and Orchar</b>	Project:	<b>Hobart, IN</b>
City:	<b>Hobart, IN</b>	GPS Northing:	<b>2895737.918</b>
Location:		GPS Easting:	<b>2895737.918</b>
Drain Area:	<b>Northwest</b>	GPS Accuracy:	<b>Sub-Meter</b>
Cover Shape:	<b>Circular</b>	Evidence of Surcharge:	<b>Yes</b>
Cover Size:	<b>23.0</b>	Potential for Runoff:	<b>None</b>
Comments:

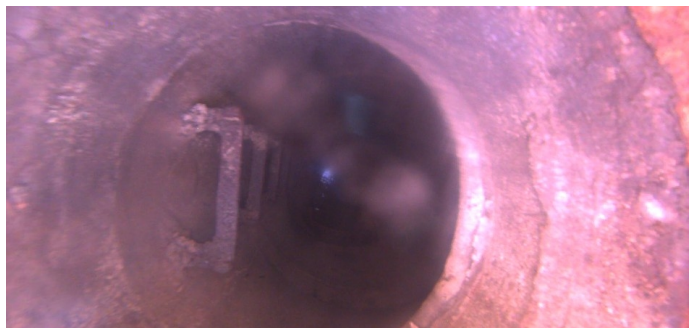
Code: **MGP**  
Description: **General Photo**

Distance (ft): **.0**  
Structural Grade: **0**  
O&M Grade: **0**  
Clock Start/From:  
Clock To:  
1st Value:  
2nd Value:  
Value Percent:  
Step: **NO**  
Remarks:

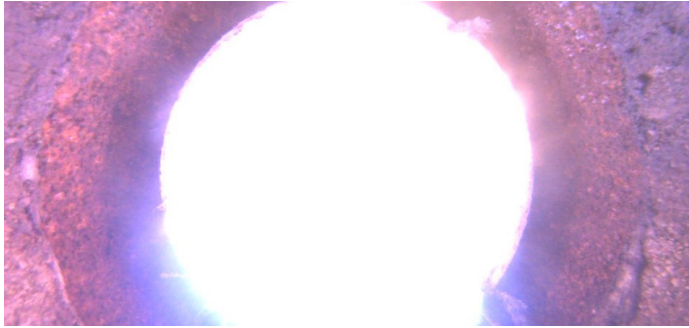
Code:	<b>MGP</b>
Description:	<b>General Photo</b>
Distance (ft):	<b>1.5</b>
Structural Grade:	<b>0</b>
O&M Grade:	<b>0</b>
Clock Start/From:	
Clock To:	
1st Value:	
2nd Value:	
Value Percent:	
Step:	<b>NO</b>
Remarks:

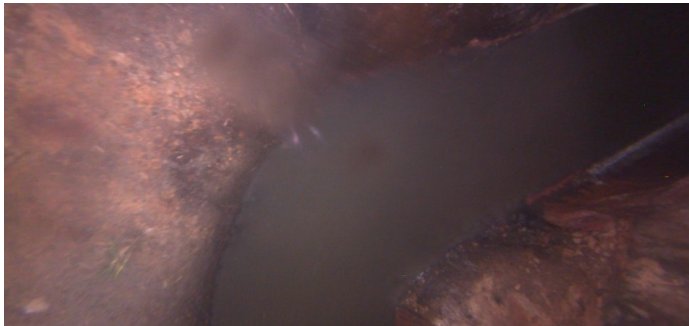
Code:	<b>MGO</b>
Description:	<b>General Observation</b>
Distance (ft):	<b>7.6</b>
Structural Grade:	<b>0</b>
O&M Grade:	<b>0</b>
Clock Start/From:	
Clock To:	
1st Value:	
2nd Value:	
Value Percent:	
Step:	<b>NO</b>
Remarks:	<b>Ins. Comp.</b>
