# Manhole Inspection Report

Date:	05/16/2018	Weather:		Coding:	RZMACP
MH#:	M-303-002	Owner:	NA	Len. Surveyed:	9.7
P.O.#:		Surveyor:	Jen Costello	Rim to Invert:	10.2
Customer:		Cert. #:	U-907-5518	Wall Material:	Brick

Street:	Orchard St. 256' North of Ridge Rd.	Project:	Hobart, IN
City:	Hobart, IN	GPS Northing:	41.54475784
Location:		GPS Easting:	-87.29167938
Drain Area:	Northwest	GPS Accuracy:	Nearest Meter
Cover Shape:	Circular	Evidence of Surcharge:	No
Cover Size:	22.5	Potential for Runoff:	None
Comments:

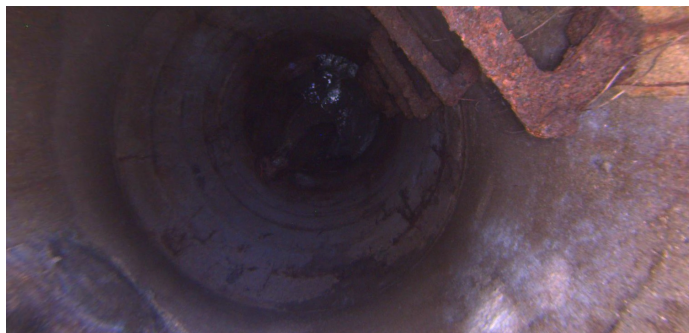
Code: **MGO**  
Description: **General Observation**

Distance (ft): **.0**  
Structural Grade: **0**  
O&M Grade: **0**  
Clock Start/From:  
Clock To:  
1st Value:  
2nd Value:  
Value Percent:  
Step: **NO**  
Remarks: **ACCESS MH**

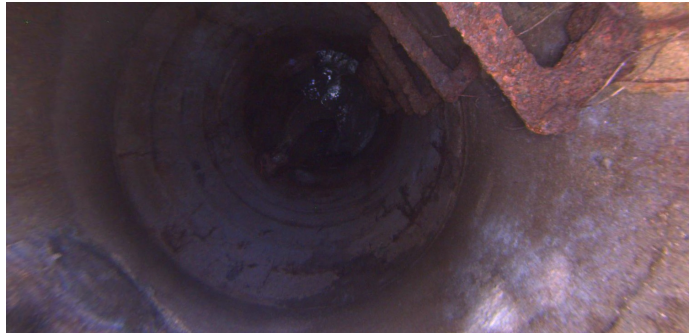
Code: **SAV**  
Description: **Surface Aggregate Visible**

Distance (ft): **.0**  
Structural Grade: **3**  
O&M Grade: **0**  
Clock Start/From: **12**  
Clock To: **12**  
1st Value:  
2nd Value:  
Value Percent:  
Step: **NO**  
Remarks:

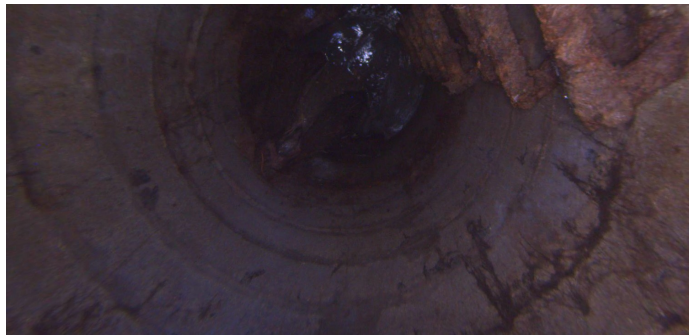
Code: **RFJ**  
Description: **Roots Fine Joint**

Distance (ft): **2.4**  
Structural Grade: **0**  
O&M Grade: **1**  
Clock Start/From: **4**  
Clock To: **8**  
1st Value:  
2nd Value:  
Value Percent:  
Step: **NO**  
Remarks:

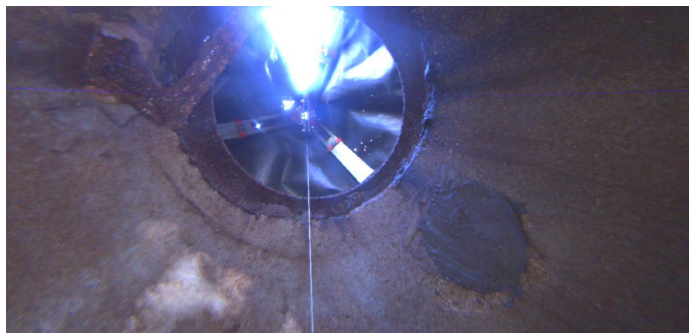
Code: **RPP**  
Description: **Repair Patch**

Distance (ft): **3.2**  
Structural Grade: **0**  
O&M Grade: **0**  
Clock Start/From: **8**  
Clock To: **9**  
1st Value:  
2nd Value:  
Value Percent:  
Step: **NO**  
Remarks: **CEMENT**

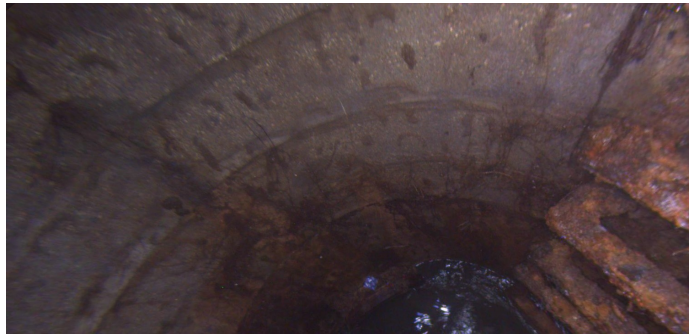
Code: **RFB**  
Description: **Roots Fine Barrel**

Distance (ft): **5.0**  
Structural Grade: **0**  
O&M Grade: **2**  
Clock Start/From: **10**  
Clock To: **2**  
1st Value:  
2nd Value:  
Value Percent:  
Step: **NO**  
Remarks:

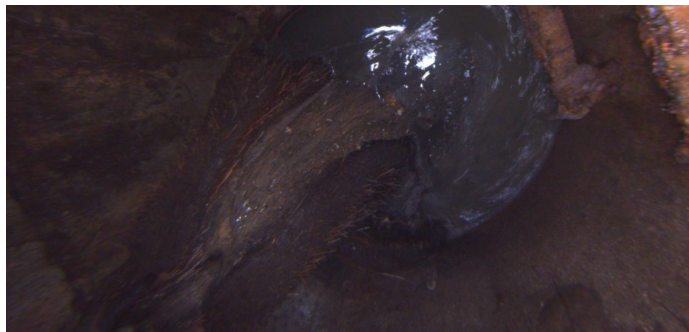
Code: **RMC**  
Description: **Roots Medium Connection**

Distance (ft): **6.9**  
Structural Grade: **0**  
O&M Grade: **3**  
Clock Start/From: **7**  
Clock To: **8**  
1st Value:  
2nd Value:  
Value Percent: **20.000**  
Step: **NO**  
Remarks:

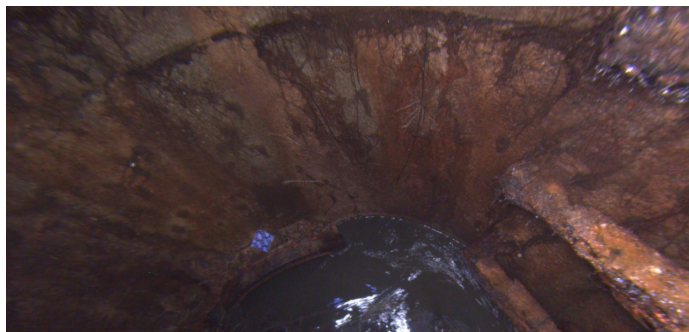
Code: **RFJ**  
Description: **Roots Fine Joint**

Distance (ft): **7.1**  
Structural Grade: **0**  
O&M Grade: **1**  
Clock Start/From: **9**  
Clock To: **3**  
1st Value:  
2nd Value:  
Value Percent:  
Step: **NO**  
Remarks:

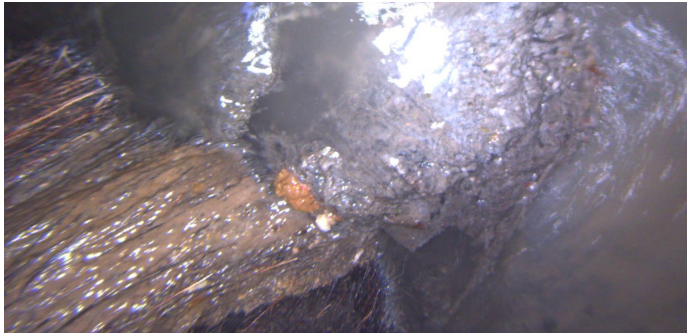
Code: **MGO**  
Description: **General Observation**

Distance (ft): **9.7**  
Structural Grade: **0**  
O&M Grade: **0**  
Clock Start/From:  
Clock To:  
1st Value:  
2nd Value:  
Value Percent:  
Step: **NO**  
Remarks: **END SURVEY**

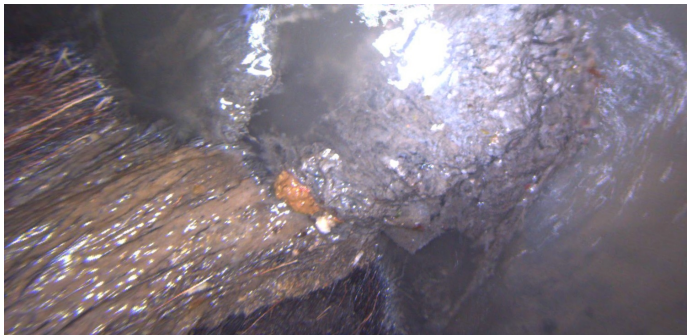
Code: **SAV**  
Description: **Surface Aggregate Visible**

Distance (ft): **9.7**  
Structural Grade: **3**  
O&M Grade: **0**  
Clock Start/From: **12**  
Clock To: **12**  
1st Value:  
2nd Value:  
Value Percent:  
Step: **NO**  
Remarks:
