# Manhole Inspection Report

Date:	<b>10/05/2022</b>	Weather:		Coding:	<b>RZMACP</b>
MH#:	<b>M-303-010</b>	Owner:	<b>NA</b>	Len. Surveyed:	<b>7.7</b>
P.O.#:		Surveyor:	<b>Jen Costello</b>	Rim to Invert:	<b>9.1</b>
Customer:		Cert. #:	<b>U-907-5518</b>	Wall Material:	<b>Concrete (cast in place)</b>

Street:	<b>Old Ridge Rd. 90' East of Ridge Pl.</b>	Project:	<b>Hobart, IN</b>
City:	<b>Hobart, IN</b>	GPS Northing:	<b>2294315.272</b>
Location:	<b>Other</b>	GPS Easting:	<b>2894889.18</b>
Drain Area:	<b>Northwest</b>	GPS Accuracy:	<b>Sub-Meter</b>
Cover Shape:	<b>Circular</b>	Evidence of Surcharge:	<b>Yes</b>
Cover Size:	<b>24.0</b>	Potential for Runoff:	<b>None</b>
Comments:

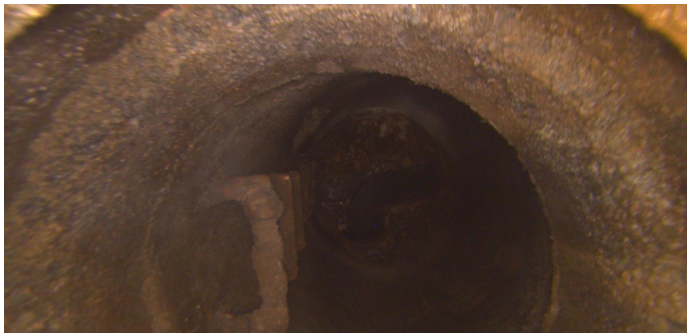
Code: **MGO**  
Description: **General Observation**

Distance (ft):	.0
Structural Grade:	0
O&M Grade:	0
Clock Start/From:	
Clock To:	
1st Value:	
2nd Value:	
Value Percent:

Step:	NO
Remarks:	access mh

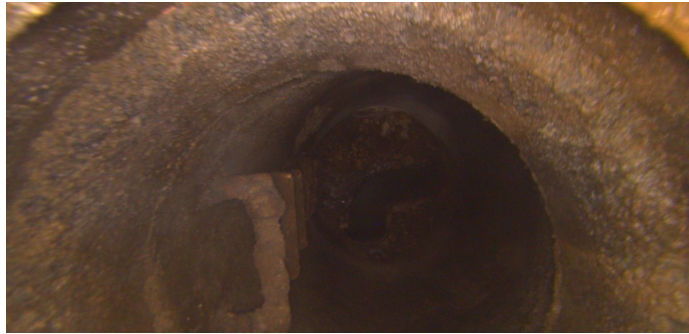
Code: **SRI**  
Description: **Surface Roughness Increased**

Distance (ft): **.0**  
Structural Grade: **1**  
O&M Grade: **0**  
Clock Start/From: **12**  
Clock To: **12**  
1st Value:  
2nd Value:  
Value Percent:  
Step: **NO**  
Remarks:

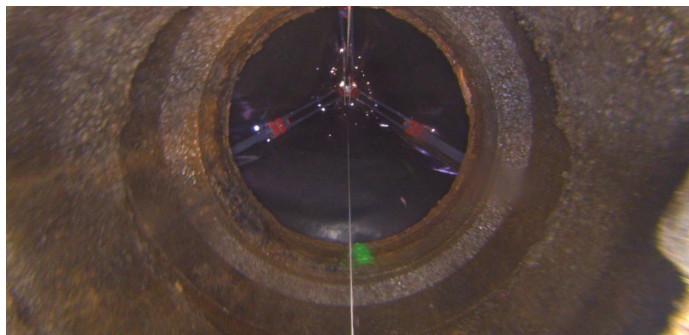
Code: **MGO**  
Description: **General Observation**

Distance (ft): **2.3**  
Structural Grade: **0**  
O&M Grade: **0**  
Clock Start/From:  
Clock To:  
1st Value:  
2nd Value:  
Value Percent:  
Step: **NO**  
Remarks: **underside of frame**

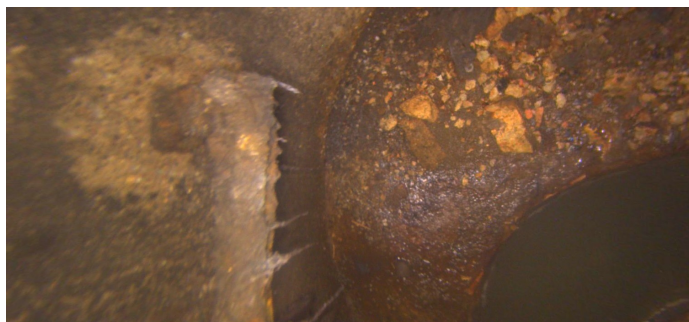
Code: **DAR**  
Description: **Deposits Attached Ragging**

Distance (ft): **6.1**  
Structural Grade: **0**  
O&M Grade: **2**  
Clock Start/From: **8**  
Clock To: **9**  
1st Value:  
2nd Value:  
Value Percent: **10.000**  
Step: **YES**  
Remarks:

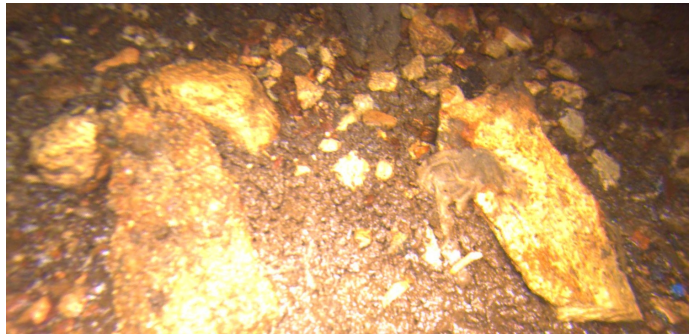
Code: **OBR**  
Description: **Obstacle Rocks**

Distance (ft): **7.7**  
Structural Grade: **0**  
O&M Grade: **2**  
Clock Start/From: **12**  
Clock To: **12**  
1st Value:  
2nd Value:  
Value Percent: **10.000**  
Step: **NO**  
Remarks:

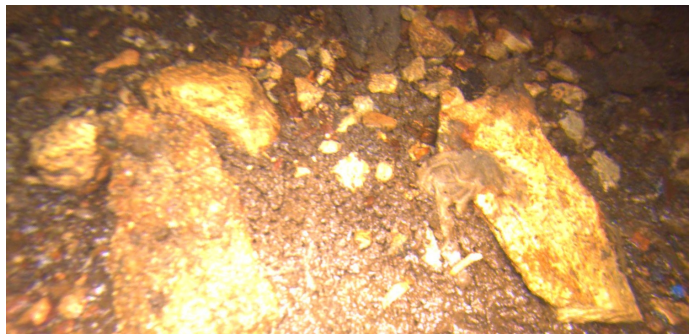
Code: **SRI**  
Description: **Surface Roughness Increased**

Distance (ft): **7.7**  
Structural Grade: **1**  
O&M Grade: **0**  
Clock Start/From: **12**  
Clock To: **12**  
1st Value:  
2nd Value:  
Value Percent:  
Step: **NO**  
Remarks:

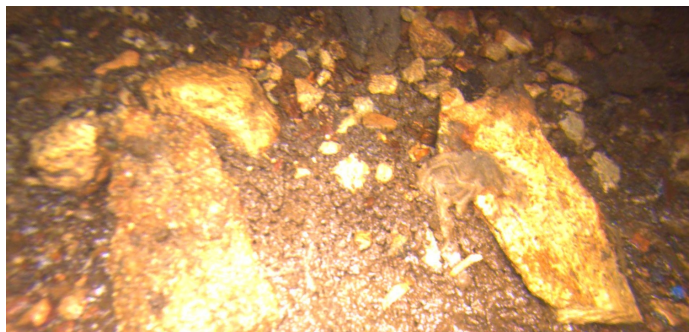
Code: **MGO**  
Description: **General Observation**

Distance (ft): **7.7**  
Structural Grade: **0**  
O&M Grade: **0**  
Clock Start/From:  
Clock To:  
1st Value:  
2nd Value:  
Value Percent:  
Step: **NO**  
Remarks: **end of survey**
