Manhole Inspection Report

Date:	04/19/2018	Weather:		Coding:	RZMACP
MH#:	M-303-029	Owner:	NA	Len. Surveyed:	4.9
P.O.#:		Surveyor:	Jen Costello	Rim to Invert:	6.6
Customer:		Cert. #:	U-907-5518	Wall Material:	Concrete (reinforced)

Street:	Kenwood St. and 38th Ave to the So	Project:	Hobart, IN
City:	Hobart, IN	GPS Northing:	2894746.598
Location:		GPS Easting:	2894746.598
Drain Area:	Northwest	GPS Accuracy:	Sub-Meter
Cover Shape:	Circular	Evidence of Surcharge:	No
Cover Size:	23.0	Potential for Runoff:	None
Comments:

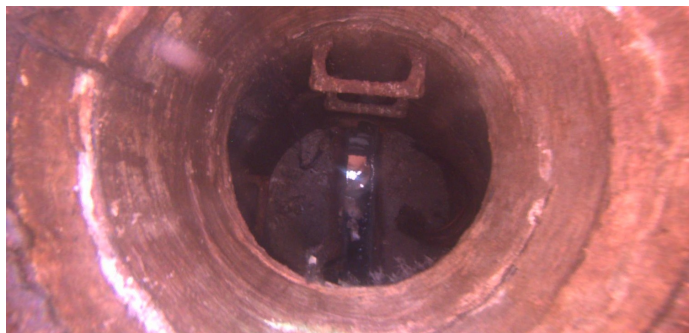
Code: **MGO**
Description: **General Observation**

Distance (ft): **.0**
Structural Grade: **0**
O&M Grade: **0**
Clock Start/From:
Clock To:
1st Value:
2nd Value:
Value Percent:
Step: **NO**
Remarks: **ACCESS MH**

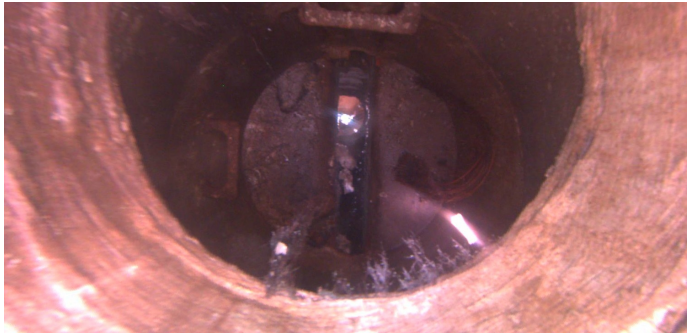
Code: **RFJ**
Description: **Roots Fine Joint**

Distance (ft): **.9**
Structural Grade: **0**
O&M Grade: **1**
Clock Start/From: **5**
Clock To: **6**
1st Value:
2nd Value:
Value Percent:
Step: **NO**
Remarks:

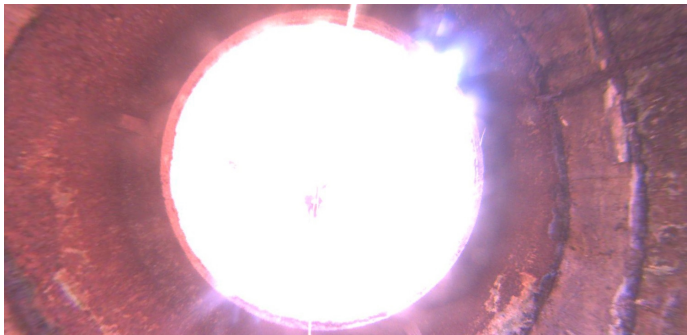
Code: **MGO**
Description: **General Observation**

Distance (ft): **1.5**
Structural Grade: **0**
O&M Grade: **0**
Clock Start/From:
Clock To:
1st Value:
2nd Value:
Value Percent:
Step: **NO**
Remarks: **UNDERSIDE OF FRAME**

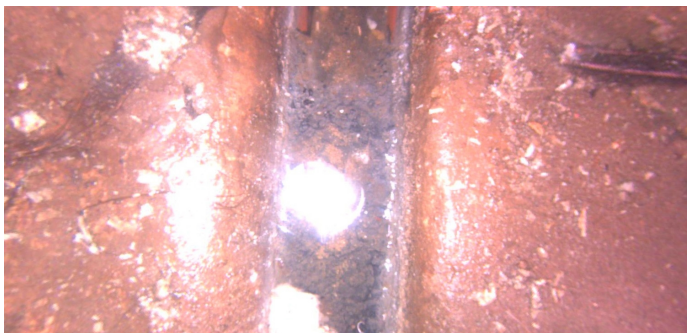
Code: **MGO**
Description: **General Observation**

Distance (ft): **4.9**
Structural Grade: **0**
O&M Grade: **0**
Clock Start/From:
Clock To:
1st Value:
2nd Value:
Value Percent:
Step: **NO**
Remarks: **END SURVEY**
