Manhole Inspection Report

Date:	04/13/2018	Weather:		Coding:	RZMACP
MH#:	M-303-033	Owner:	NA	Len. Surveyed:	6.0
P.O.#:		Surveyor:	Jen Costello	Rim to Invert:	13.0
Customer:		Cert. #:	U-907-5518	Wall Material:	Concrete (reinforced)

Street:	Ridgelawn St. 168' North of 38th Av	Project:	Hobart, IN
City:	Hobart, IN	GPS Northing:	0.0
Location:		GPS Easting:	0.0
Drain Area:	Northwest	GPS Accuracy:	Nearest Meter
Cover Shape:	Circular	Evidence of Surcharge:	No
Cover Size:	23.0	Potential for Runoff:	None
Comments:

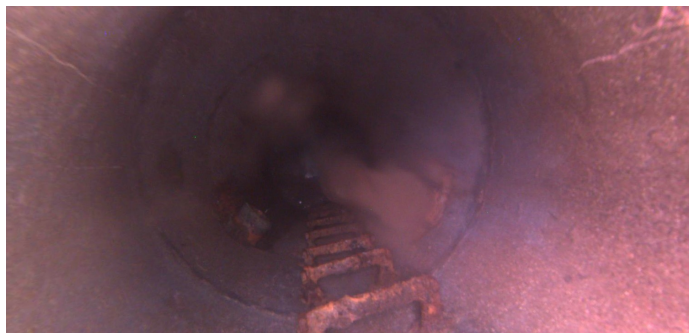
Code: **MGO**
Description: **General Observation**

Distance (ft): **.0**
Structural Grade: **0**
O&M Grade: **0**
Clock Start/From:
Clock To:
1st Value:
2nd Value:
Value Percent:
Step: **NO**
Remarks: **END SURVEY**

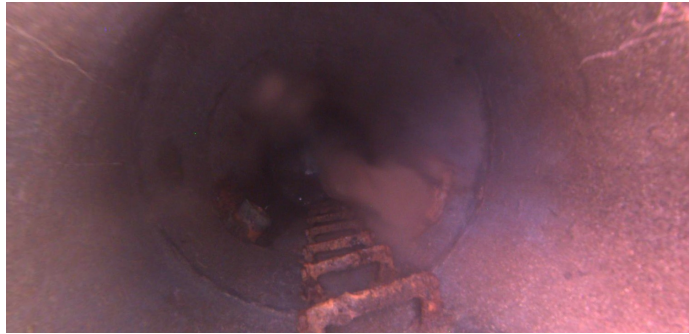
Code: **SAV**
Description: **Surface Aggregate Visible**

Distance (ft): **.0**
Structural Grade: **3**
O&M Grade: **0**
Clock Start/From: **12**
Clock To: **12**
1st Value:
2nd Value:
Value Percent:
Step: **NO**
Remarks:

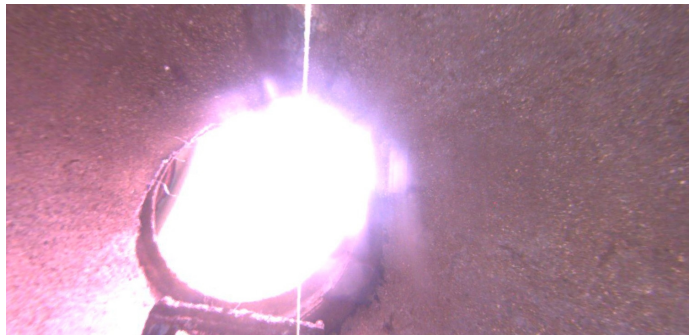
Code: **MGO**
Description: **General Observation**

Distance (ft): **3.1**
Structural Grade: **0**
O&M Grade: **0**
Clock Start/From:
Clock To:
1st Value:
2nd Value:
Value Percent:
Step: **NO**
Remarks: **UNDERSIDE OF FRAME**

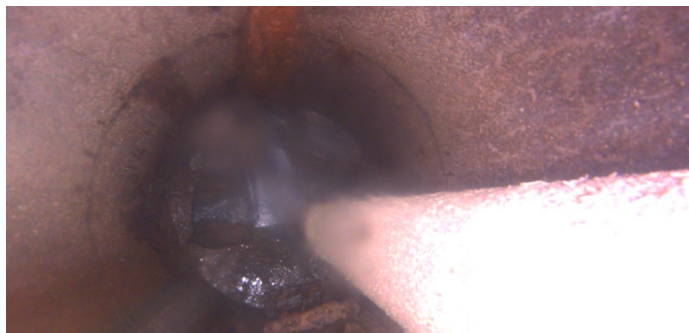
Code: **OBP**
Description: **Obstacle External Pipe or Cable**

Distance (ft): **6.0**
Structural Grade: **0**
O&M Grade: **3**
Clock Start/From: **3**
Clock To: **6**
1st Value:
2nd Value:
Value Percent: **20.000**
Step: **NO**
Remarks:
