# Manhole Inspection Report

Date:	<b>04/13/2018</b>	Weather:		Coding:	<b>RZMACP</b>
MH#:	<b>M-303-038</b>	Owner:	<b>NA</b>	Len. Surveyed:	<b>6.6</b>
P.O.#:		Surveyor:	<b>Jen Costello</b>	Rim to Invert:	<b>8.3</b>
Customer:		Cert. #:	<b>U-907-5518</b>	Wall Material:	<b>Concrete (reinforced)</b>

Street:	<b>Roche St. 416' South of 38th Ave.</b>	Project:	<b>Hobart, IN</b>
City:	<b>Hobart, IN</b>	GPS Northing:	<b>0.0</b>
Location:		GPS Easting:	<b>0.0</b>
Drain Area:	<b>Northwest</b>	GPS Accuracy:	<b>Nearest Meter</b>
Cover Shape:	<b>Circular</b>	Evidence of Surcharge:	<b>No</b>
Cover Size:	<b>23.0</b>	Potential for Runoff:	<b>None</b>
Comments:

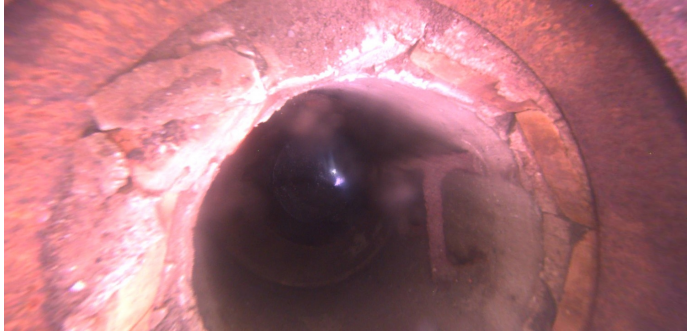
Code: **DB**  
Description: **Displaced Brick**

Distance (ft): **.0**  
Structural Grade: **3**  
O&M Grade: **0**  
Clock Start/From: **9**  
Clock To: **12**  
1st Value:  
2nd Value:  
Value Percent:  
Step: **NO**  
Remarks:

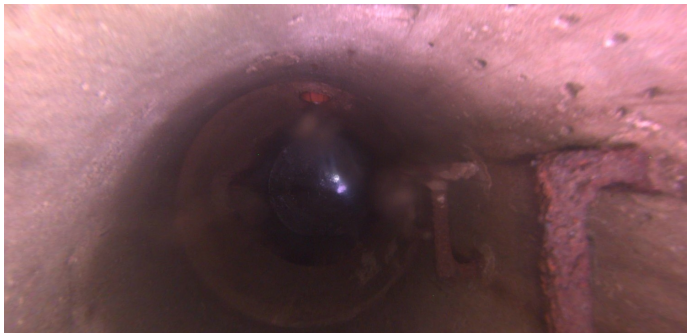
Code: **SRI**  
Description: **Surface Roughness Increased**

Distance (ft): **.8**  
Structural Grade: **1**  
O&M Grade: **0**  
Clock Start/From: **12**  
Clock To: **12**  
1st Value:  
2nd Value:  
Value Percent:  
Step: **NO**  
Remarks:

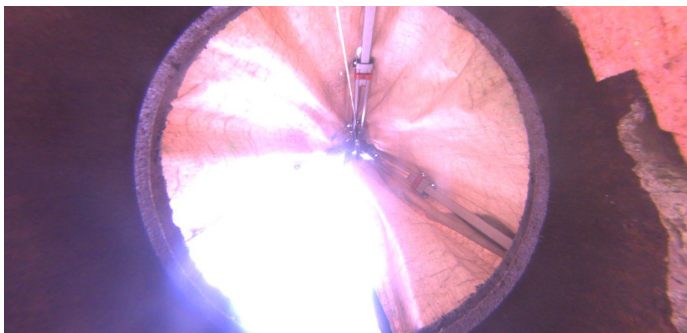
Code: **MGO**  
Description: **General Observation**

Distance (ft): **1.0**  
Structural Grade: **0**  
O&M Grade: **0**  
Clock Start/From:  
Clock To:  
1st Value:  
2nd Value:  
Value Percent:  
Step: **NO**  
Remarks: **UNDERSIDE OF FRAME**

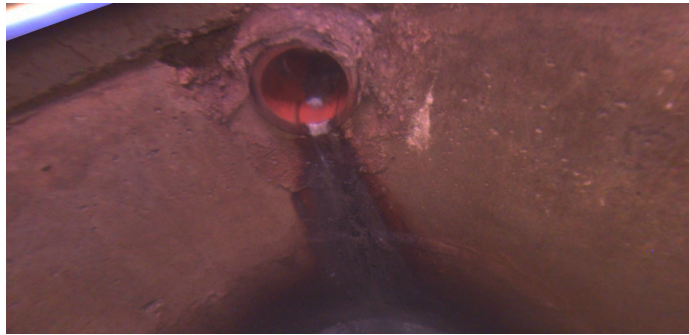
Code: **HSV**  
Description: **Hole Soil Visible**

Distance (ft): **3.6**  
Structural Grade: **5**  
O&M Grade: **0**  
Clock Start/From: **11**  
Clock To: **12**  
1st Value:  
2nd Value:  
Value Percent:  
Step: **NO**  
Remarks:

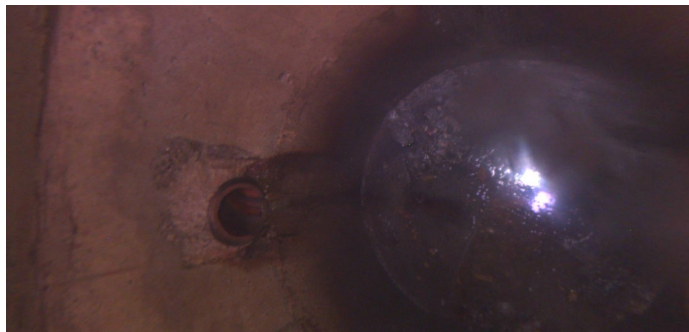
Code: **FC**  
Description: **Fracture Circumferential**

Distance (ft): **3.6**  
Structural Grade: **2**  
O&M Grade: **0**  
Clock Start/From: **8**  
Clock To: **9**  
1st Value:  
2nd Value:  
Value Percent:  
Step: **NO**  
Remarks:

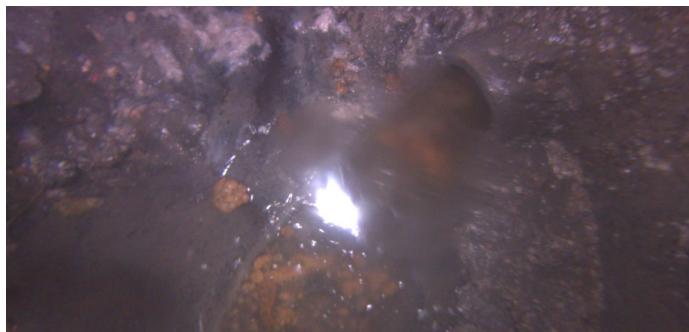
Code: **DSF**  
Description: **Deposits Settled Fine**

Distance (ft): **6.4**  
Structural Grade: **0**  
O&M Grade: **2**  
Clock Start/From: **12**  
Clock To: **12**  
1st Value:  
2nd Value:  
Value Percent: **10.000**  
Step: **NO**  
Remarks:

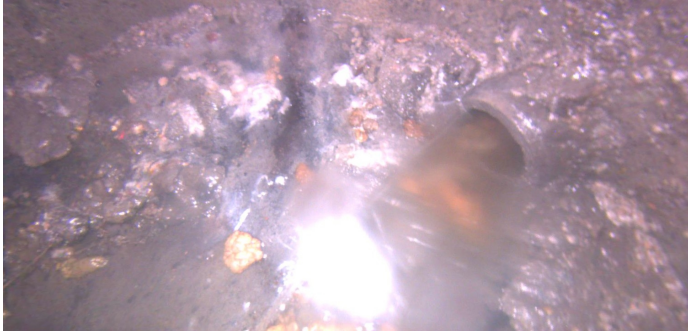
Code:	<b>MGO</b>
Description:	<b>General Observation</b>
Distance (ft):	<b>6.6</b>
Structural Grade:	<b>0</b>
O&M Grade:	<b>0</b>
Clock Start/From:	
Clock To:	
1st Value:	
2nd Value:	
Value Percent:	
Step:	<b>NO</b>
Remarks:	<b>UNDERSIDE OF FRAME</b>
