Manhole Inspection Report

Date:	04/13/2018	Weather:		Coding:	RZMACP
MH#:	M-303-039	Owner:	NA	Len. Surveyed:	7.2
P.O.#:		Surveyor:	Jen Costello	Rim to Invert:	8.3
Customer:		Cert. #:	U-907-5518	Wall Material:	Concrete (reinforced)

Street:	Intersection of 38th Ave. and Roche	Project:	Hobart, IN
City:	Hobart, IN	GPS Northing:	0.0
Location:		GPS Easting:	0.0
Drain Area:	Northwest	GPS Accuracy:	Nearest Meter
Cover Shape:	Circular	Evidence of Surcharge:	No
Cover Size:	23.0	Potential for Runoff:	None
Comments:

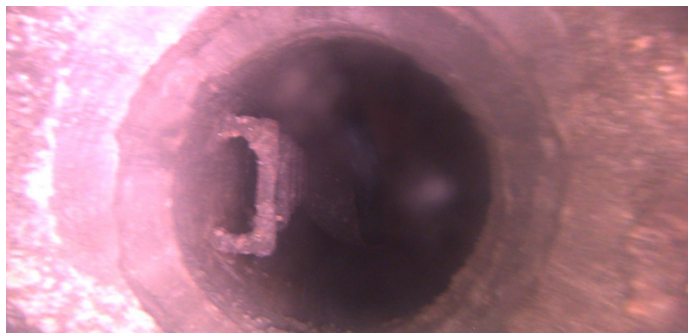
Code: **MGO**
Description: **General Observation**

Distance (ft): **.0**
Structural Grade: **0**
O&M Grade: **0**
Clock Start/From:
Clock To:
1st Value:
2nd Value:
Value Percent:
Step: **NO**
Remarks: **ACCESS MH**

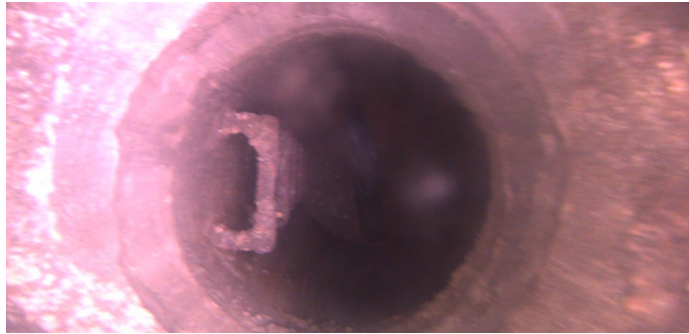
Code:	SRV
Description:	Surface Reinforcement Visible
Distance (ft):	.0
Structural Grade:	5
O&M Grade:	0
Clock Start/From:	12
Clock To:	12
1st Value:	
2nd Value:	
Value Percent:	
Step:	NO
Remarks:

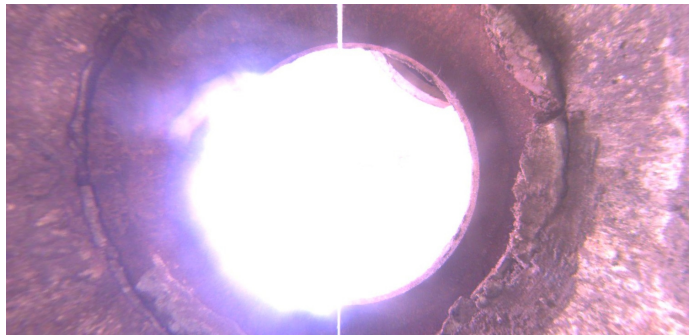
Code:	MGP
Description:	General Photo
Distance (ft):	1.5
Structural Grade:	0
O&M Grade:	0
Clock Start/From:	
Clock To:	
1st Value:	
2nd Value:	
Value Percent:	
Step:	NO
Remarks:	UNDERSIDE OF FRAME

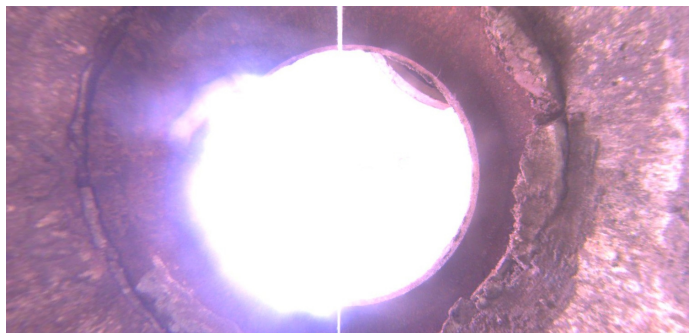
Code:	B
Description:	Broken
Distance (ft):	1.5
Structural Grade:	5
O&M Grade:	0
Clock Start/From:	8
Clock To:	10
1st Value:	
2nd Value:	
Value Percent:	
Step:	NO
Remarks:

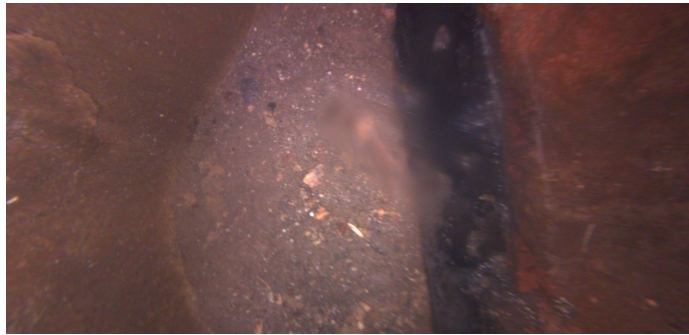
Code: **DSF**
Description: **Deposits Settled Fine**

Distance (ft): **6.5**
Structural Grade: **0**
O&M Grade: **2**
Clock Start/From: **6**
Clock To: **12**
1st Value:
2nd Value:
Value Percent: **5.000**
Step: **NO**
Remarks:

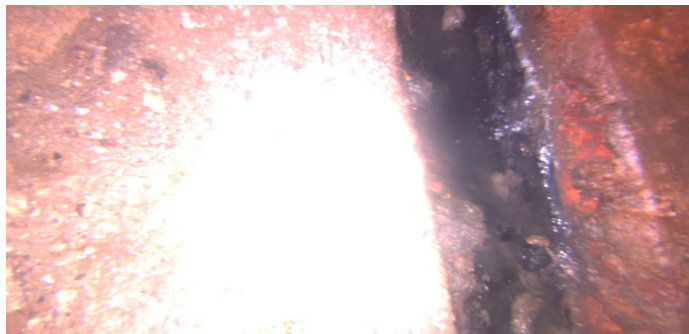
Code: **MGO**
Description: **General Observation**

Distance (ft): **7.2**
Structural Grade: **0**
O&M Grade: **0**
Clock Start/From:
Clock To:
1st Value:
2nd Value:
Value Percent:
Step: **NO**
Remarks: **END SURVEY**

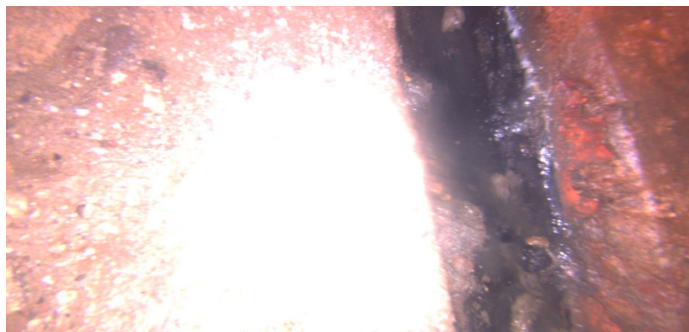
Code: **SRV**
Description: **Surface Reinforcement Visible**

Distance (ft): **7.2**
Structural Grade: **5**
O&M Grade: **0**
Clock Start/From: **12**
Clock To: **12**
1st Value:
2nd Value:
Value Percent:
Step: **NO**
Remarks:
