Manhole Inspection Report

Date:	04/13/2018	Weather:		Coding:	RZMACP
MH#:	M-303-045	Owner:	NA	Len. Surveyed:	5.1
P.O.#:		Surveyor:	Jen Costello	Rim to Invert:	6.0
Customer:		Cert. #:	U-907-5518	Wall Material:	Concrete (reinforced)

Street:	Intersection of Brown St. and 38th A	Project:	Hobart, IN
City:	Hobart, IN	GPS Northing:	0.0
Location:		GPS Easting:	0.0
Drain Area:	Northwest	GPS Accuracy:	Nearest Meter
Cover Shape:	Circular	Evidence of Surcharge:	No
Cover Size:	23.0	Potential for Runoff:	None
Comments:

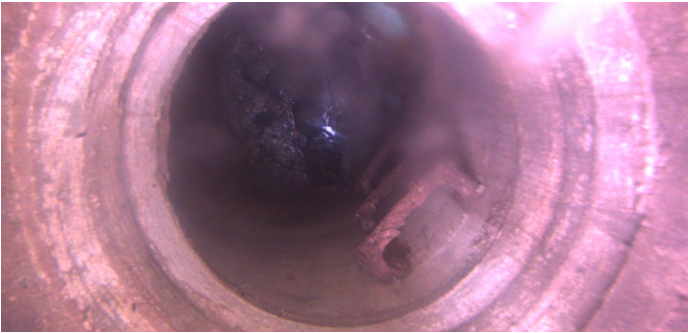
Code:

Description:

MGP

General Photo

Distance (ft):

Structural Grade:

O&M Grade:

.0

0

NO

ACCESS MH

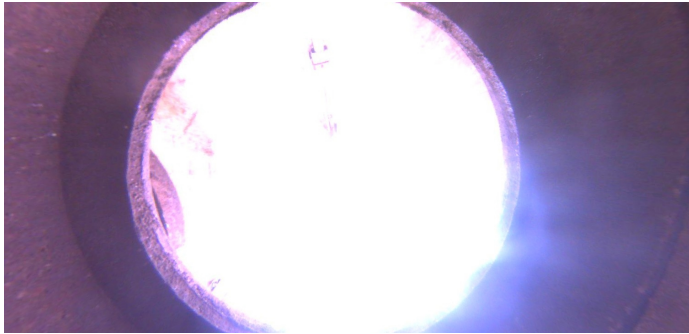
Code: **MGO**
Description: **General Observation**

Distance (ft): **1.1**
Structural Grade: **0**
O&M Grade: **0**
Clock Start/From:
Clock To:
1st Value:
2nd Value:
Value Percent:
Step: **NO**
Remarks: **ACCESS MH**

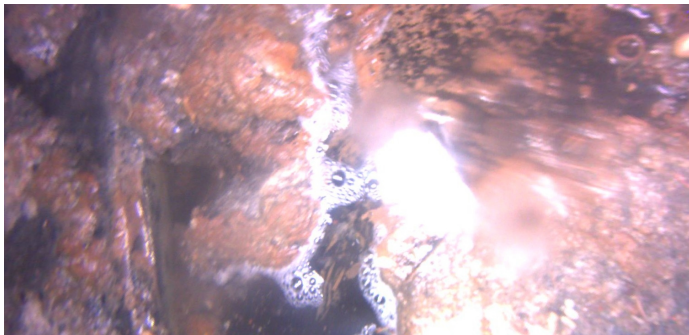
Code: **MGO**
Description: **General Observation**

Distance (ft): **5.1**
Structural Grade: **0**
O&M Grade: **0**
Clock Start/From:
Clock To:
1st Value:
2nd Value:
Value Percent:
Step: **NO**
Remarks: **END SURVEY**
