Manhole Inspection Report

Date:	09/20/2022	Weather:		Coding:	RZMACP
MH#:	M-303-047	Owner:	NA	Len. Surveyed:	14.4
P.O.#:		Surveyor:	Jen Costello	Rim to Invert:	16.0
Customer:		Cert. #:	U-907-5518	Wall Material:	Concrete (cast in place)

Street:	Ridgelawn St. 248' South of 37th Av	Project:	Hobart, IN
City:	Hobart, IN	GPS Northing:	2295610.466
Location:	Yard	GPS Easting:	2895399.349
Drain Area:	Northwest	GPS Accuracy:	Sub-Meter
Cover Shape:	Circular	Evidence of Surcharge:	No
Cover Size:	24.0	Potential for Runoff:	None
Comments:

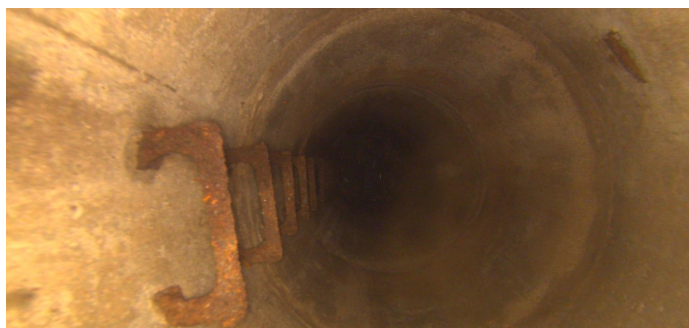
Code: **MGO**
Description: **General Observation**

Distance (ft): **.0**
Structural Grade: **0**
O&M Grade: **0**
Clock Start/From:
Clock To:
1st Value:
2nd Value:
Value Percent:
Step: **NO**
Remarks: **access mh**

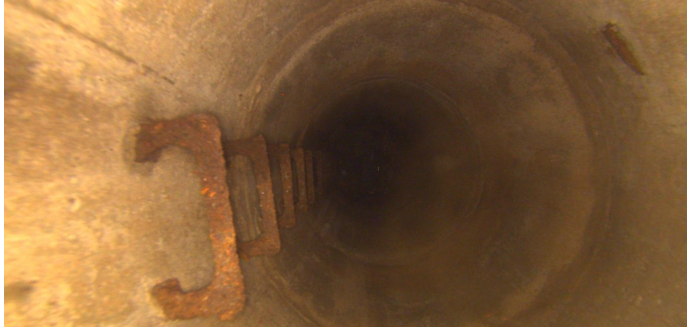
Code: **SRI**
Description: **Surface Roughness Increased**

Distance (ft): **.0**
Structural Grade: **1**
O&M Grade: **0**
Clock Start/From: **12**
Clock To: **12**
1st Value:
2nd Value:
Value Percent:
Step: **NO**
Remarks:

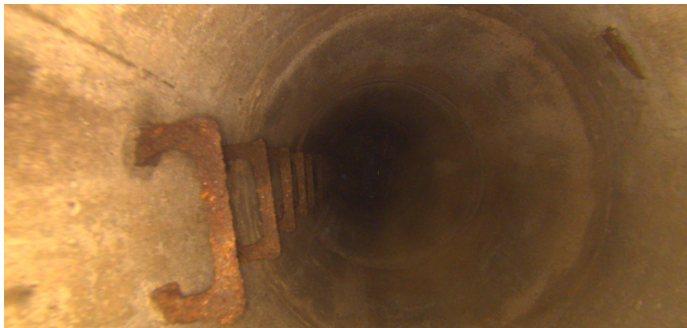
Code: **SRV**
Description: **Surface Reinforcement Visible**

Distance (ft): **.0**
Structural Grade: **5**
O&M Grade: **0**
Clock Start/From: **2**
Clock To:
1st Value:
2nd Value:
Value Percent:
Step: **NO**
Remarks:

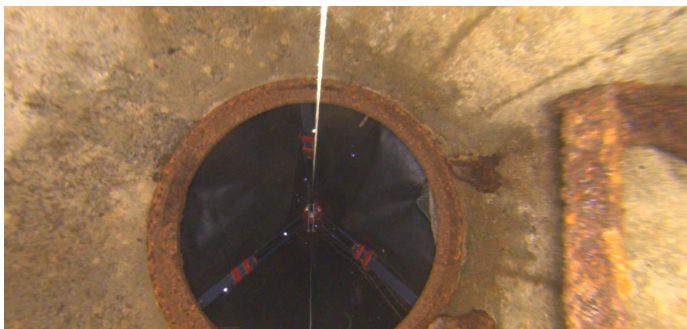
Code: **MGO**
Description: **General Observation**

Distance (ft): **2.3**
Structural Grade: **0**
O&M Grade: **0**
Clock Start/From:
Clock To:
1st Value:
2nd Value:
Value Percent:
Step: **NO**
Remarks: **underside of frame**

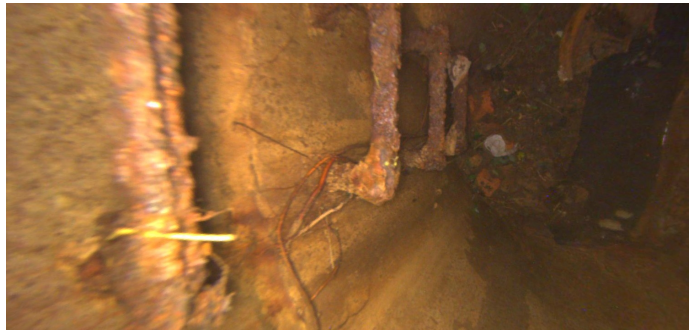
Code: **RFJ**
Description: **Roots Fine Joint**

Distance (ft): **10.4**
Structural Grade: **0**
O&M Grade: **1**
Clock Start/From: **8**
Clock To: **9**
1st Value:
2nd Value:
Value Percent:
Step: **NO**
Remarks:

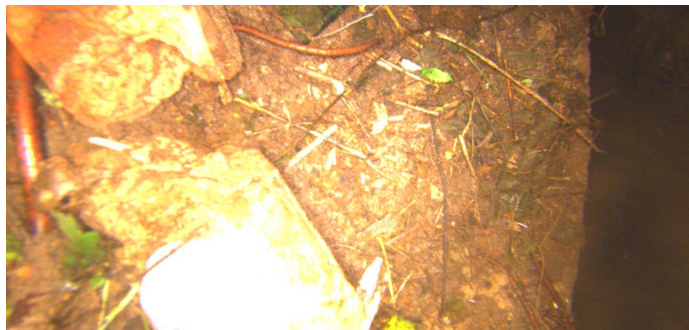
Code: **OBZ**
Description: **Obstacle Other**

Distance (ft): **14.4**
Structural Grade: **0**
O&M Grade: **2**
Clock Start/From: **12**
Clock To: **12**
1st Value:
2nd Value:
Value Percent: **10.000**
Step: **NO**
Remarks: **misc**

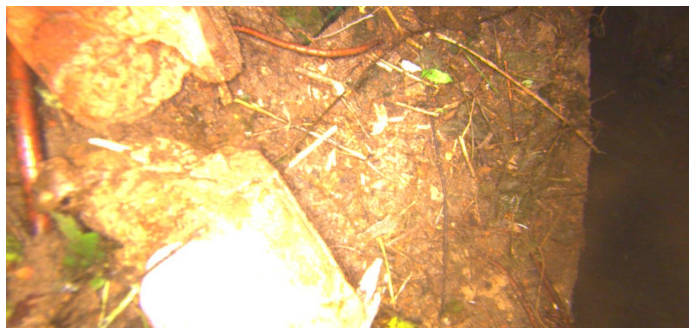
Code: **DSF**
Description: **Deposits Settled Fine**

Distance (ft): **14.4**
Structural Grade: **0**
O&M Grade: **2**
Clock Start/From: **12**
Clock To: **12**
1st Value:
2nd Value:
Value Percent: **5.000**
Step: **NO**
Remarks:

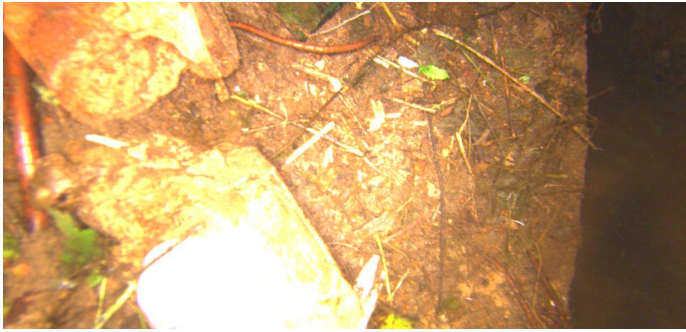
Code: **MGO**
Description: **General Observation**

Distance (ft): **14.4**
Structural Grade: **0**
O&M Grade: **0**
Clock Start/From:
Clock To:
1st Value:
2nd Value:
Value Percent:
Step: **NO**
Remarks: **end of survey**

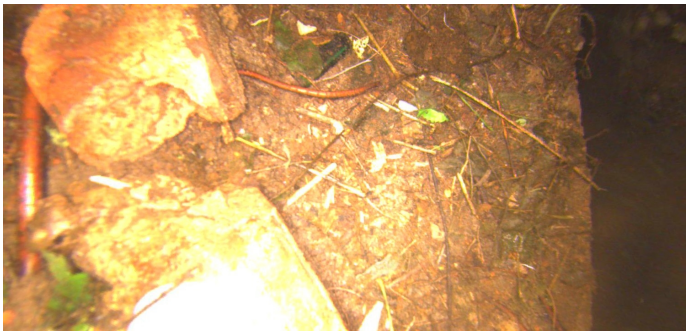
Code: **OBM**
Description: **Obstacle Pipe Material**

Distance (ft): **14.4**
Structural Grade: **0**
O&M Grade: **2**
Clock Start/From: **6**
Clock To: **12**
1st Value:
2nd Value:
Value Percent: **5.000**
Step: **NO**
Remarks:
