Manhole Inspection Report

Date:	05/16/2018	Weather:		Coding:	RZMACP
MH#:	M-303-048	Owner:	NA	Len. Surveyed:	11.4
P.O.#:		Surveyor:	Jen Costello	Rim to Invert:	12.0
Customer:		Cert. #:	U-907-5518	Wall Material:	Concrete (reinforced)

Street:	North of L.S. #4.	Project:	Hobart, IN
City:	Hobart, IN	GPS Northing:	41.55062866
Location:		GPS Easting:	-87.29304504
Drain Area:	Northwest	GPS Accuracy:	Nearest Meter
Cover Shape:	Circular	Evidence of Surcharge:	No
Cover Size:	22.5	Potential for Runoff:	None
Comments:

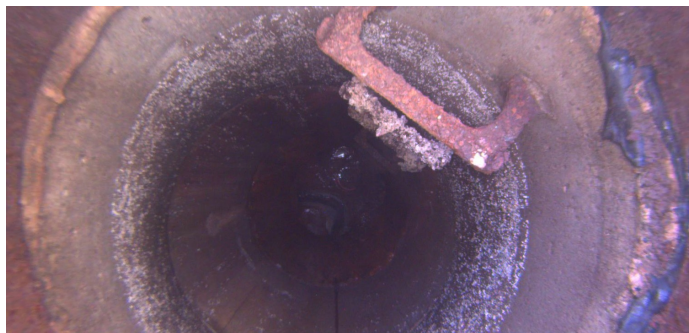
Code:	MGP
Description:	General Photo
Distance (ft):	.0
Structural Grade:	0
O&M Grade:	0
Clock Start/From:	
Clock To:	
1st Value:	
2nd Value:	
Value Percent:	
Step:	NO
Remarks:	ACCESS MH

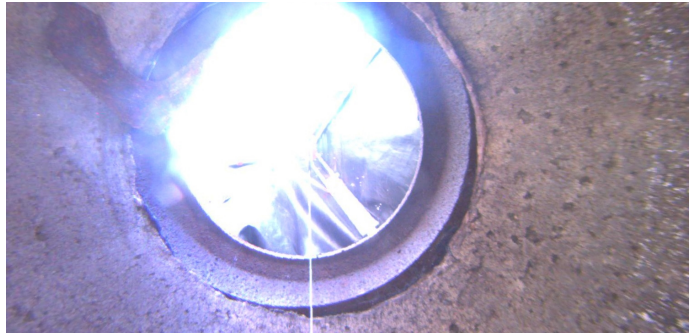
Code: **SRI**
Description: **Surface Roughness Increased**

Distance (ft): **3.0**
Structural Grade: **1**
O&M Grade: **0**
Clock Start/From: **12**
Clock To: **12**
1st Value:
2nd Value:
Value Percent:
Step: **NO**
Remarks:

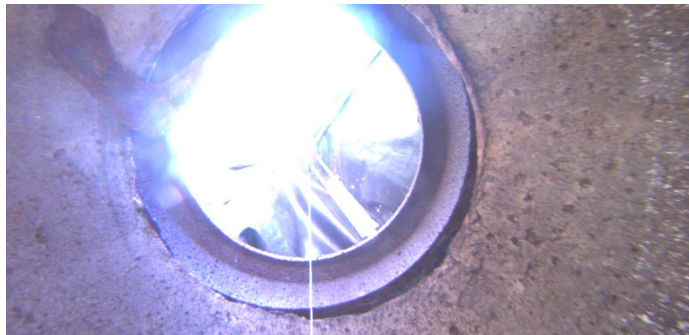
Code: **MGO**
Description: **General Observation**

Distance (ft): **3.0**
Structural Grade: **0**
O&M Grade: **0**
Clock Start/From:
Clock To:
1st Value:
2nd Value:
Value Percent:
Step: **NO**
Remarks: **UNDERSIDE OF FRAME**

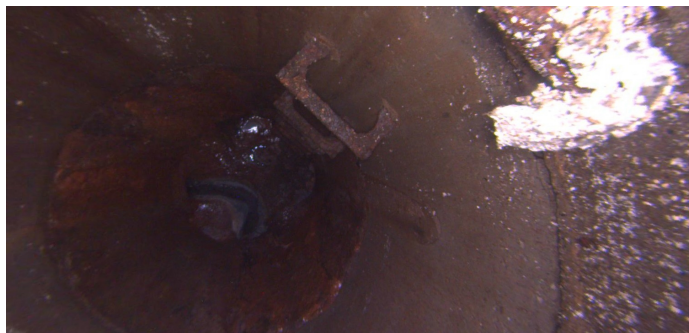
Code: **DAR**
Description: **Deposits Attached Ragging**

Distance (ft): **3.0**
Structural Grade: **0**
O&M Grade: **2**
Clock Start/From: **2**
Clock To:
1st Value:
2nd Value:
Value Percent: **5.000**
Step: **YES**
Remarks:

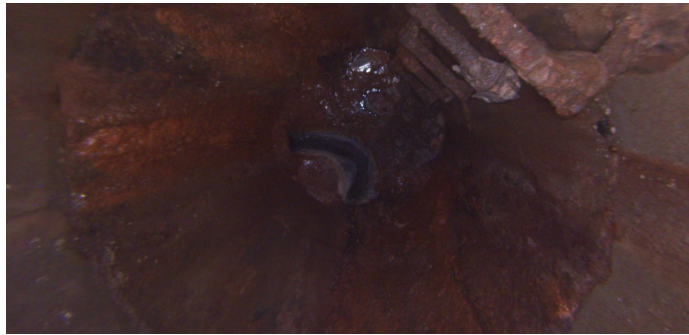
Code: **IW**
Description: **Infil Weeper**

Distance (ft): **5.5**
Structural Grade: **0**
O&M Grade: **2**
Clock Start/From: **12**
Clock To: **12**
1st Value:
2nd Value:
Value Percent:
Step: **NO**
Remarks:

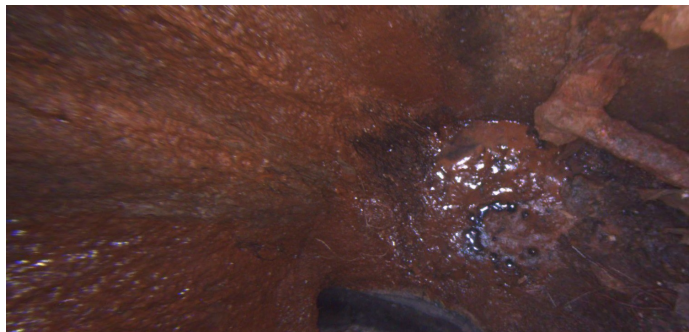
Code: **DAE**
Description: **Deposits Attached Encrustation**

Distance (ft): **9.1**
Structural Grade: **0**
O&M Grade: **2**
Clock Start/From: **9**
Clock To: **12**
1st Value:
2nd Value:
Value Percent: **5.000**
Step: **NO**
Remarks:

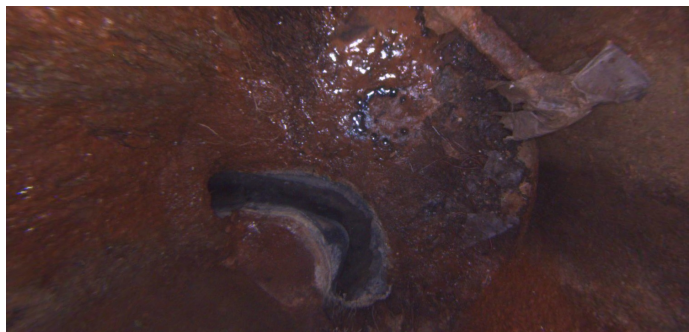
Code: **DAR**
Description: **Deposits Attached Ragging**

Distance (ft): **9.1**
Structural Grade: **0**
O&M Grade: **2**
Clock Start/From: **2**
Clock To:
1st Value:
2nd Value:
Value Percent: **5.000**
Step: **YES**
Remarks:

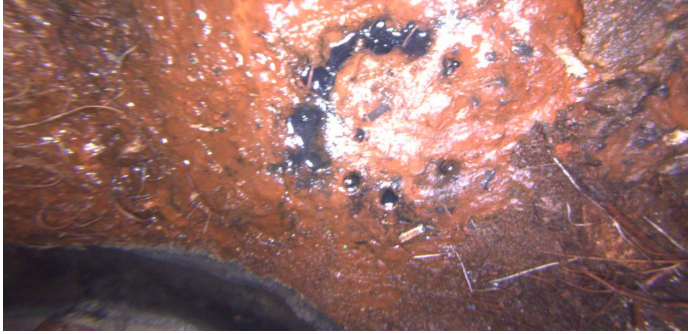
Code:	MGO
Description:	General Observation
Distance (ft):	11.4
Structural Grade:	0
O&M Grade:	0
Clock Start/From:	
Clock To:	
1st Value:	
2nd Value:	
Value Percent:	
Step:	NO
Remarks:	end survey
