Manhole Inspection Report

Date:	04/13/2018	Weather:		Coding:	RZMACP
MH#:	M-303-059	Owner:	NA	Len. Surveyed:	4.3
P.O.#:		Surveyor:	Jen Costello	Rim to Invert:	5.4
Customer:		Cert. #:	U-907-5518	Wall Material:	Concrete (reinforced)

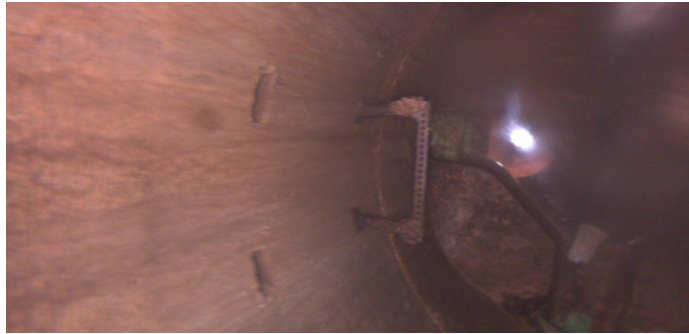
Code: **MGO**
Description: **General Observation**

Distance (ft): **1.1**
Structural Grade: **0**
O&M Grade: **0**
Clock Start/From:
Clock To:
1st Value:
2nd Value:
Value Percent:
Step: **NO**
Remarks: **MISSING STEP**

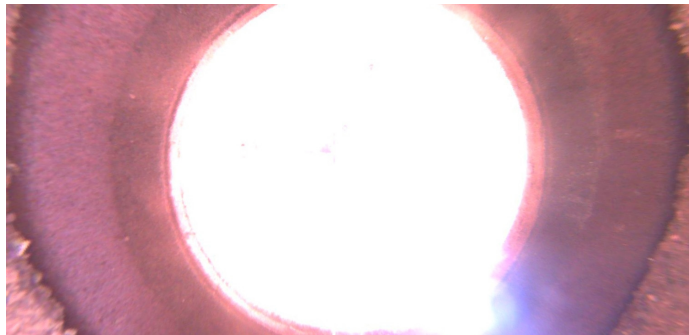
Code: **MGP**
Description: **General Photo**

Distance (ft): **1.1**
Structural Grade: **0**
O&M Grade: **0**
Clock Start/From:
Clock To:
1st Value:
2nd Value:
Value Percent:
Step: **NO**
Remarks: **UNDERSIDE OF FRAME**

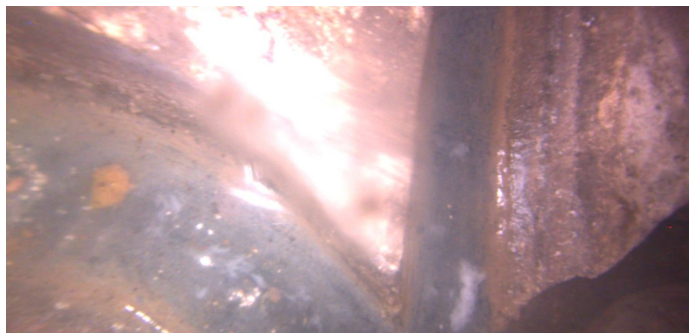
Code: **MGO**
Description: **General Observation**

Distance (ft): **4.3**
Structural Grade: **0**
O&M Grade: **0**
Clock Start/From:
Clock To:
1st Value:
2nd Value:
Value Percent:
Step: **NO**
Remarks: **END SURVEY**
