Manhole Inspection Report

Date:	04/13/2018	Weather:		Coding:	RZMACP
MH#:	M-303-060	Owner:	NA	Len. Surveyed:	4.8
P.O.#:		Surveyor:	Jen Costello	Rim to Invert:	5.6
Customer:		Cert. #:	U-907-5518	Wall Material:	Concrete (reinforced)

Street:	W. Hansen Blvd. 607' South of N. Ha	Project:	Hobart, IN
City:	Hobart, IN	GPS Northing:	0.0
Location:		GPS Easting:	0.0
Drain Area:	Northwest	GPS Accuracy:	Nearest Meter
Cover Shape:	Circular	Evidence of Surcharge:	No
Cover Size:	23.0	Potential for Runoff:	None
Comments:

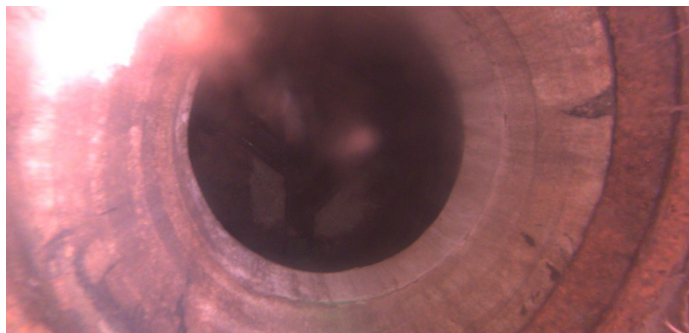
Code: **MGO**
Description: **General Observation**

Distance (ft): **.0**
Structural Grade: **0**
O&M Grade: **0**
Clock Start/From:
Clock To:
1st Value:
2nd Value:
Value Percent:
Step: **NO**
Remarks: **access MH**

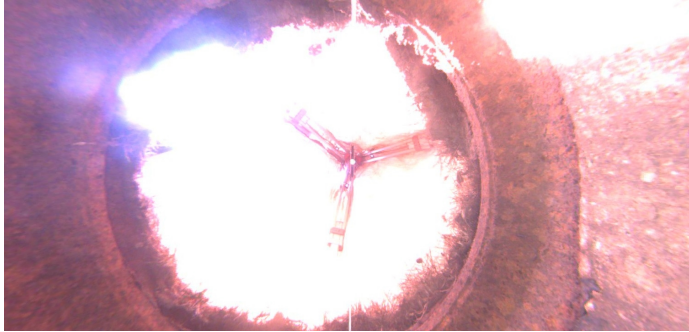
Code:	MGP
Description:	General Photo
Distance (ft):	1.3
Structural Grade:	0
O&M Grade:	0
Clock Start/From:	
Clock To:	
1st Value:	
2nd Value:	
Value Percent:	
Step:	NO
Remarks:	UNDERSIDE OF FRAME

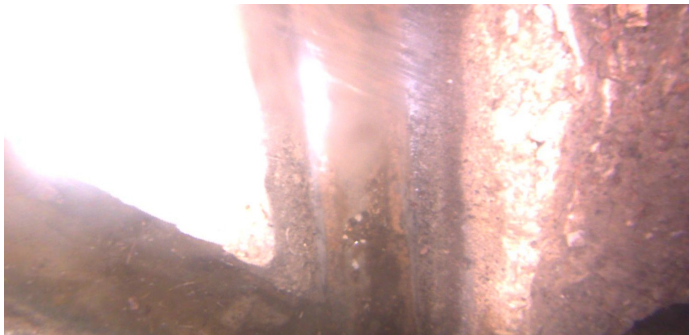
Code:	MGO
Description:	General Observation
Distance (ft):	4.8
Structural Grade:	0
O&M Grade:	0
Clock Start/From:	
Clock To:	
1st Value:	
2nd Value:	
Value Percent:	
Step:	NO
Remarks:	END SURVEY
