Manhole Inspection Report

Date:	04/13/2018	Weather:		Coding:	RZMACP
MH#:	M-303-068	Owner:	NA	Len. Surveyed:	5.0
P.O.#:		Surveyor:	Jen Costello	Rim to Invert:	6.2
Customer:		Cert. #:	U-907-5518	Wall Material:	Concrete (reinforced)

Street:	S. Hanson Blvd. and E. Hanson Blvd.	Project:	Hobart, IN
City:	Hobart, IN	GPS Northing:	0.0
Location:		GPS Easting:	0.0
Drain Area:	Northwest	GPS Accuracy:	Nearest Meter
Cover Shape:	Circular	Evidence of Surcharge:	No
Cover Size:	23.0	Potential for Runoff:	None
Comments:

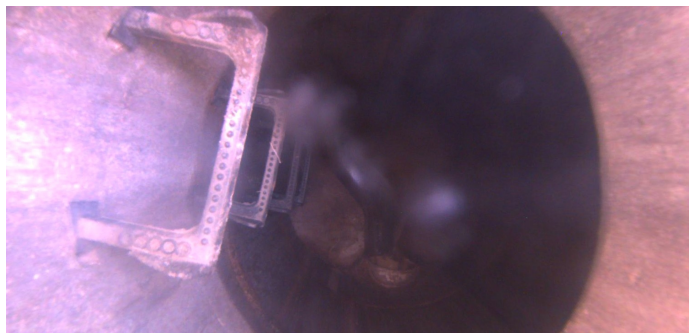
Code: **MGO**
Description: **General Observation**

Distance (ft): **.0**
Structural Grade: **0**
O&M Grade: **0**
Clock Start/From:
Clock To:
1st Value:
2nd Value:
Value Percent:
Step: **NO**
Remarks: **access MH**

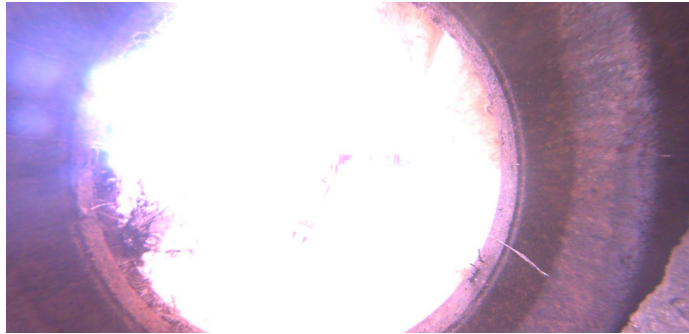
Code:	MGP
Description:	General Photo
Distance (ft):	1.0
Structural Grade:	0
O&M Grade:	0
Clock Start/From:	
Clock To:	
1st Value:	
2nd Value:	
Value Percent:	
Step:	NO
Remarks:	UNDERSIDE OF FRAME

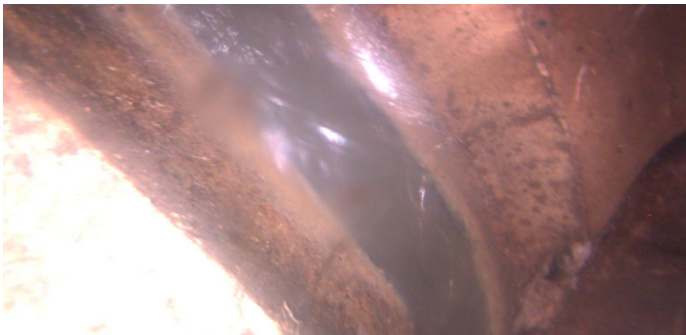
Code:	MGO
Description:	General Observation
Distance (ft):	5.0
Structural Grade:	0
O&M Grade:	0
Clock Start/From:	
Clock To:	
1st Value:	
2nd Value:	
Value Percent:	
Step:	NO
Remarks:	END SURVEY
