Manhole Inspection Report

Date:	04/12/2018	Weather:		Coding:	RZMACP
MH#:	M-303-070	Owner:	NA	Len. Surveyed:	3.3
P.O.#:		Surveyor:	John Kuglmaier	Rim to Invert:	4.5
Customer:		Cert. #:	U-1215-07002349	Wall Material:	Concrete (reinforced)

Street:	39th Ave. 387' East of Ridgelawn St.	Project:	Hobart, IN
City:	Hobart, IN	GPS Northing:	2895766.838
Location:		GPS Easting:	2895766.838
Drain Area:	Northwest	GPS Accuracy:	Sub-Meter
Cover Shape:	Circular	Evidence of Surcharge:	No
Cover Size:	23.0	Potential for Runoff:	None
Comments:

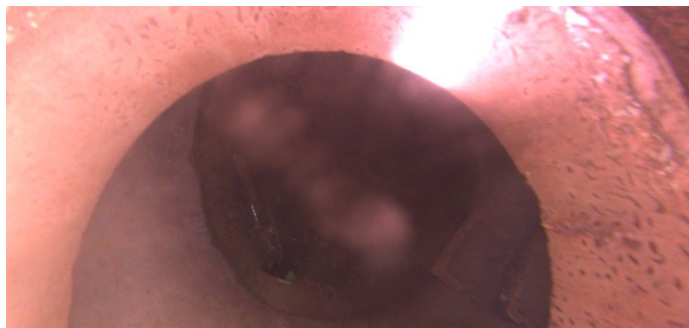
Code: **MGP**
Description: **General Photo**

Distance (ft): **.0**
Structural Grade: **0**
O&M Grade: **0**
Clock Start/From:
Clock To:
1st Value:
2nd Value:
Value Percent:
Step: **NO**
Remarks:

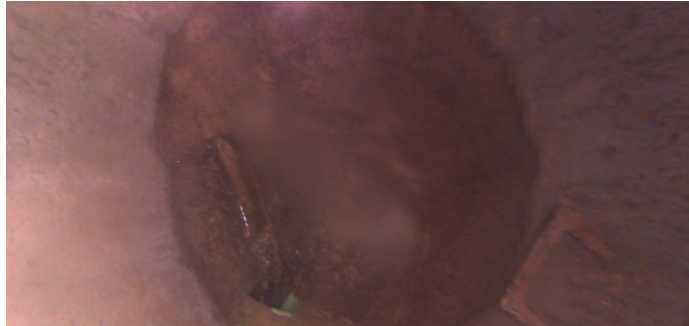
Code: **DAZ**
Description: **Deposits Attached Other**

Distance (ft): **1.1**
Structural Grade: **0**
O&M Grade: **2**
Clock Start/From: **12**
Clock To: **12**
1st Value:
2nd Value:
Value Percent: **10.000**
Step: **NO**
Remarks: **Mixed materials**

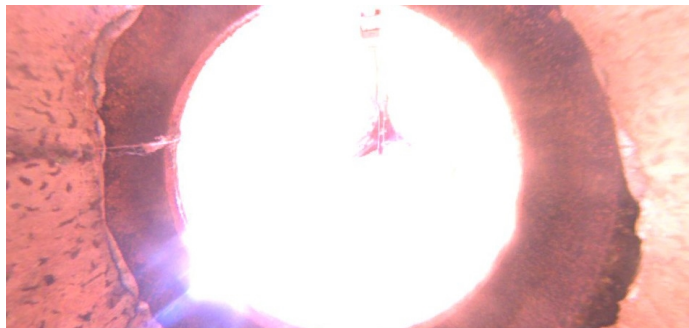
Code: **MGP**
Description: **General Photo**

Distance (ft): **1.5**
Structural Grade: **0**
O&M Grade: **0**
Clock Start/From:
Clock To:
1st Value:
2nd Value:
Value Percent:
Step: **NO**
Remarks:

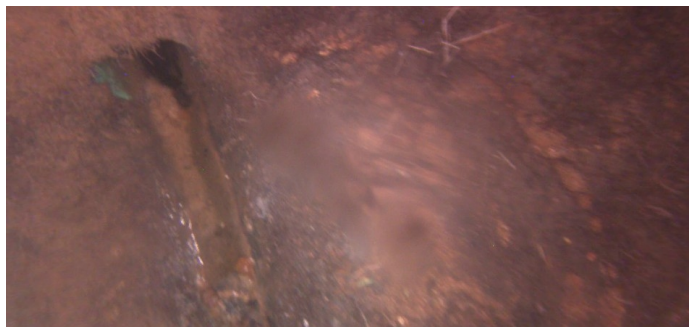
Code: **MGO**
Description: **General Observation**

Distance (ft): **2.8**
Structural Grade: **0**
O&M Grade: **0**
Clock Start/From:
Clock To:
1st Value:
2nd Value:
Value Percent:
Step: **NO**
Remarks: **Ins. Comp.**
