Manhole Inspection Report

Date:	04/12/2018	Weather:		Coding:	RZMACP
MH#:	M-303-072	Owner:	NA	Len. Surveyed:	2.7
P.O.#:		Surveyor:	John Kuglmaier	Rim to Invert:	3.4
Customer:		Cert. #:	U-1215-07002349	Wall Material:	Concrete (reinforced)

Street:	Ridgelawn St. 369' North of Old Ridg	Project:	Hobart, IN
City:	Hobart, IN	GPS Northing:	2895423.225
Location:		GPS Easting:	2895423.225
Drain Area:	Northwest	GPS Accuracy:	Sub-Meter
Cover Shape:	Circular	Evidence of Surcharge:	No
Cover Size:	23.0	Potential for Runoff:	None
Comments:

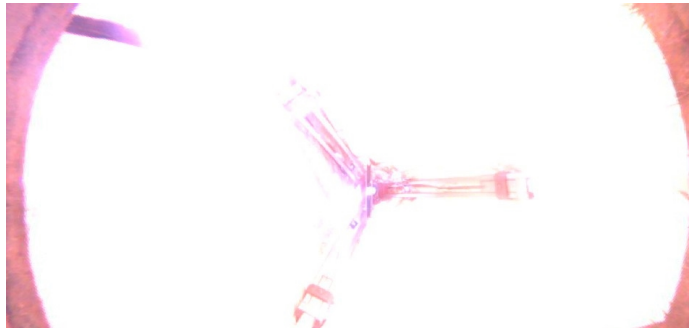
Code:	MGP
Description:	General Photo

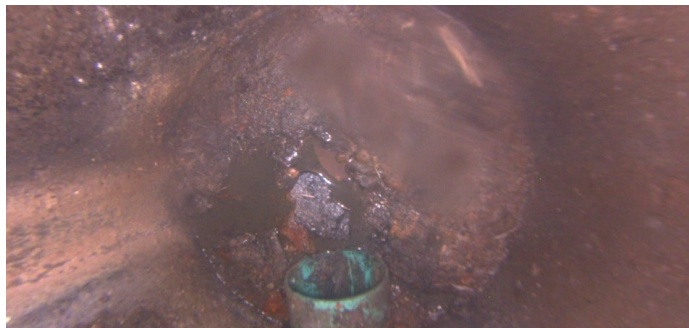
Code: **MGP**
Description: **General Photo**

Distance (ft): **1.0**
Structural Grade: **0**
O&M Grade: **0**
Clock Start/From:
Clock To:
1st Value:
2nd Value:
Value Percent:
Step: **NO**
Remarks:

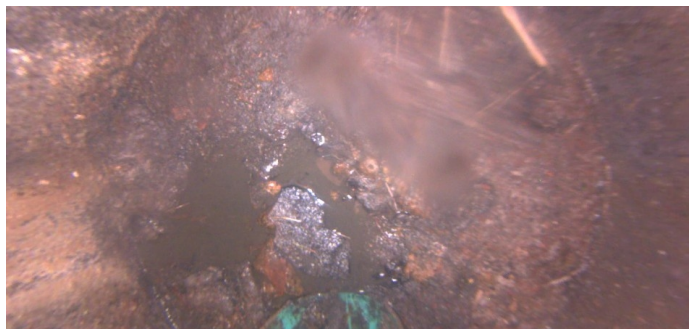
Code: **DAZ**
Description: **Deposits Attached Other**

Distance (ft): **1.9**
Structural Grade: **0**
O&M Grade: **3**
Clock Start/From: **12**
Clock To: **12**
1st Value:
2nd Value:
Value Percent: **15.000**
Step: **NO**
Remarks: **Mixed materials**
