Manhole Inspection Report

Date:	04/13/2018	Weather:		Coding:	RZMACP
MH#:	M-304-004	Owner:	NA	Len. Surveyed:	6.6
P.O.#:		Surveyor:	John Kuglmaier	Rim to Invert:	8.1
Customer:		Cert. #:	U-1215-07002349	Wall Material:	Concrete (reinforced)

Street:	Old Ridge Road. EHansen Dr. North	Project:	Hobart, IN
City:	Hobart, IN	GPS Northing:	0.0
Location:		GPS Easting:	0.0
Drain Area:	Northwest	GPS Accuracy:	Nearest Meter
Cover Shape:	Circular	Evidence of Surcharge:	No
Cover Size:	23.0	Potential for Runoff:	None
Comments:

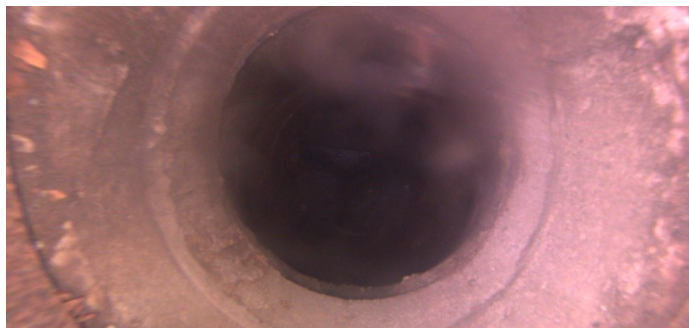
Code: **MGP**
Description: **General Photo**

Distance (ft): **.0**
Structural Grade: **0**
O&M Grade: **0**
Clock Start/From:
Clock To:
1st Value:
2nd Value:
Value Percent:
Step: **NO**
Remarks:

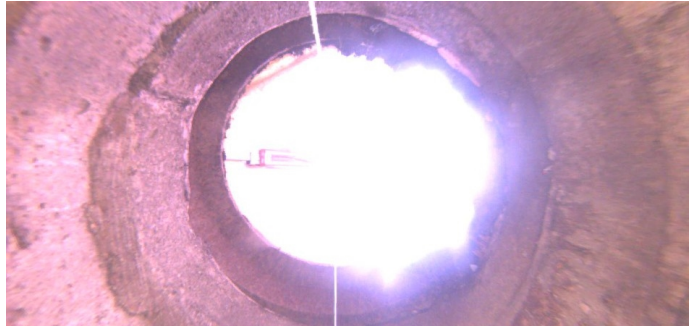
Code: **MGP**
Description: **General Photo**

Distance (ft): **2.6**
Structural Grade: **0**
O&M Grade: **0**
Clock Start/From:
Clock To:
1st Value:
2nd Value:
Value Percent:
Step: **NO**
Remarks:

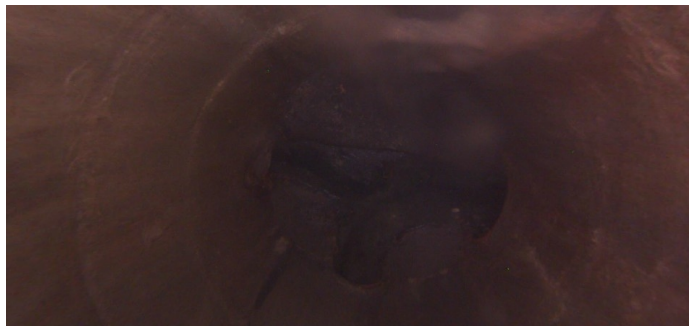
Code: **IS**
Description: **Infil Stain**

Distance (ft): **3.3**
Structural Grade: **0**
O&M Grade: **0**
Clock Start/From: **7**
Clock To:
1st Value:
2nd Value:
Value Percent:
Step: **NO**
Remarks:

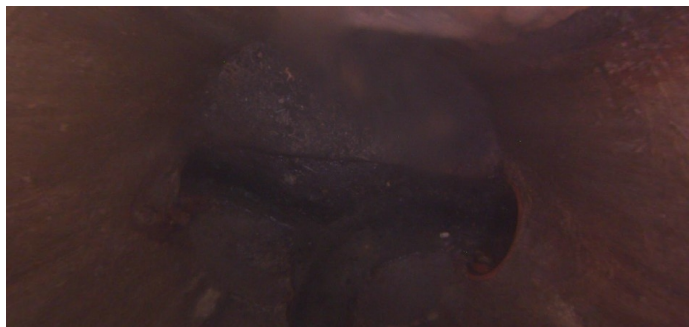
Code: **DSF**
Description: **Deposits Settled Fine**

Distance (ft): **4.7**
Structural Grade: **0**
O&M Grade: **2**
Clock Start/From: **12**
Clock To: **12**
1st Value:
2nd Value:
Value Percent: **5.000**
Step: **NO**
Remarks:

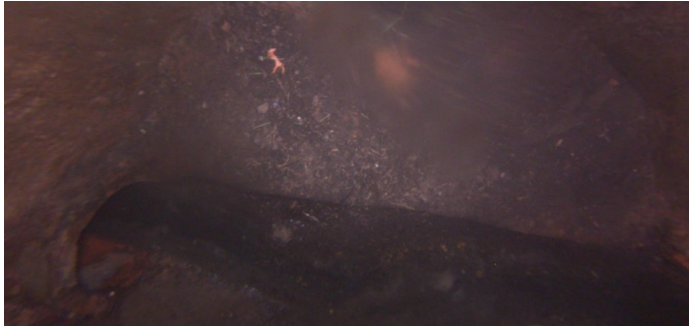
Code:	MGO
Description:	General Observation
Distance (ft):	6.1
Structural Grade:	0
O&M Grade:	0
Clock Start/From:	
Clock To:	
1st Value:	
2nd Value:	
Value Percent:	
Step:	NO
Remarks:	Ins. Comp.
