Manhole Inspection Report

Date:	04/13/2018	Weather:		Coding:	RZMACP
MH#:	M-304-004	Owner:	NA	Len. Surveyed:	6.6
P.O.#:		Surveyor:	Jen Costello	Rim to Invert:	9.1
Customer:		Cert. #:	U-907-5518	Wall Material:	Concrete (reinforced)

Street:	Old Ridge Road. East of Hansen Dr.	Project:	Hobart, IN
City:	Hobart, IN	GPS Northing:	0.0
Location:		GPS Easting:	0.0
Drain Area:	Northwest	GPS Accuracy:	Nearest Meter
Cover Shape:	Circular	Evidence of Surcharge:	No
Cover Size:	23.0	Potential for Runoff:	None
Comments:

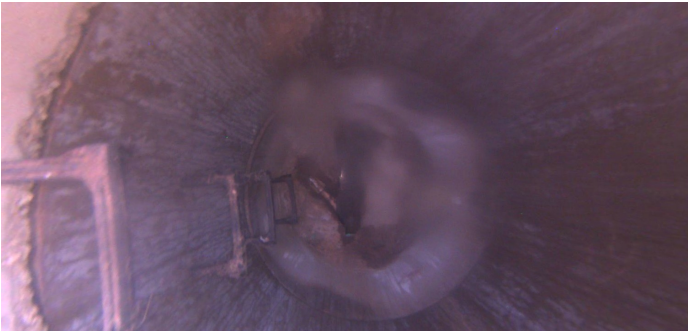
Code:

MGP

Description:

General Photo

Distance (ft):

.0

Remarks:

ACCESS MH

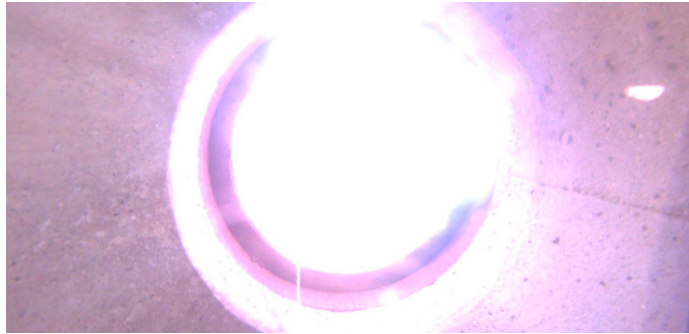
Code:	MGO
Description:	General Observation
Distance (ft):	1.5
Structural Grade:	0
O&M Grade:	0
Clock Start/From:	
Clock To:	
1st Value:	
2nd Value:	
Value Percent:	
Step:	NO
Remarks:	UNDERSIDE OF FRAME

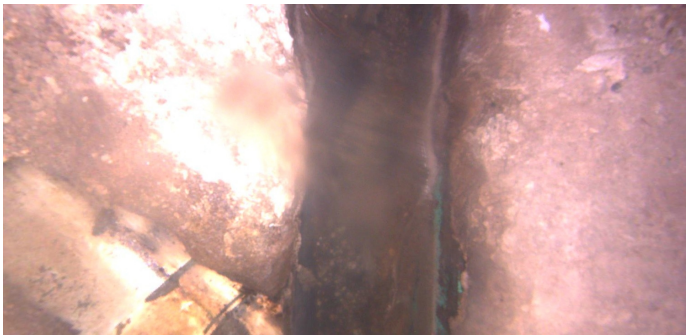
Code:	MGO
Description:	General Observation
Distance (ft):	6.6
Structural Grade:	0
O&M Grade:	0
Clock Start/From:	
Clock To:	
1st Value:	
2nd Value:	
Value Percent:	
Step:	NO
Remarks:	END SURVEY
