Manhole Inspection Report

Date:	05/17/2018	Weather:		Coding:	RZMACP
MH#:	M-305-011	Owner:	NA	Len. Surveyed:	4.0
P.O.#:		Surveyor:	Jen Costello	Rim to Invert:	3.9
Customer:		Cert. #:	U-907-5518	Wall Material:	Concrete (reinforced)

Street:	151' West of Briarwood Lane and W	Project:	Hobart, IN
City:	Hobart, IN	GPS Northing:	2894271.933
Location:		GPS Easting:	2894271.933
Drain Area:	West	GPS Accuracy:	Sub-Meter
Cover Shape:	Circular	Evidence of Surcharge:	No
Cover Size:	22.5	Potential for Runoff:	None
Comments:

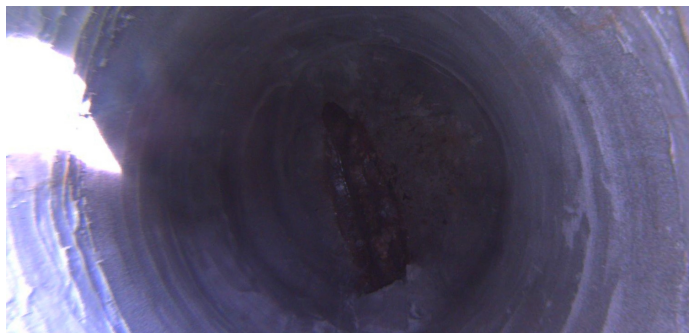
Code: **MGO**
Description: **General Observation**

Distance (ft): **.0**
Structural Grade: **0**
O&M Grade: **0**
Clock Start/From:
Clock To:
1st Value:
2nd Value:
Value Percent:
Step: **NO**
Remarks: **access mh**

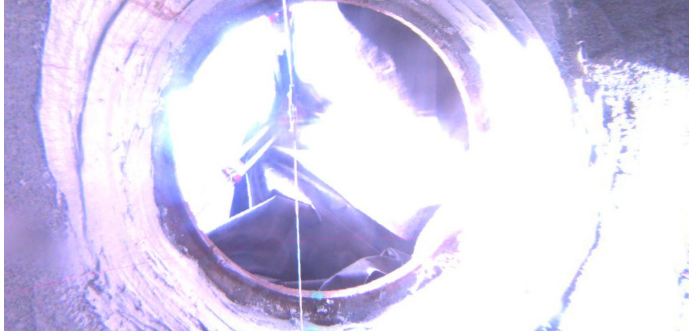
Code:	MGO
Description:	General Observation
Distance (ft):	2.0
Structural Grade:	0
O&M Grade:	0
Clock Start/From:	
Clock To:	
1st Value:	
2nd Value:	
Value Percent:	
Step:	NO
Remarks:	underside of frame

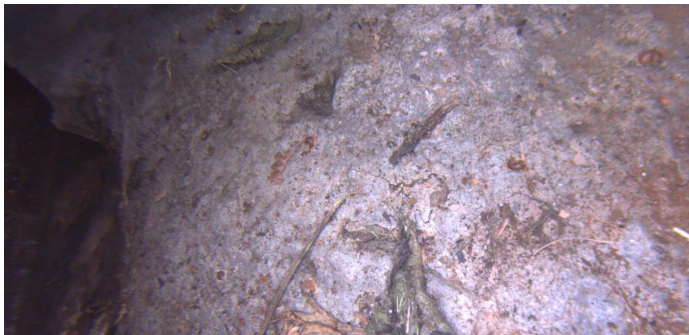
Code:	MGO
Description:	General Observation
Distance (ft):	4.0
Structural Grade:	0
O&M Grade:	0
Clock Start/From:	
Clock To:	
1st Value:	
2nd Value:	
Value Percent:	
Step:	NO
Remarks:	end survey
