Manhole Inspection Report

Date:	05/06/2018	Weather:		Coding:	RZMACP
MH#:	M-305-012	Owner:	NA	Len. Surveyed:	6.0
P.O.#:		Surveyor:	Jen Costello	Rim to Invert:	7.0
Customer:		Cert. #:	U-907-5518	Wall Material:	Concrete (reinforced)

Street:	North of Walnut Ln. 115' West of W	Project:	Hobart, IN
City:	Hobart, IN	GPS Northing:	2896518.47
Location:		GPS Easting:	2896518.47
Drain Area:	West	GPS Accuracy:	Sub-Meter
Cover Shape:	Circular	Evidence of Surcharge:	No
Cover Size:	23.0	Potential for Runoff:	None
Comments:

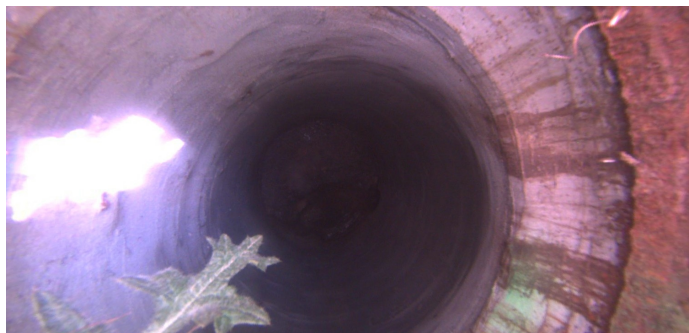
Code: **MGO**
Description: **General Observation**

Distance (ft): **.0**
Structural Grade: **0**
O&M Grade: **0**
Clock Start/From:
Clock To:
1st Value:
2nd Value:
Value Percent:
Step: **NO**
Remarks: **ACCESS MH**

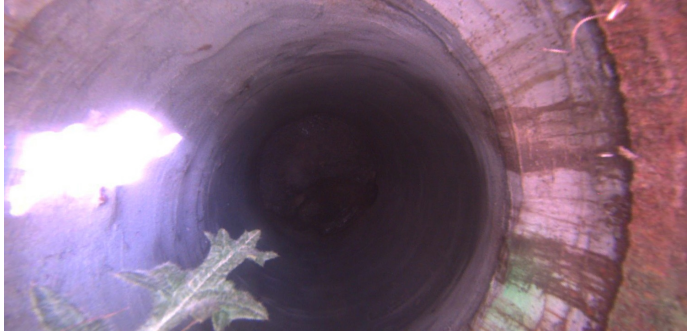
Code: **IS**
Description: **Infil Stain**

Distance (ft): **.0**
Structural Grade: **0**
O&M Grade: **0**
Clock Start/From: **12**
Clock To: **12**
1st Value:
2nd Value:
Value Percent:
Step: **NO**
Remarks:

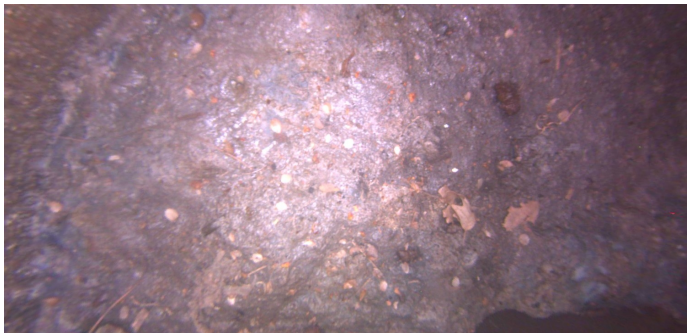
Code: **MGO**
Description: **General Observation**

Distance (ft): **6.0**
Structural Grade: **0**
O&M Grade: **0**
Clock Start/From:
Clock To:
1st Value:
2nd Value:
Value Percent:
Step: **NO**
Remarks: **END SURVEY**
