Manhole Inspection Report

Date:	05/06/2018	Weather:		Coding:	RZMACP
MH#:	M-305-013	Owner:	NA	Len. Surveyed:	5.9
P.O.#:		Surveyor:	Jen Costello	Rim to Invert:	6.6
Customer:		Cert. #:	U-907-5518	Wall Material:	Concrete (reinforced)

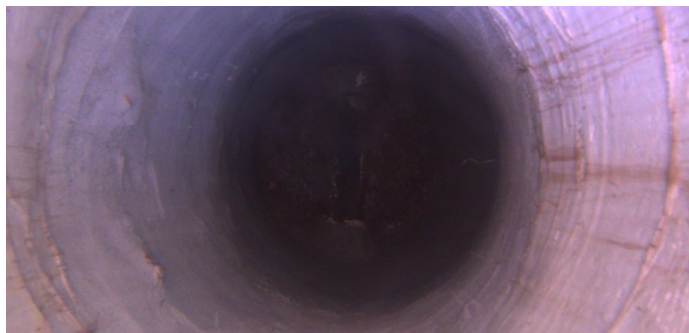
Code: **MGO**
Description: **General Observation**

Distance (ft): **.0**
Structural Grade: **0**
O&M Grade: **0**
Clock Start/From:
Clock To:
1st Value:
2nd Value:
Value Percent:
Step: **NO**
Remarks: **ACCESS mh**

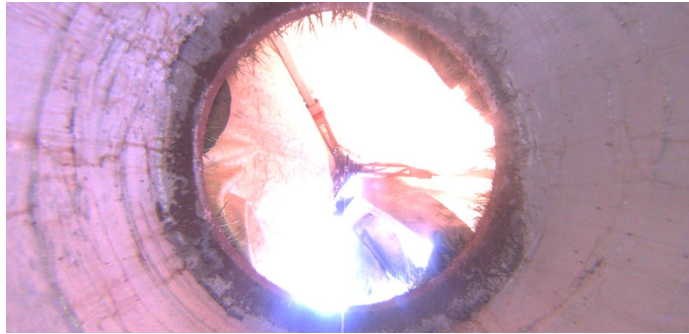
Code:	MGO
Description:	General Observation
Distance (ft):	1.4
Structural Grade:	0
O&M Grade:	0
Clock Start/From:	
Clock To:	
1st Value:	
2nd Value:	
Value Percent:	
Step:	NO
Remarks:	underside of frame

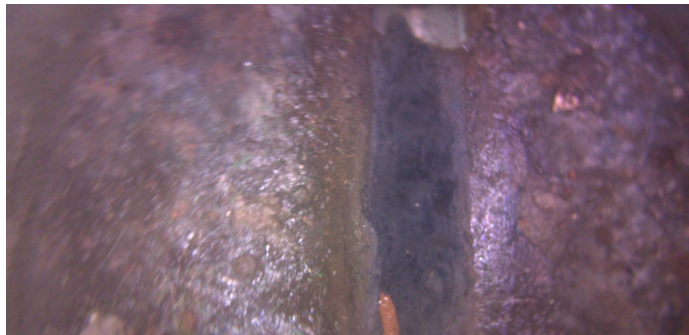
Code:	DSF
Description:	Deposits Settled Fine
Distance (ft):	4.6
Structural Grade:	0
O&M Grade:	2
Clock Start/From:	12
Clock To:	12
1st Value:	
2nd Value:	
Value Percent:	5.000
Step:	NO
Remarks:

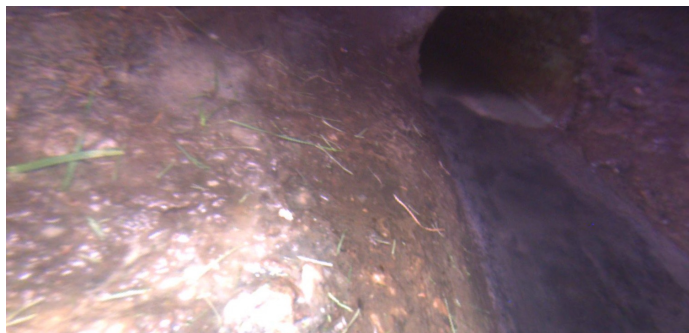
Code:	MGO
Description:	General Observation
Distance (ft):	5.9
Structural Grade:	0
O&M Grade:	0
Clock Start/From:	
Clock To:	
1st Value:	
2nd Value:	
Value Percent:	
Step:	NO
Remarks:	end survey
