Manhole Inspection Report

Date:	05/17/2018	Weather:		Coding:	RZMACP
MH#:	M-305-014	Owner:	NA	Len. Surveyed:	8.1
P.O.#:		Surveyor:	Jen Costello	Rim to Invert:	8.8
Customer:		Cert. #:	U-907-5518	Wall Material:	Concrete (reinforced)

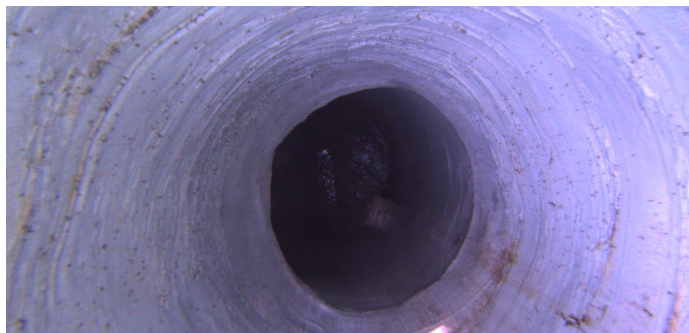
Code: **MGO**
Description: **General Observation**

Distance (ft): **.0**
Structural Grade: **0**
O&M Grade: **0**
Clock Start/From:
Clock To:
1st Value:
2nd Value:
Value Percent:
Step: **NO**
Remarks: **ACCESS MH**

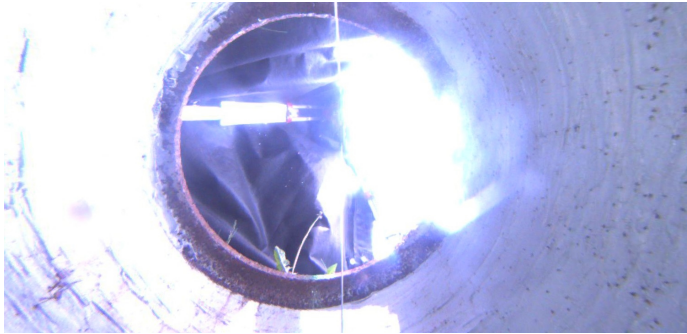
Code: **MGO**
Description: **General Observation**

Distance (ft): **2.5**
Structural Grade: **0**
O&M Grade: **0**
Clock Start/From:
Clock To:
1st Value:
2nd Value:
Value Percent:
Step: **NO**
Remarks: **UNDERSIDE OF FRAME**

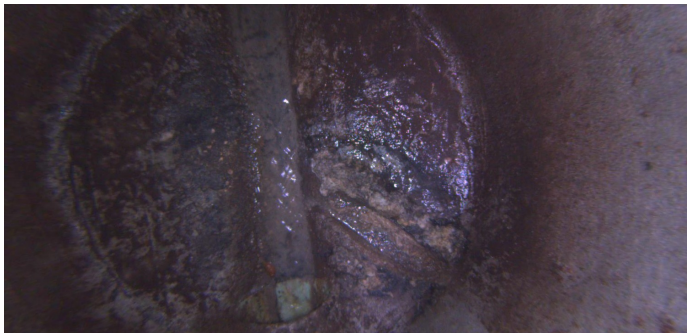
Code: **DSF**
Description: **Deposits Settled Fine**

Distance (ft): **6.2**
Structural Grade: **0**
O&M Grade: **2**
Clock Start/From: **12**
Clock To: **12**
1st Value:
2nd Value:
Value Percent: **5.000**
Step: **NO**
Remarks:

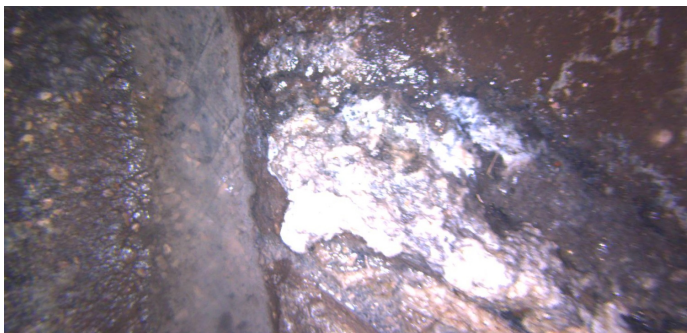
Code: **MGO**
Description: **General Observation**

Distance (ft): **8.1**
Structural Grade: **0**
O&M Grade: **0**
Clock Start/From:
Clock To:
1st Value:
2nd Value:
Value Percent:
Step: **NO**
Remarks: **END SURVEY**
