# Manhole Inspection Report

Date:	<b>04/20/2018</b>	Weather:		Coding:	<b>RZMACP</b>
MH#:	<b>M-305-016</b>	Owner:	<b>NA</b>	Len. Surveyed:	<b>7.0</b>
P.O.#:		Surveyor:	<b>Jen Costello</b>	Rim to Invert:	<b>8.4</b>
Customer:		Cert. #:	<b>U-907-5518</b>	Wall Material:	<b>Concrete (reinforced)</b>

Street:	<b>North of Walnut Ln. 38' West of Wil</b>	Project:	<b>Hobart, IN</b>
City:	<b>Hobart, IN</b>	GPS Northing:	<b>0.0</b>
Location:		GPS Easting:	<b>0.0</b>
Drain Area:	<b>West</b>	GPS Accuracy:	<b>Nearest Meter</b>
Cover Shape:	<b>Circular</b>	Evidence of Surcharge:	<b>No</b>
Cover Size:	<b>23.0</b>	Potential for Runoff:	<b>None</b>
Comments:

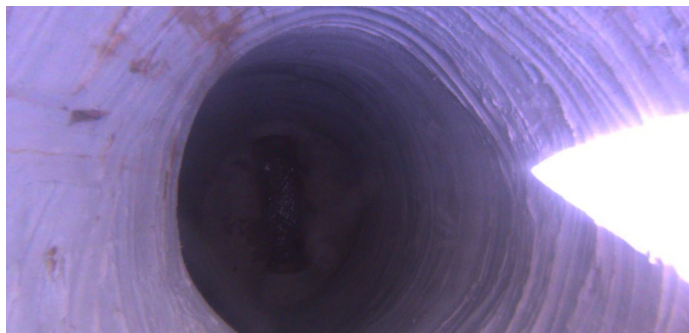
Code: **MGO**  
Description: **General Observation**

Distance (ft): **.0**  
Structural Grade: **0**  
O&M Grade: **0**  
Clock Start/From:  
Clock To:  
1st Value:  
2nd Value:  
Value Percent:  
Step: **NO**  
Remarks: **ACCESS MH**

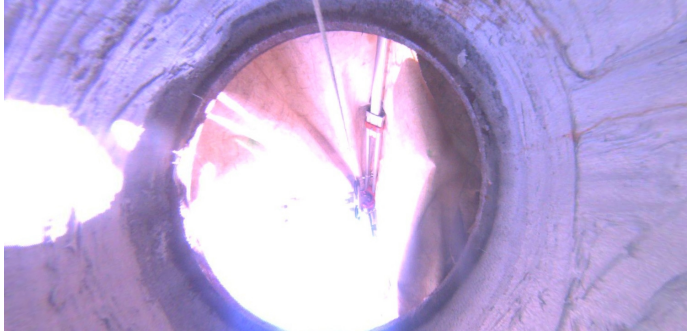
Code: **MGO**  
Description: **General Observation**

Distance (ft): **1.5**  
Structural Grade: **0**  
O&M Grade: **0**  
Clock Start/From:  
Clock To:  
1st Value:  
2nd Value:  
Value Percent:  
Step: **NO**  
Remarks: **UNDERSIDE OF FRAME**

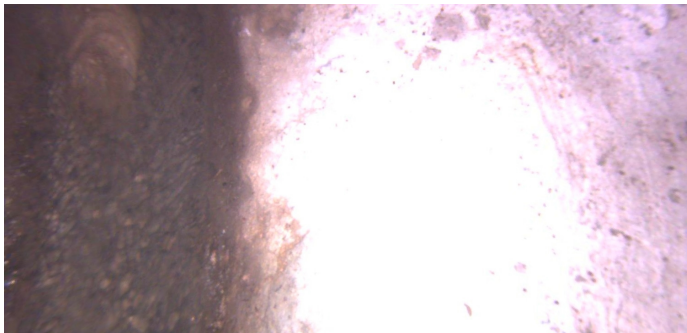
Code: **MGO**  
Description: **General Observation**

Distance (ft): **7.0**  
Structural Grade: **0**  
O&M Grade: **0**  
Clock Start/From:  
Clock To:  
1st Value:  
2nd Value:  
Value Percent:  
Step: **NO**  
Remarks: **END SURVEY**
