# Manhole Inspection Report

Date:	<b>09/28/2022</b>	Weather:		Coding:	<b>RZMACP</b>
MH#:	<b>M-305-018</b>	Owner:	<b>NA</b>	Len. Surveyed:	<b>6.6</b>
P.O.#:		Surveyor:	<b>Jen Costello</b>	Rim to Invert:	<b>7.7</b>
Customer:		Cert. #:	<b>U-907-5518</b>	Wall Material:	<b>Concrete (cast in place)</b>

Street:	<b>North of Walnut Ln. 393' East of Bria</b>	Project:	<b>Hobart, IN</b>
City:	<b>Hobart, IN</b>	GPS Northing:	<b>2288394.041</b>
Location:	<b>Yard</b>	GPS Easting:	<b>2894789.66</b>
Drain Area:	<b>West</b>	GPS Accuracy:	<b>Sub-Meter</b>
Cover Shape:	<b>Circular</b>	Evidence of Surcharge:	<b>No</b>
Cover Size:	<b>24.0</b>	Potential for Runoff:	<b>None</b>
Comments:

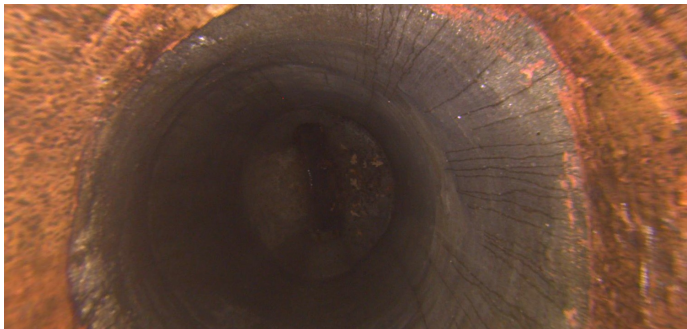
Code: **MGO**  
Description: **General Observation**

Distance (ft): **.0**  
Structural Grade: **0**  
O&M Grade: **0**  
Clock Start/From:  
Clock To:  
1st Value:  
2nd Value:  
Value Percent:  
Step: **NO**  
Remarks: **access mh**

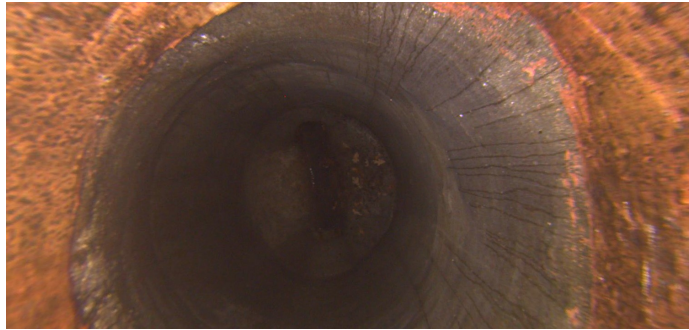
Code: **SRI**  
Description: **Surface Roughness Increased**

Distance (ft): **.0**  
Structural Grade: **1**  
O&M Grade: **0**  
Clock Start/From: **12**  
Clock To: **12**  
1st Value:  
2nd Value:  
Value Percent:  
Step: **NO**  
Remarks:

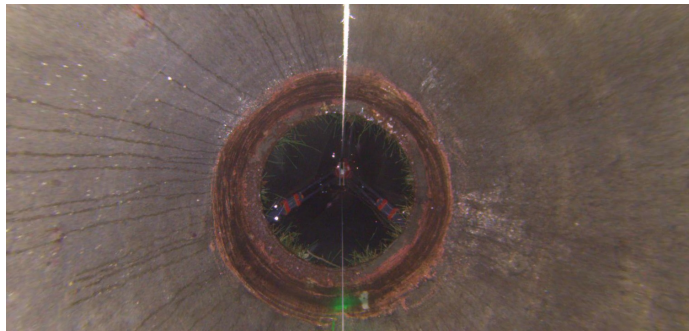
Code: **MGO**  
Description: **General Observation**

Distance (ft): **3.5**  
Structural Grade: **0**  
O&M Grade: **0**  
Clock Start/From:  
Clock To:  
1st Value:  
2nd Value:  
Value Percent:  
Step: **NO**  
Remarks: **underside of frame**

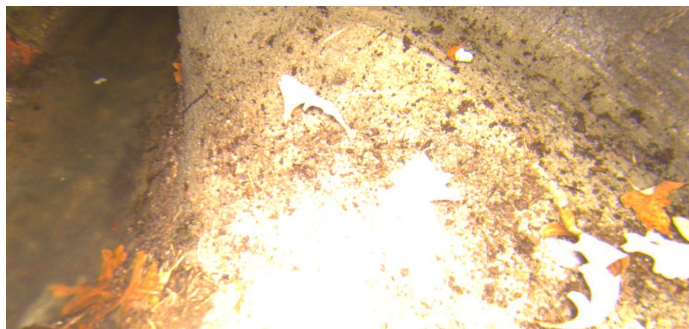
Code: **SAV**  
Description: **Surface Aggregate Visible**

Distance (ft): **6.6**  
Structural Grade: **3**  
O&M Grade: **0**  
Clock Start/From: **12**  
Clock To: **12**  
1st Value:  
2nd Value:  
Value Percent:  
Step: **NO**  
Remarks:

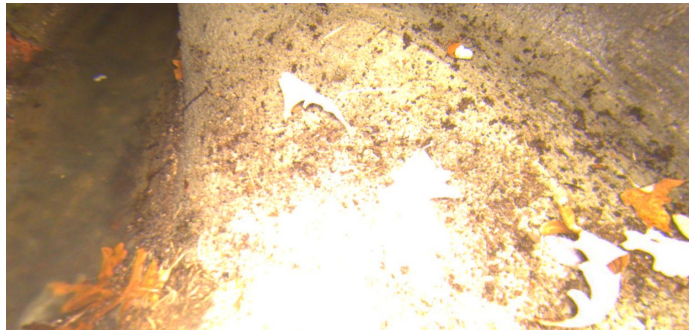
Code: **SAV**  
Description: **Surface Aggregate Visible**

Distance (ft): **6.6**  
Structural Grade: **3**  
O&M Grade: **0**  
Clock Start/From: **3**  
Clock To: **9**  
1st Value:  
2nd Value:  
Value Percent:  
Step: **NO**  
Remarks:

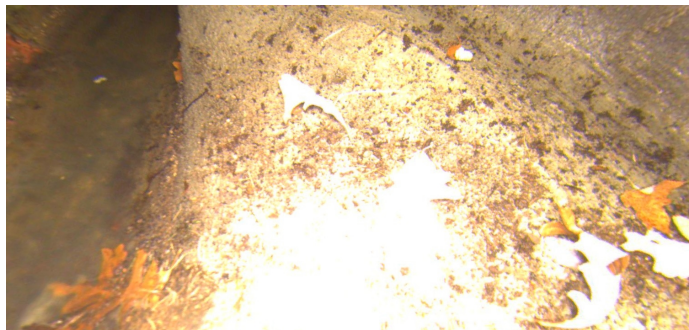
Code: **MGO**  
Description: **General Observation**

Distance (ft): **6.6**  
Structural Grade: **0**  
O&M Grade: **0**  
Clock Start/From:  
Clock To:  
1st Value:  
2nd Value:  
Value Percent:  
Step: **NO**  
Remarks: **end of survey**

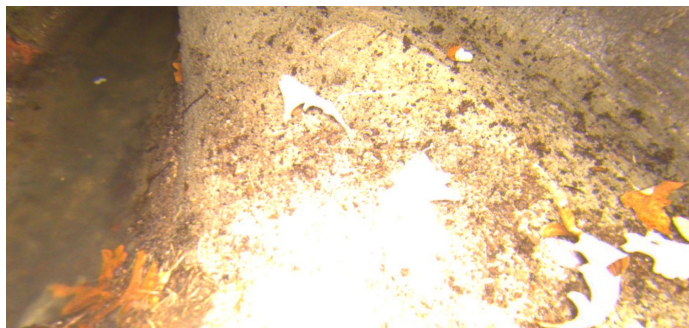
Code: **SRI**  
Description: **Surface Roughness Increased**

Distance (ft): **6.6**  
Structural Grade: **1**  
O&M Grade: **0**  
Clock Start/From: **12**  
Clock To: **12**  
1st Value:  
2nd Value:  
Value Percent:  
Step: **NO**  
Remarks:
