Manhole Inspection Report

Date:	04/20/2018	Weather:		Coding:	RZMACP
MH#:	M-305-024	Owner:	NA	Len. Surveyed:	7.0
P.O.#:		Surveyor:	Jen Costello	Rim to Invert:	8.8
Customer:		Cert. #:	U-907-5518	Wall Material:	Concrete (reinforced)

Street:	W. 3rd Pl. 151' East of Woodland Ct.	Project:	Hobart, IN
City:	Hobart, IN	GPS Northing:	0.0
Location:		GPS Easting:	0.0
Drain Area:	West	GPS Accuracy:	Nearest Meter
Cover Shape:	Circular	Evidence of Surcharge:	No
Cover Size:	23.0	Potential for Runoff:	None
Comments:

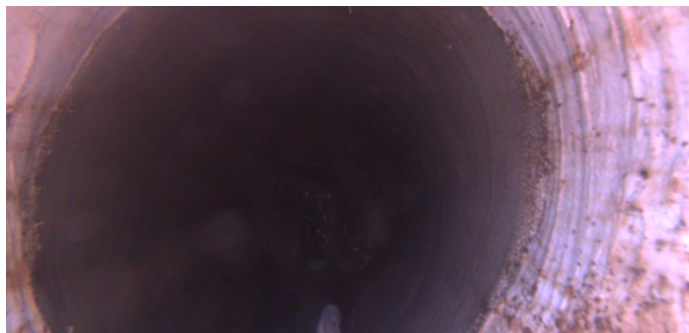
Code: **MGO**
Description: **General Observation**

Distance (ft): **.0**
Structural Grade: **0**
O&M Grade: **0**
Clock Start/From:
Clock To:
1st Value:
2nd Value:
Value Percent:
Step: **NO**
Remarks: **ACCESS MH**

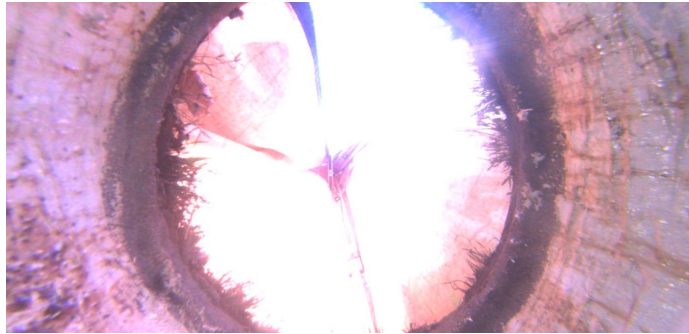
Code: **MGP**
Description: **General Photo**

Distance (ft): **1.4**
Structural Grade: **0**
O&M Grade: **0**
Clock Start/From:
Clock To:
1st Value:
2nd Value:
Value Percent:
Step: **NO**
Remarks: **UNDERSIDE OF FRAME**

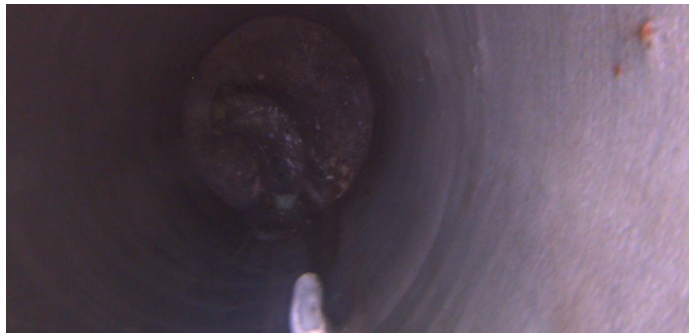
Code: **OBP**
Description: **Obstacle External Pipe or Cable**

Distance (ft): **1.7**
Structural Grade: **0**
O&M Grade: **2**
Clock Start/From: **6**
Clock To:
1st Value:
2nd Value:
Value Percent: **5.000**
Step: **NO**
Remarks:

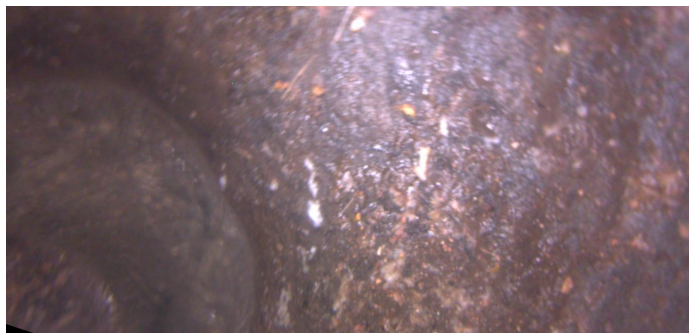
Code: **MGO**
Description: **General Observation**

Distance (ft): **7.0**
Structural Grade: **0**
O&M Grade: **0**
Clock Start/From:
Clock To:
1st Value:
2nd Value:
Value Percent:
Step: **NO**
Remarks: **END SURVEY**
