# Manhole Inspection Report

Date:	05/06/2018	Weather:		Coding:	RZMACP
MH#:	M-305-030	Owner:	NA	Len. Surveyed:	6.9
P.O.#:		Surveyor:	Jen Costello	Rim to Invert:	8.7
Customer:		Cert. #:	U-907-5518	Wall Material:	Concrete (reinforced)

Street:	North of Crows Nest Dr. 672' East of	Project:	Hobart, IN
City:	Hobart, IN	GPS Northing:	0.0
Location:		GPS Easting:	0.0
Drain Area:	West	GPS Accuracy:	Nearest Meter
Cover Shape:	Circular	Evidence of Surcharge:	No
Cover Size:	23.0	Potential for Runoff:	None
Comments:

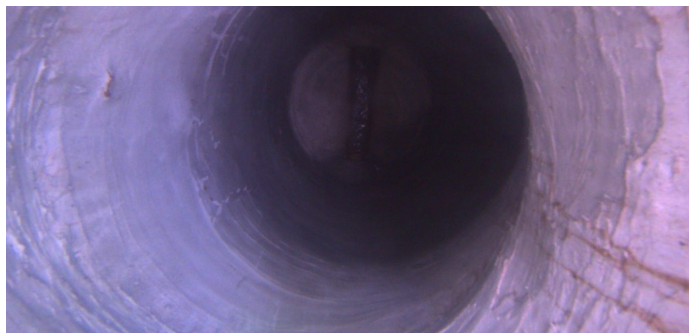
Code: **MGO**  
Description: **General Observation**

Distance (ft): **.0**  
Structural Grade: **0**  
O&M Grade: **0**  
Clock Start/From:  
Clock To:  
1st Value:  
2nd Value:  
Value Percent:  
Step: **NO**  
Remarks: **ACCESS MH**

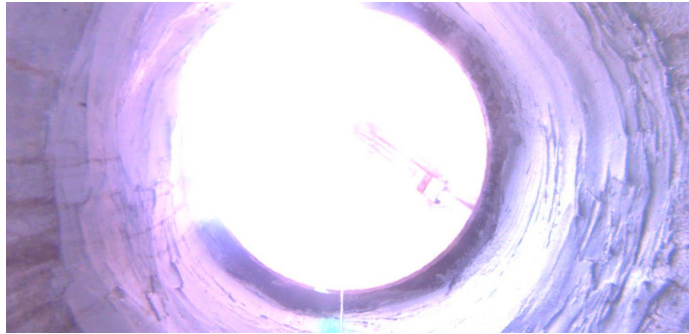
Code:	<b>MGO</b>
Description:	<b>General Observation</b>
Distance (ft):	<b>2.1</b>
Structural Grade:	<b>0</b>
O&M Grade:	<b>0</b>
Clock Start/From:	
Clock To:	
1st Value:	
2nd Value:	
Value Percent:	
Step:	<b>NO</b>
Remarks:	<b>UNDERSIDE OF FRAME</b>

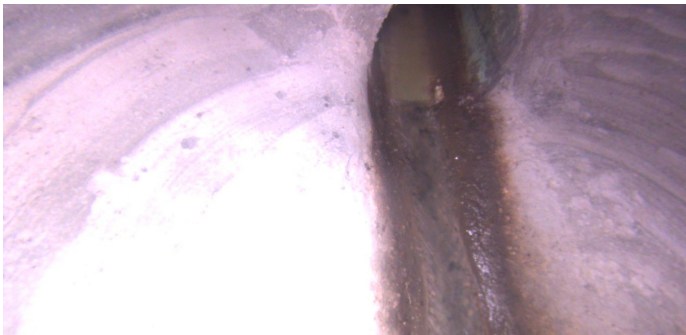
Code:	<b>MGO</b>
Description:	<b>General Observation</b>
Distance (ft):	<b>6.9</b>
Structural Grade:	<b>0</b>
O&M Grade:	<b>0</b>
Clock Start/From:	
Clock To:	
1st Value:	
2nd Value:	
Value Percent:	
Step:	<b>NO</b>
Remarks:	<b>END SURVEY</b>
