Manhole Inspection Report

Date:	09/27/2022	Weather:		Coding:	RZMACP
MH#:	M-305-032	Owner:	NA	Len. Surveyed:	6.1
P.O.#:		Surveyor:	Jen Costello	Rim to Invert:	6.5
Customer:		Cert. #:	U-907-5518	Wall Material:	Concrete (cast in place)

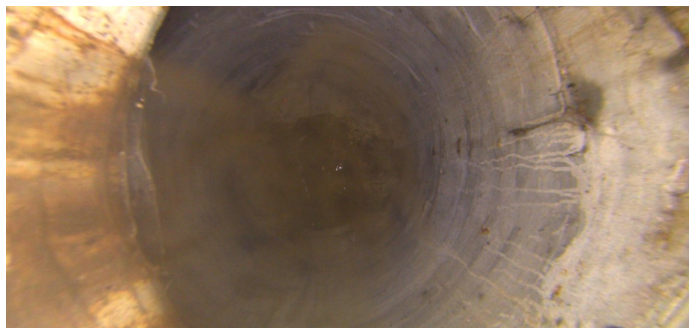
Code: **MGO**
Description: **General Observation**

Distance (ft): **.0**
Structural Grade: **0**
O&M Grade: **0**
Clock Start/From:
Clock To:
1st Value:
2nd Value:
Value Percent:
Step: **NO**
Remarks: **access mh**

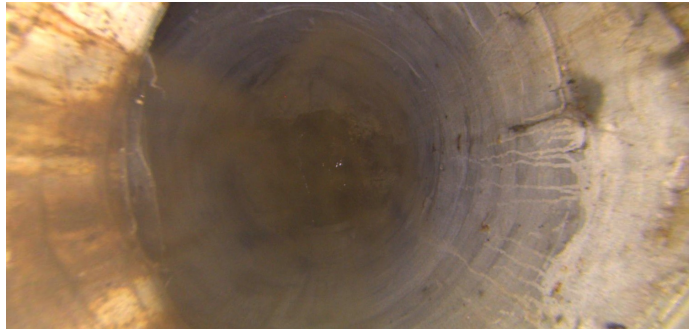
Code:	SRI
Description:	Surface Roughness Increased
Distance (ft):	.0
Structural Grade:	1
O&M Grade:	0
Clock Start/From:	12
Clock To:	2
1st Value:	
2nd Value:	
Value Percent:	
Step:	NO
Remarks:

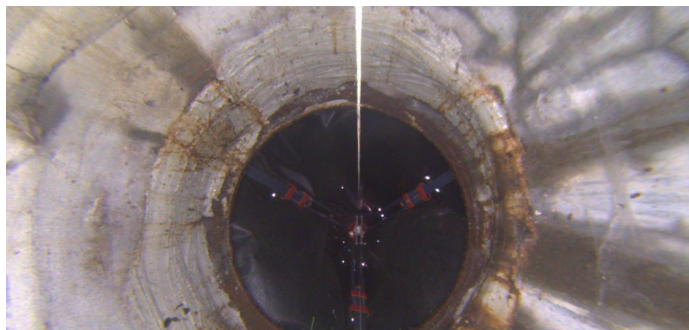
Code:	IW
Description:	Infil Weeper
Distance (ft):	2.3
Structural Grade:	0
O&M Grade:	2
Clock Start/From:	12
Clock To:	12
1st Value:	
2nd Value:	
Value Percent:	
Step:	NO
Remarks:

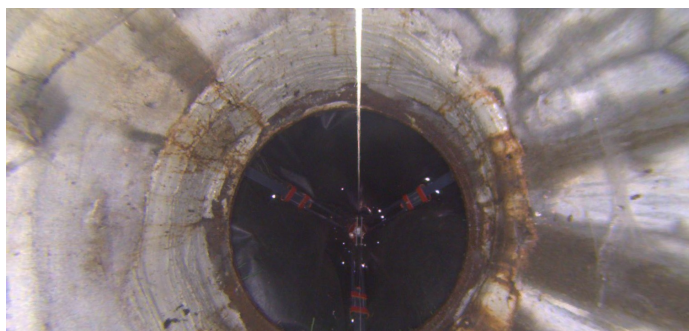
Code:	MGO
Description:	General Observation
Distance (ft):	2.3
Structural Grade:	0
O&M Grade:	0
Clock Start/From:	
Clock To:	
1st Value:	
2nd Value:	
Value Percent:	
Step:	NO
Remarks:	underside of frame

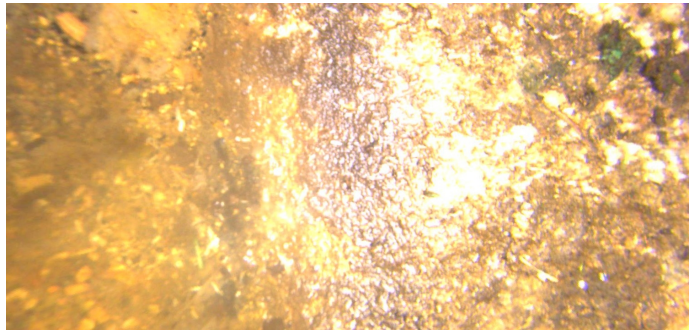
Code:	SAV
Description:	Surface Aggregate Visible
Distance (ft):	6.1
Structural Grade:	3
O&M Grade:	0
Clock Start/From:	12
Clock To:	12
1st Value:	
2nd Value:	
Value Percent:	
Step:	NO
Remarks:

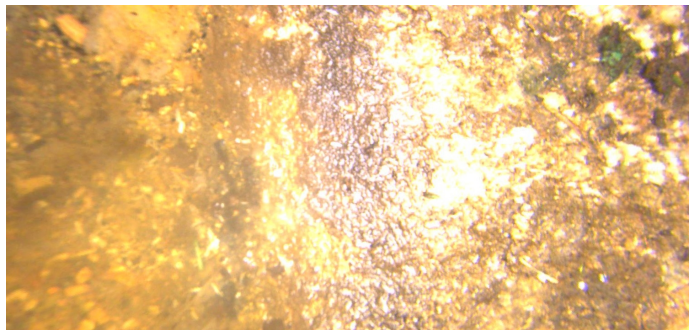
Code:	SAV
Description:	Surface Aggregate Visible
Distance (ft):	6.1
Structural Grade:	3
O&M Grade:	0
Clock Start/From:	3
Clock To:	9
1st Value:	
2nd Value:	
Value Percent:	
Step:	NO
Remarks:

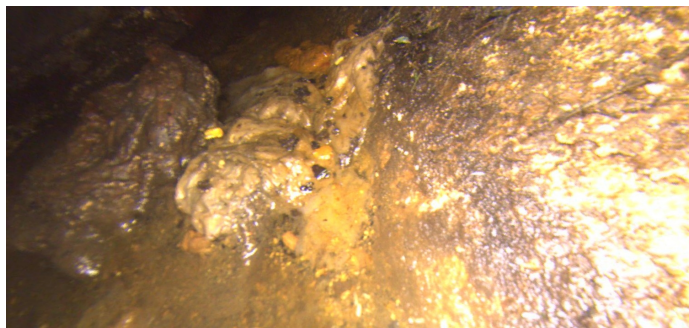
Code:	DSF
Description:	Deposits Settled Fine
Distance (ft):	6.1
Structural Grade:	0
O&M Grade:	3
Clock Start/From:	4
Clock To:	8
1st Value:	
2nd Value:	
Value Percent:	20.000
Step:	NO
Remarks:

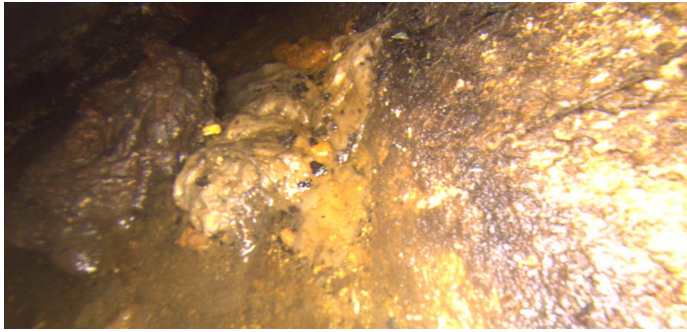
Code: **SRI**
Description: **Surface Roughness Increased**

Distance (ft): **6.1**
Structural Grade: **1**
O&M Grade: **0**
Clock Start/From: **12**
Clock To: **2**
1st Value:
2nd Value:
Value Percent:
Step: **NO**
Remarks:

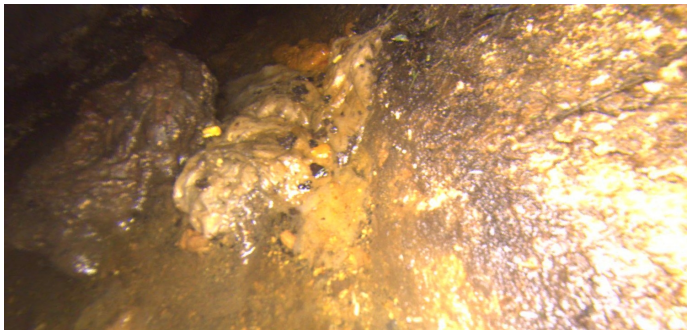
Code: **MGO**
Description: **General Observation**

Distance (ft): **6.1**
Structural Grade: **0**
O&M Grade: **0**
Clock Start/From:
Clock To:
1st Value:
2nd Value:
Value Percent:
Step: **NO**
Remarks: **end of survey**
