# Manhole Inspection Report

Date:	<b>04/28/2018</b>	Weather:		Coding:	<b>RZMACP</b>
MH#:	<b>M-305-037</b>	Owner:	<b>NA</b>	Len. Surveyed:	<b>8.7</b>
P.O.#:		Surveyor:	<b>Jen Costello</b>	Rim to Invert:	<b>9.5</b>
Customer:		Cert. #:	<b>U-907-5518</b>	Wall Material:	<b>Concrete (reinforced)</b>

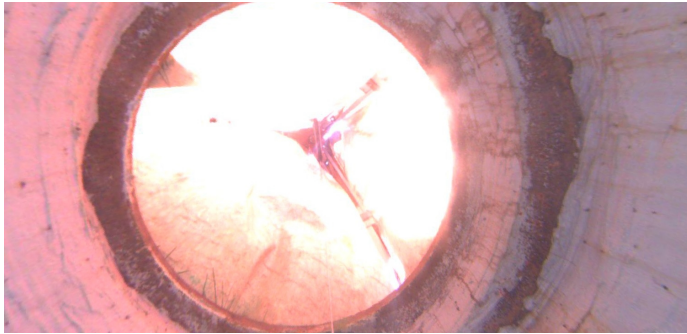
Code:	MGO
Description:	General Observation

Remarks: **access MH**

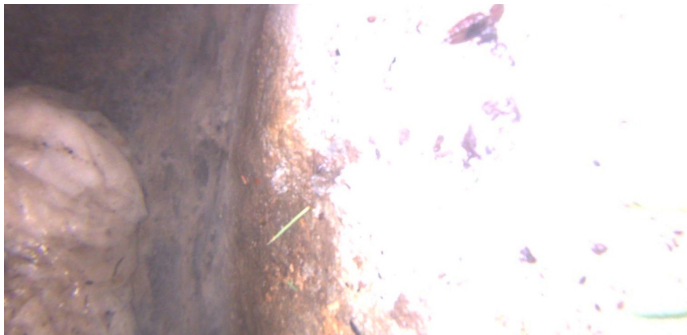
Code:	MGO
Description:	General Observation
Distance (ft):	1.8
Structural Grade:	0
O&M Grade:	0
Clock Start/From:	
Clock To:	
1st Value:	
2nd Value:	
Value Percent:	
Step:	NO
Remarks:	UNDERSIDE OF FRAME
