Manhole Inspection Report

Date:	04/28/2018	Weather:		Coding:	RZMACP
MH#:	M-305-040	Owner:	NA	Len. Surveyed:	5.9
P.O.#:		Surveyor:	Jen Costello	Rim to Invert:	7.4
Customer:		Cert. #:	U-907-5518	Wall Material:	Concrete (reinforced)

Street:	North of Crab Apple Ln. 70' East of B	Project:	Hobart, IN
City:	Hobart, IN	GPS Northing:	2894496.331
Location:		GPS Easting:	2894496.331
Drain Area:	West	GPS Accuracy:	Sub-Meter
Cover Shape:	Circular	Evidence of Surcharge:	No
Cover Size:	23.0	Potential for Runoff:	None
Comments:

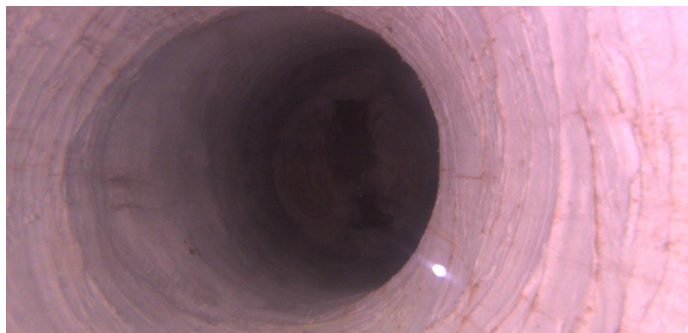
Code: **MGO**
Description: **General Observation**

Distance (ft): **.0**
Structural Grade: **0**
O&M Grade: **0**
Clock Start/From:
Clock To:
1st Value:
2nd Value:
Value Percent:
Step: **NO**
Remarks: **access MH**

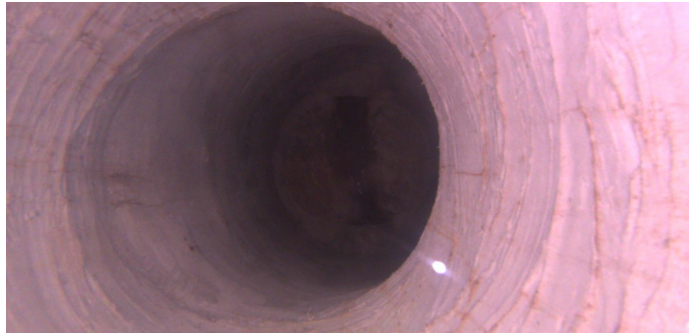
Code: **CM**
Description: **Crack Multiple**

Distance (ft): **.0**
Structural Grade: **3**
O&M Grade: **0**
Clock Start/From: **12**
Clock To: **12**
1st Value:
2nd Value:
Value Percent:
Step: **NO**
Remarks:

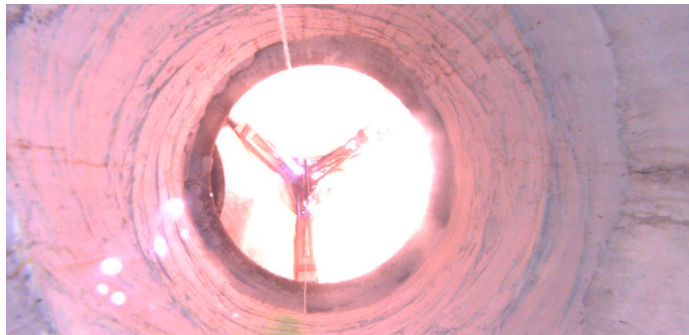
Code: **MGO**
Description: **General Observation**

Distance (ft): **2.6**
Structural Grade: **0**
O&M Grade: **0**
Clock Start/From:
Clock To:
1st Value:
2nd Value:
Value Percent:
Step: **NO**
Remarks: **UNDERSIDE OF FRAME**

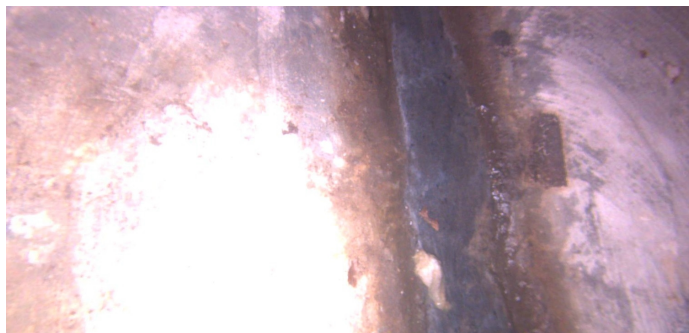
Code: **MGO**
Description: **General Observation**

Distance (ft): **5.9**
Structural Grade: **0**
O&M Grade: **0**
Clock Start/From:
Clock To:
1st Value:
2nd Value:
Value Percent:
Step: **NO**
Remarks: **END SURVEY**
