Manhole Inspection Report

Date:	04/28/2018	Weather:		Coding:	RZMACP
MH#:	M-305-041	Owner:	NA	Len. Surveyed:	5.1
P.O.#:		Surveyor:	Jen Costello	Rim to Invert:	6.5
Customer:		Cert. #:	U-907-5518	Wall Material:	Concrete (reinforced)

Street:	North of Crab Apple Ln. 159' West of	Project:	Hobart, IN
City:	Hobart, IN	GPS Northing:	2894266.857
Location:		GPS Easting:	2894266.857
Drain Area:	West	GPS Accuracy:	Sub-Meter
Cover Shape:	Circular	Evidence of Surcharge:	No
Cover Size:	23.0	Potential for Runoff:	None
Comments:

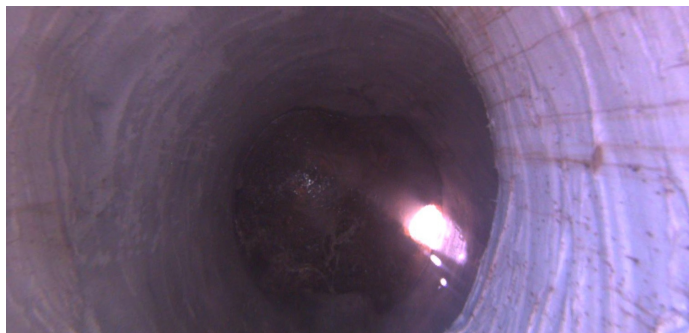
Code: **MGO**
Description: **General Observation**

Distance (ft): **.0**
Structural Grade: **0**
O&M Grade: **0**
Clock Start/From:
Clock To:
1st Value:
2nd Value:
Value Percent:
Step: **NO**
Remarks: **ACCESS MH**

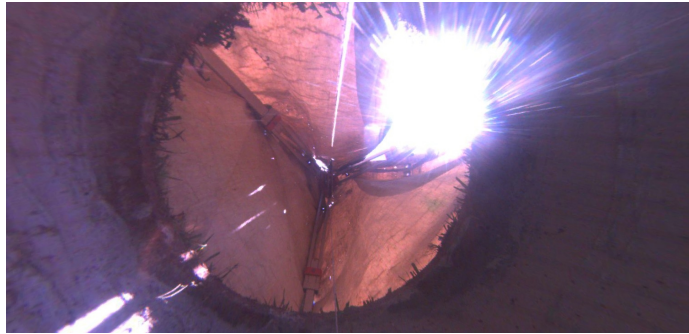
Code:	MGP
Description:	General Photo
Distance (ft):	1.7
Structural Grade:	0
O&M Grade:	0
Clock Start/From:	
Clock To:	
1st Value:	
2nd Value:	
Value Percent:	
Step:	NO
Remarks:	UNDERSIDE OF FRAME

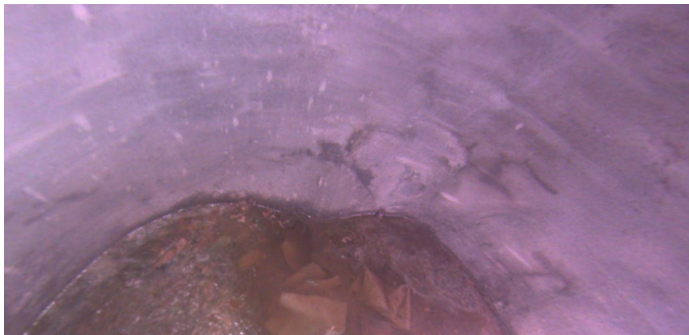
Code:	CM
Description:	Crack Multiple
Distance (ft):	3.2
Structural Grade:	3
O&M Grade:	0
Clock Start/From:	10
Clock To:	2
1st Value:	
2nd Value:	
Value Percent:	
Step:	NO
Remarks:

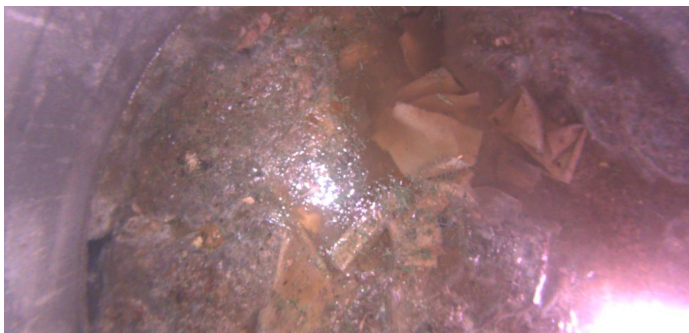
Code:	DSZ
Description:	Deposits Settled Other
Distance (ft):	4.1
Structural Grade:	0
O&M Grade:	2
Clock Start/From:	12
Clock To:	12
1st Value:	
2nd Value:	
Value Percent:	10.000
Step:	NO
Remarks:	MISC

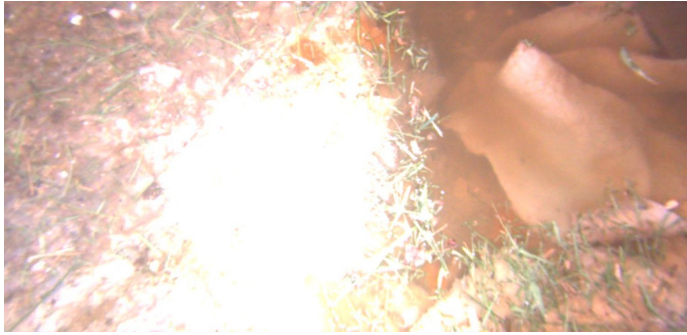
Code: **MGO**
Description: **General Observation**

Distance (ft): **5.1**
Structural Grade: **0**
O&M Grade: **0**
Clock Start/From:
Clock To:
1st Value:
2nd Value:
Value Percent:
Step: **NO**
Remarks: **END SURVEY**
