Manhole Inspection Report

Date:	04/20/2018	Weather:		Coding:	RZMACP
MH#:	M-305-047	Owner:	NA	Len. Surveyed:	6.1
P.O.#:		Surveyor:	Jen Costello	Rim to Invert:	8.0
Customer:		Cert. #:	U-907-5518	Wall Material:	Concrete (reinforced)

Street:	Woodland Ln. 139' South of 3rd St.	Project:	Hobart, IN
City:	Hobart, IN	GPS Northing:	0.0
Location:		GPS Easting:	0.0
Drain Area:	West	GPS Accuracy:	Nearest Meter
Cover Shape:	Circular	Evidence of Surcharge:	No
Cover Size:	23.0	Potential for Runoff:	None
Comments:

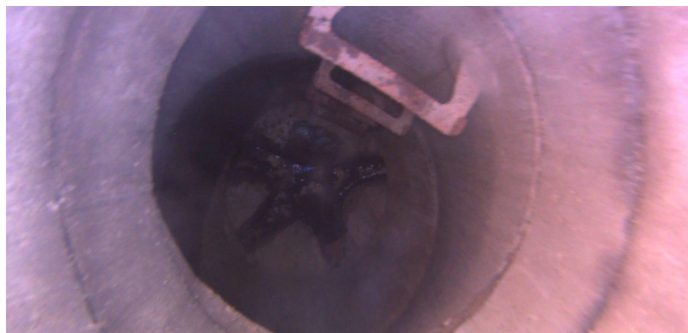
Code: **MGO**
Description: **General Observation**

Distance (ft): **.0**
Structural Grade: **0**
O&M Grade: **0**
Clock Start/From:
Clock To:
1st Value:
2nd Value:
Value Percent:
Step: **NO**
Remarks: **ACCESS MH**

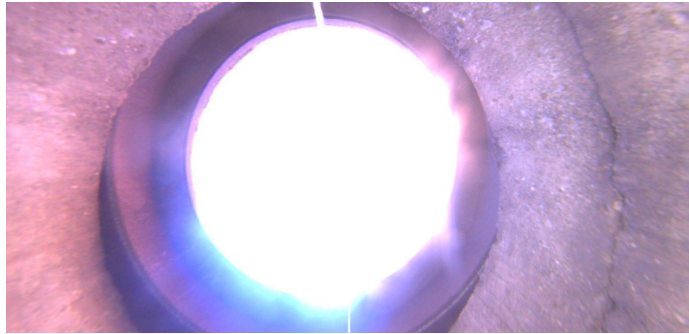
Code:	MGP
Description:	General Photo
Distance (ft):	1.8
Structural Grade:	0
O&M Grade:	0
Clock Start/From:	
Clock To:	
1st Value:	
2nd Value:	
Value Percent:	
Step:	NO
Remarks:	UNDERSIDE OF FRAME

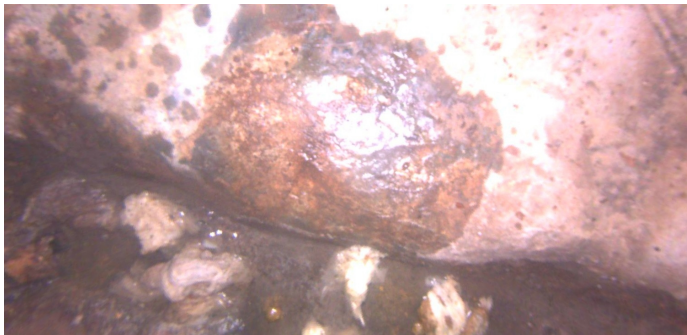
Code:	MGO
Description:	General Observation
Distance (ft):	6.1
Structural Grade:	0
O&M Grade:	0
Clock Start/From:	
Clock To:	
1st Value:	
2nd Value:	
Value Percent:	
Step:	NO
Remarks:	END SURVEY
