Manhole Inspection Report

Date:	04/28/2018	Weather:		Coding:	RZMACP
MH#:	M-305-054	Owner:	NA	Len. Surveyed:	7.0
P.O.#:		Surveyor:	Jen Costello	Rim to Invert:	8.0
Customer:		Cert. #:	U-907-5518	Wall Material:	Brick

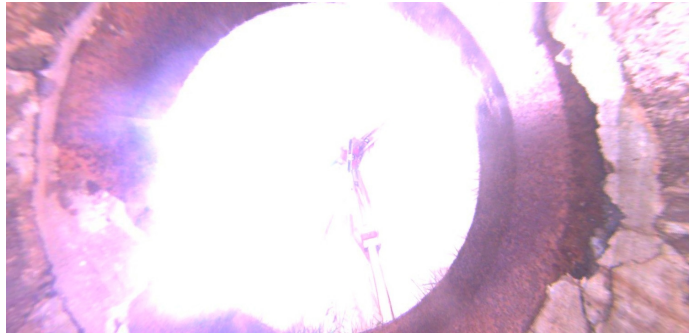
Code:	MGO
Description:	General Observation
Distance (ft):	.0
Structural Grade:	0
O&M Grade:	0
Clock Start/From:	
Clock To:	
1st Value:	
2nd Value:	
Value Percent:	
Step:	NO
Remarks:	ACCESS MH

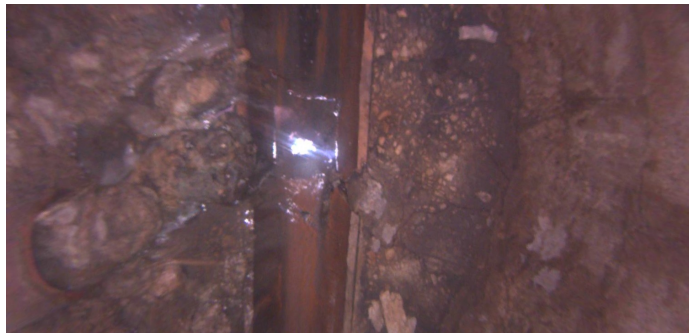
Code:	MGP
Description:	General Photo
Distance (ft):	1.6
Structural Grade:	0
O&M Grade:	0
Clock Start/From:	
Clock To:	
1st Value:	
2nd Value:	
Value Percent:	
Step:	NO
Remarks:	UNDERSIDE OF FRAME

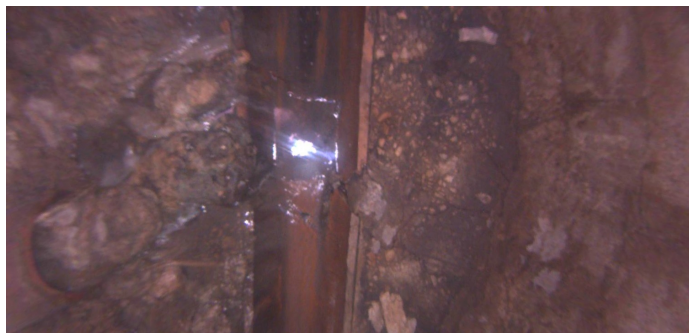
Code:	SAP
Description:	Surface Aggregate Projecting
Distance (ft):	5.2
Structural Grade:	3
O&M Grade:	0
Clock Start/From:	12
Clock To:	6
1st Value:	
2nd Value:	
Value Percent:	
Step:	NO
Remarks:

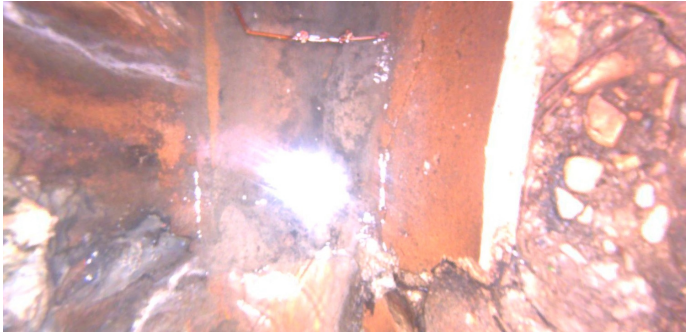
Code:	DSZ
Description:	Deposits Settled Other
Distance (ft):	5.2
Structural Grade:	0
O&M Grade:	2
Clock Start/From:	6
Clock To:	12
1st Value:	
2nd Value:	
Value Percent:	5.000
Step:	NO
Remarks:	MISC
