Manhole Inspection Report

Date:	04/28/2018	Weather:		Coding:	RZMACP
MH#:	M-305-056	Owner:	NA	Len. Surveyed:	5.1
P.O.#:		Surveyor:	Jen Costello	Rim to Invert:	6.4
Customer:		Cert. #:	U-907-5518	Wall Material:	Brick

Street:	West 2nd Pl. and Crestwood Dr. to t	Project:	Hobart, IN
City:	Hobart, IN	GPS Northing:	2896784.627
Location:		GPS Easting:	2896784.627
Drain Area:	West	GPS Accuracy:	Sub-Meter
Cover Shape:	Circular	Evidence of Surcharge:	No
Cover Size:	23.0	Potential for Runoff:	None
Comments:

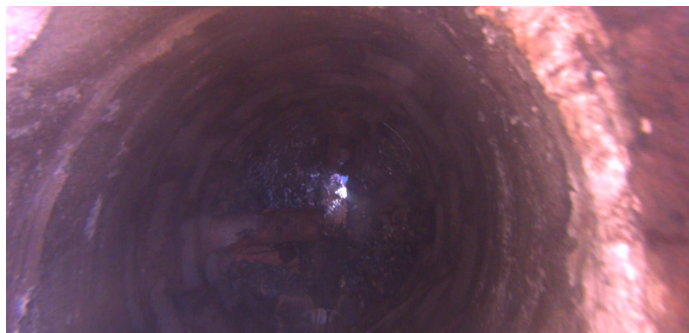
Code: **MGO**
Description: **General Observation**

Distance (ft): **.0**
Structural Grade: **0**
O&M Grade: **0**
Clock Start/From:
Clock To:
1st Value:
2nd Value:
Value Percent:
Step: **NO**
Remarks: **ACCESS mh**

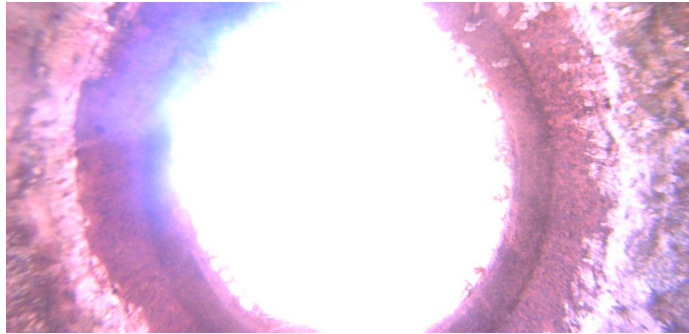
Code: **MGP**
Description: **General Photo**

Distance (ft): **1.5**
Structural Grade: **0**
O&M Grade: **0**
Clock Start/From:
Clock To:
1st Value:
2nd Value:
Value Percent:
Step: **NO**
Remarks: **underside of frame**

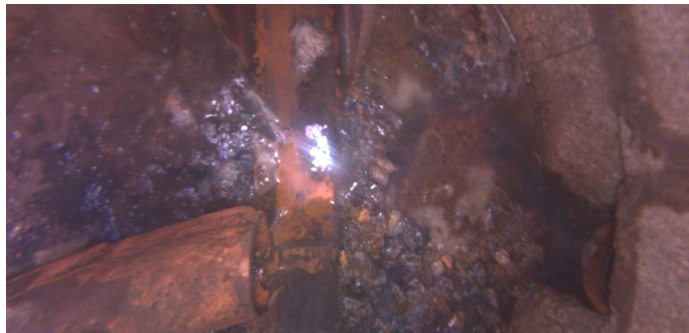
Code: **OBR**
Description: **Obstacle Rocks**

Distance (ft): **3.9**
Structural Grade: **0**
O&M Grade: **2**
Clock Start/From: **12**
Clock To: **12**
1st Value:
2nd Value:
Value Percent: **5.000**
Step: **NO**
Remarks:

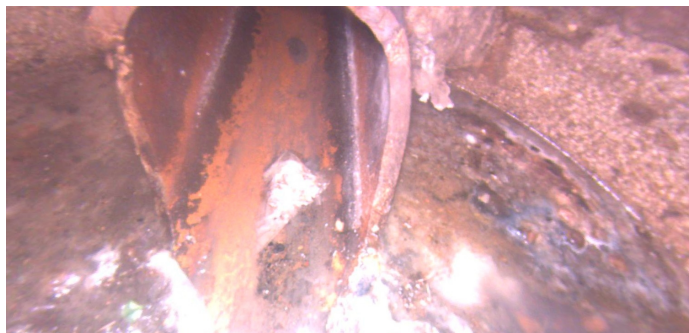
Code: **MGO**
Description: **General Observation**

Distance (ft): **5.1**
Structural Grade: **0**
O&M Grade: **0**
Clock Start/From:
Clock To:
1st Value:
2nd Value:
Value Percent:
Step: **NO**
Remarks: **end survey**
