Manhole Inspection Report

Date:	04/20/2018	Weather:		Coding:	RZMACP
MH#:	M-305-057	Owner:	NA	Len. Surveyed:	10.0
P.O.#:		Surveyor:	Jen Costello	Rim to Invert:	11.8
Customer:		Cert. #:	U-907-5518	Wall Material:	Brick

Street:	146' Southwest of 3rd St. and Crest	Project:	Hobart, IN
City:	Hobart, IN	GPS Northing:	0.0
Location:		GPS Easting:	0.0
Drain Area:	West	GPS Accuracy:	Nearest Meter
Cover Shape:	Circular	Evidence of Surcharge:	No
Cover Size:	23.0	Potential for Runoff:	None
Comments:

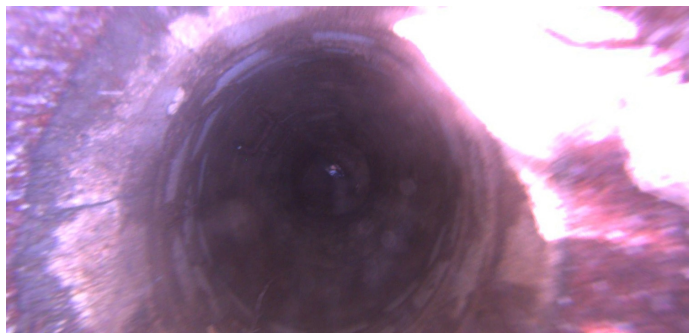
Code: **MGO**
Description: **General Observation**

Distance (ft): **.0**
Structural Grade: **0**
O&M Grade: **0**
Clock Start/From:
Clock To:
1st Value:
2nd Value:
Value Percent:
Step: **NO**
Remarks: **ACCESS MH**

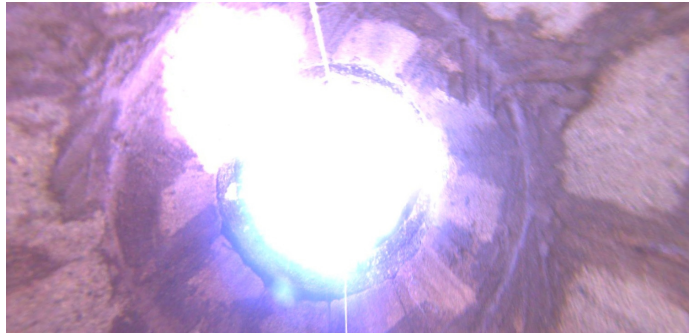
Code:	MGO
Description:	General Observation
Distance (ft):	2.7
Structural Grade:	0
O&M Grade:	0
Clock Start/From:	
Clock To:	
1st Value:	
2nd Value:	
Value Percent:	
Step:	NO
Remarks:	UNDERSIDE OF FRAME

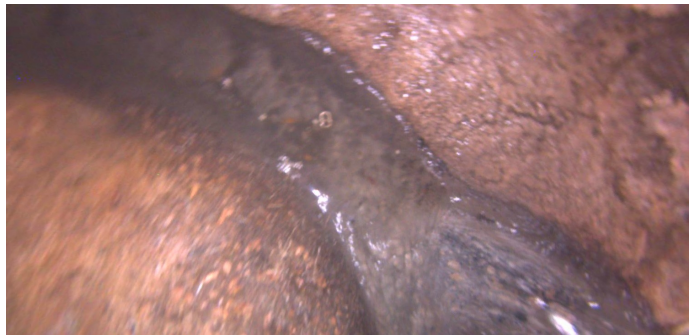
Code:	MGO
Description:	General Observation
Distance (ft):	10.0
Structural Grade:	0
O&M Grade:	0
Clock Start/From:	
Clock To:	
1st Value:	
2nd Value:	
Value Percent:	
Step:	NO
Remarks:	END SURVEY
