Manhole Inspection Report

Date:	03/23/2018	Weather:		Coding:	RZMACP
MH#:	M-308-001	Owner:	NA	Len. Surveyed:	19.1
P.O.#:		Surveyor:	John Kuglmaier	Rim to Invert:	21.5
Customer:		Cert. #:	U-1215-07002349	Wall Material:	Concrete (reinforced)

Street:	North of 61st Ave. 226' West of Clay	Project:	Hobart, IN
City:	Hobart, IN	GPS Northing:	0.0
Location:		GPS Easting:	0.0
Drain Area:	Southwest	GPS Accuracy:	Nearest Meter
Cover Shape:	Circular	Evidence of Surcharge:	No
Cover Size:	22.5	Potential for Runoff:	None
Comments:

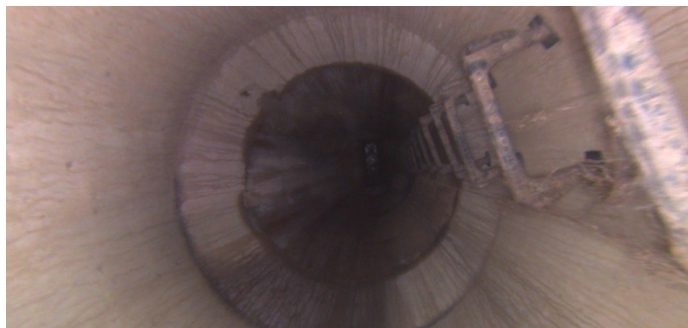
Code: **MGP**
Description: **General Photo**

Distance (ft): **.0**
Structural Grade: **0**
O&M Grade: **0**
Clock Start/From:
Clock To:
1st Value:
2nd Value:
Value Percent:
Step: **NO**
Remarks:

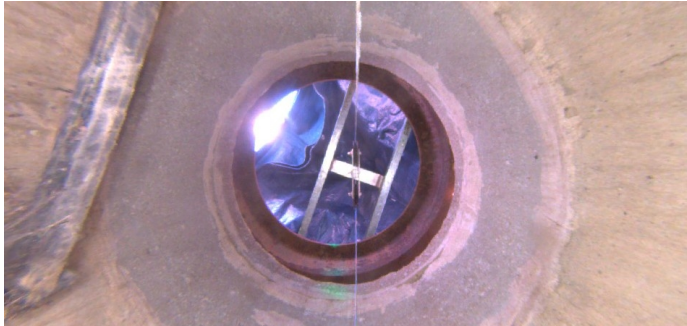
Code: **MGP**
Description: **General Photo**

Distance (ft): **1.3**
Structural Grade: **0**
O&M Grade: **0**
Clock Start/From:
Clock To:
1st Value:
2nd Value:
Value Percent:
Step: **NO**
Remarks:

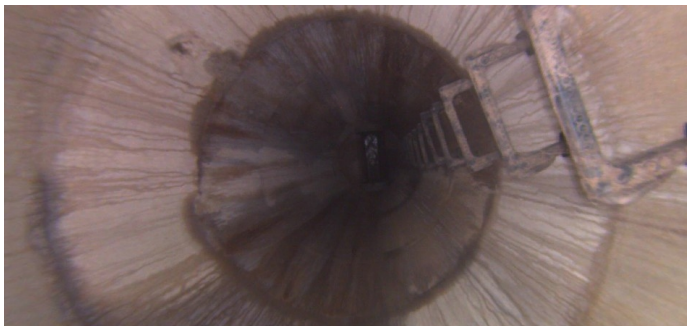
Code: **IS**
Description: **Infil Stain**

Distance (ft): **1.4**
Structural Grade: **0**
O&M Grade: **0**
Clock Start/From: **12**
Clock To: **12**
1st Value:
2nd Value:
Value Percent:
Step: **NO**
Remarks:

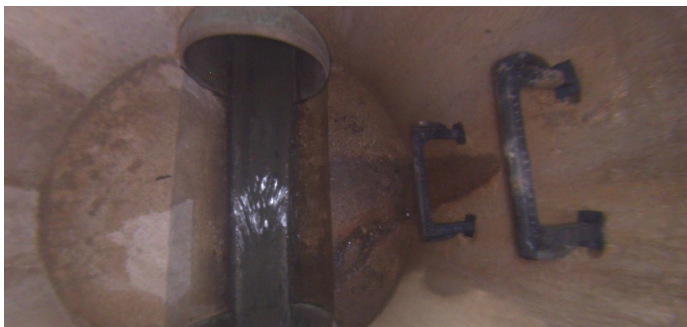
Code: **IS**
Description: **Infil Stain**

Distance (ft): **15.7**
Structural Grade: **0**
O&M Grade: **0**
Clock Start/From: **3**
Clock To:
1st Value:
2nd Value:
Value Percent:
Step: **NO**
Remarks:

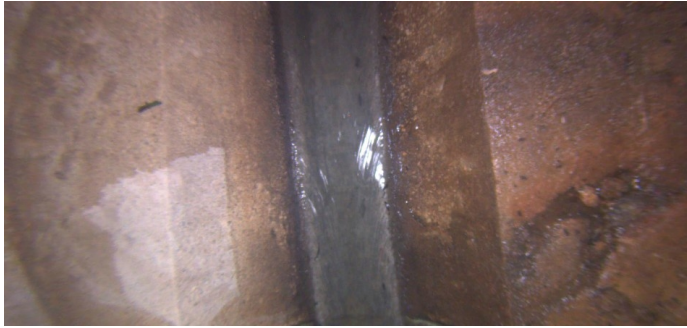
Code:	MGO
Description:	General Observation
Distance (ft):	17.6
Structural Grade:	0
O&M Grade:	0
Clock Start/From:	
Clock To:	
1st Value:	
2nd Value:	
Value Percent:	
Step:	NO
Remarks:	Ins. Comp.
