# Manhole Inspection Report

Date:	<b>03/23/2018</b>	Weather:		Coding:	<b>RZMACP</b>
MH#:	<b>M-308-001A</b>	Owner:	<b>NA</b>	Len. Surveyed:	<b>22.2</b>
P.O.#:		Surveyor:	<b>John Kuglmaier</b>	Rim to Invert:	<b>22.1</b>
Customer:		Cert. #:	<b>U-1215-07002349</b>	Wall Material:	<b>Concrete (reinforced)</b>

Street:	<b>ARIZONA ST</b>	Project:	<b>Hobart, IN</b>
City:	<b>Hobart, IN</b>	GPS Northing:	<b>0.0</b>
Location:		GPS Easting:	<b>0.0</b>
Drain Area:	<b>Southwest</b>	GPS Accuracy:	<b>Nearest Meter</b>
Cover Shape:	<b>Circular</b>	Evidence of Surcharge:	<b>No</b>
Cover Size:	<b>22.5</b>	Potential for Runoff:	<b>None</b>
Comments:

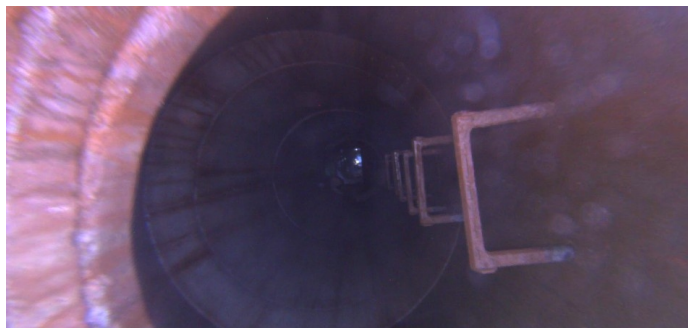
Code: **MGP**  
Description: **General Photo**

Distance (ft): **.0**  
Structural Grade: **0**  
O&M Grade: **0**  
Clock Start/From:  
Clock To:  
1st Value:  
2nd Value:  
Value Percent:  
Step: **NO**  
Remarks:

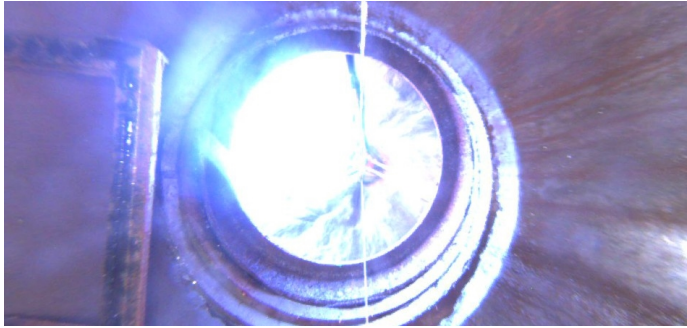
Code: **MGP**  
Description: **General Photo**

Distance (ft): **2.8**  
Structural Grade: **0**  
O&M Grade: **0**  
Clock Start/From:  
Clock To:  
1st Value:  
2nd Value:  
Value Percent:  
Step: **NO**  
Remarks:

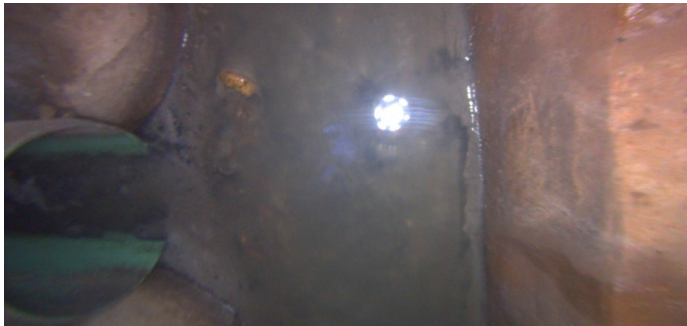
Code: **MGO**  
Description: **General Observation**

Distance (ft): **21.0**  
Structural Grade: **0**  
O&M Grade: **0**  
Clock Start/From:  
Clock To:  
1st Value:  
2nd Value:  
Value Percent:  
Step: **NO**  
Remarks: **Ins. Comp.**
