Manhole Inspection Report

Date:	03/23/2018	Weather:		Coding:	RZMACP
MH#:	M-308-004	Owner:	NA	Len. Surveyed:	18.9
P.O.#:		Surveyor:	John Kuglmaier	Rim to Invert:	19.4
Customer:		Cert. #:	U-1215-07002349	Wall Material:	Concrete (reinforced)

Street:	North of 61st Ave. 542' West of Clay	Project:	Hobart, IN
City:	Hobart, IN	GPS Northing:	0.0
Location:		GPS Easting:	0.0
Drain Area:	Southwest	GPS Accuracy:	Nearest Meter
Cover Shape:	Circular	Evidence of Surcharge:	No
Cover Size:	22.5	Potential for Runoff:	None
Comments:

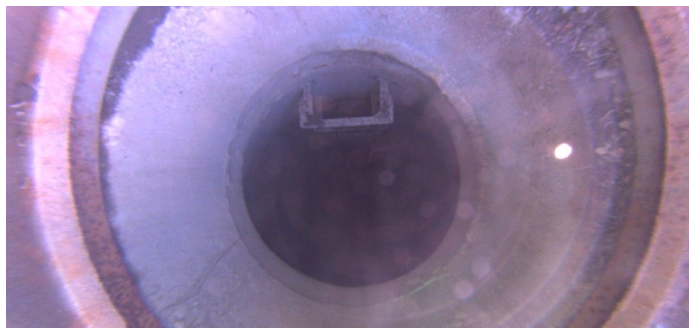
Code: **MGP**
Description: **General Photo**

Distance (ft): **.0**
Structural Grade: **0**
O&M Grade: **0**
Clock Start/From:
Clock To:
1st Value:
2nd Value:
Value Percent:
Step: **NO**
Remarks:

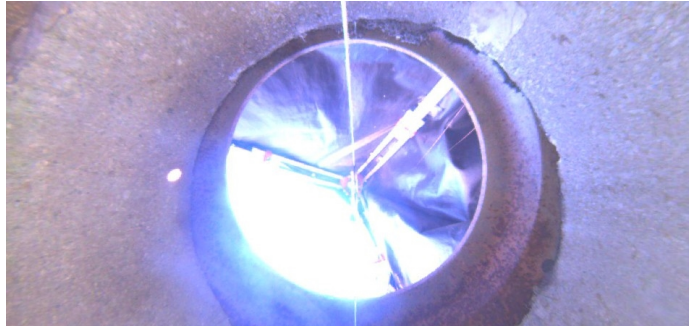
Code: **MGP**
Description: **General Photo**

Distance (ft): **3.0**
Structural Grade: **0**
O&M Grade: **0**
Clock Start/From:
Clock To:
1st Value:
2nd Value:
Value Percent:
Step: **NO**
Remarks:

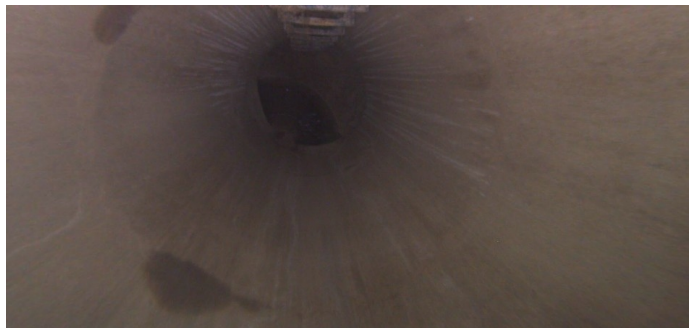
Code: **IS**
Description: **Infil Stain**

Distance (ft): **9.1**
Structural Grade: **0**
O&M Grade: **0**
Clock Start/From: **7**
Clock To:
1st Value:
2nd Value:
Value Percent:
Step: **NO**
Remarks:

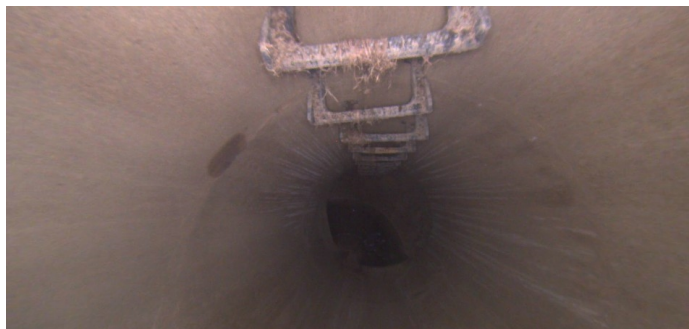
Code: **IS**
Description: **Infil Stain**

Distance (ft): **9.1**
Structural Grade: **0**
O&M Grade: **0**
Clock Start/From: **10**
Clock To:
1st Value:
2nd Value:
Value Percent:
Step: **NO**
Remarks:

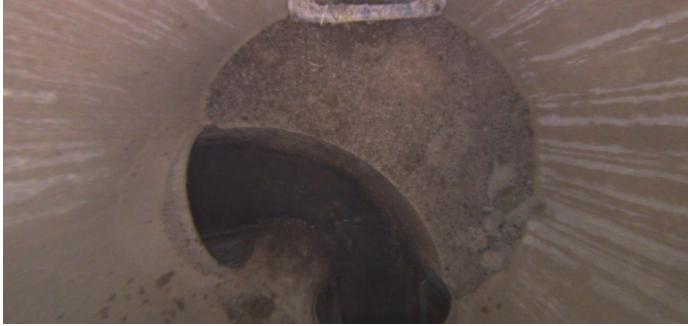
Code:	MGO
Description:	General Observation
Distance (ft):	16.6
Structural Grade:	0
O&M Grade:	0
Clock Start/From:	
Clock To:	
1st Value:	
2nd Value:	
Value Percent:	
Step:	NO
Remarks:	Ins. Comp.
