Manhole Inspection Report

Date:	03/23/2018	Weather:		Coding:	RZMACP
MH#:	M-308-005	Owner:	NA	Len. Surveyed:	18.8
P.O.#:		Surveyor:	John Kuglmaier	Rim to Invert:	19.8
Customer:		Cert. #:	U-1215-07002349	Wall Material:	Concrete (reinforced)

Street:	61st Ave. 535' West of Clay St.	Project:	Hobart, IN
City:	Hobart, IN	GPS Northing:	0.0
Location:		GPS Easting:	0.0
Drain Area:	Southwest	GPS Accuracy:	Nearest Meter
Cover Shape:	Circular	Evidence of Surcharge:	No
Cover Size:	22.5	Potential for Runoff:	None
Comments:

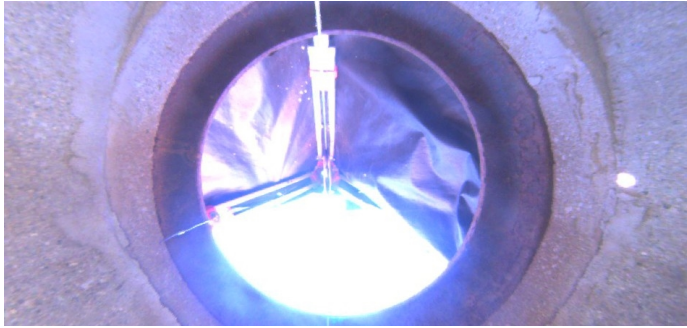
Code: **MGP**
Description: **General Photo**

Distance (ft): **1.8**
Structural Grade: **0**
O&M Grade: **0**
Clock Start/From:
Clock To:
1st Value:
2nd Value:
Value Percent:
Step: **NO**
Remarks:

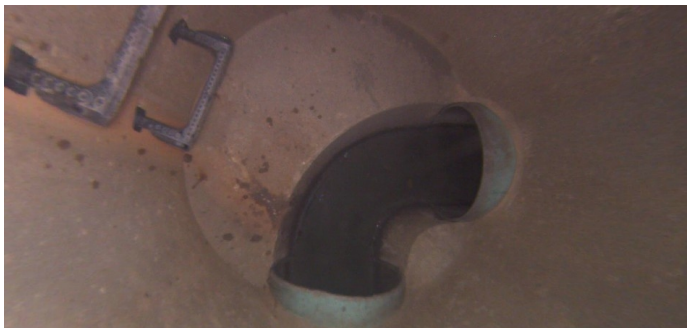
Code: **MGO**
Description: **General Observation**

Distance (ft): **15.4**
Structural Grade: **0**
O&M Grade: **0**
Clock Start/From:
Clock To:
1st Value:
2nd Value:
Value Percent:
Step: **NO**
Remarks: **Ins. Comp.**
