Manhole Inspection Report

| MH#: | M-308-006 | Owner: | NA | Len. Surveyed: | 20.2 |

| Street: | 61st Ave. 881' East of Amber Dr. | Project: | Hobart, IN |

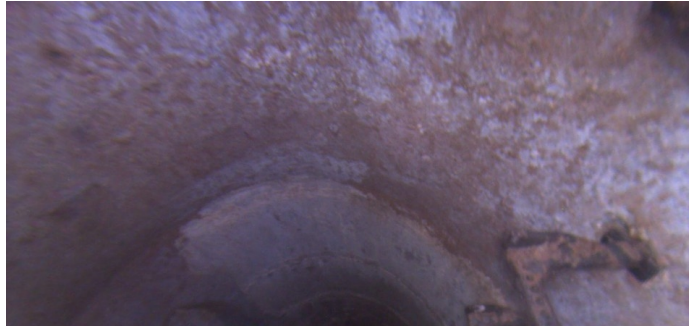
| | Position | Code | Observation | Video (sec) | Grade |
|--|---|---|---|---|---|
| | 1.9 | DAGS | Deposits Attached Grease | 26 | M 2 |

| Code: | DAGS |
| Description: | Deposits Attached Grease |
| Distance (ft): | 1.9 |
| O&M Grade: | 2 |

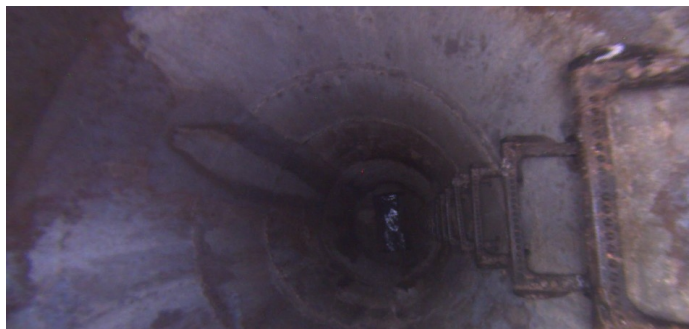
| | Position | Code | Observation | Video (sec) | Grade |
|--|---|---|---|---|---|
| | 3.1 | IS | Infil Stain | 56 | NA |

| Code: | IS |
| Description: | Infil Stain |
| Distance (ft): | 3.1 |
| Clock Start/From: | 10 |

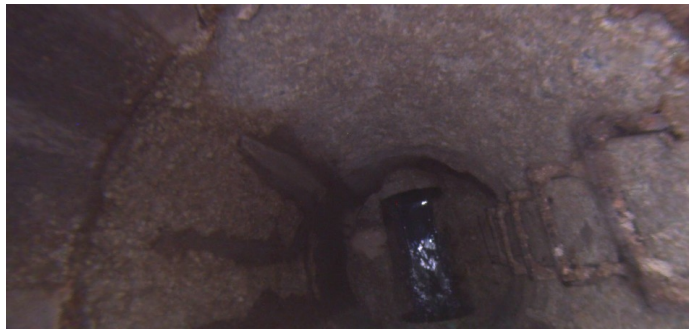
| | Position | Code | Observation | Video (sec) | Grade |
|--|---|---|---|---|---|
| | 11.3 | IS | Infil Stain | 84 | NA |

Code: **IS**
Description: **Infil Stain**

Distance (ft): **11.3**
Structural Grade: **0**
O&M Grade: **0**
Clock Start/From: **11**
Clock To:
1st Value:
2nd Value:
Value Percent:
Step: **NO**
Remarks:

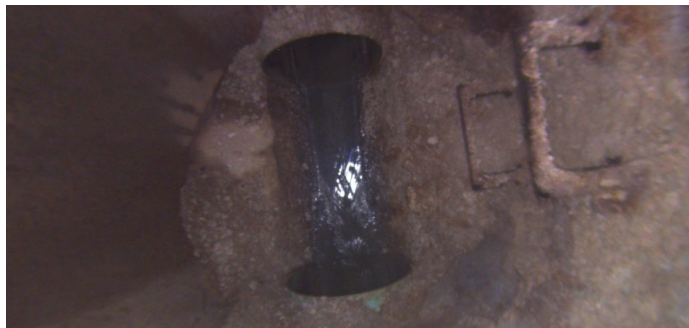
| | Position | Code | Observation | Video (sec) | Grade |
|--|---|---|---|---|---|
| | 15.6 | DAZ | Deposits Attached Other | 104 | M 3 |

Code: **DAZ**
Description: **Deposits Attached Other**

Distance (ft): **15.6**
Structural Grade: **0**
O&M Grade: **3**
Clock Start/From: **12**
Clock To: **12**
1st Value:
2nd Value:
Value Percent: **15.000**
Step: **NO**
Remarks: **Mixed materials**

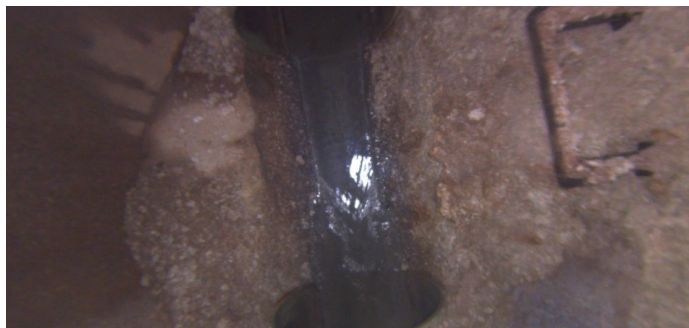
| | Position | Code | Observation | Video (sec) | Grade |
|--|---|---|---|---|---|
| | 16.7 | DAGS | Deposits Attached Grease | 117 | M 2 |

Code: **DAGS**
Description: **Deposits Attached Grease**

Distance (ft): **16.7**
Structural Grade: **0**
O&M Grade: **2**
Clock Start/From: **12**
Clock To: **12**
1st Value:
2nd Value:
Value Percent: **10.000**
Step: **NO**
Remarks: **Clock positions vary**

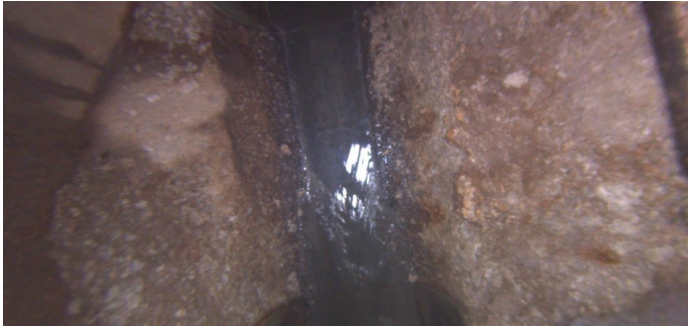
| Code: | MGO |
| Description: | General Observation |
| Remarks: | Ins. Comp. |
