Manhole Inspection Report

Date:	03/23/2018	Weather:		Coding:	RZMACP
MH#:	M-308-010	Owner:	NA	Len. Surveyed:	14.2
P.O.#:		Surveyor:	John Kuglmaier	Rim to Invert:	15.6
Customer:		Cert. #:	U-1215-07002349	Wall Material:	Concrete (reinforced)

Street:	Amber Dr. 232' North of 61st Ave.	Project:	Hobart, IN
City:	Hobart, IN	GPS Northing:	0.0
Location:		GPS Easting:	0.0
Drain Area:	Southwest	GPS Accuracy:	Nearest Meter
Cover Shape:	Circular	Evidence of Surcharge:	Yes
Cover Size:	22.5	Potential for Runoff:	None
Comments:

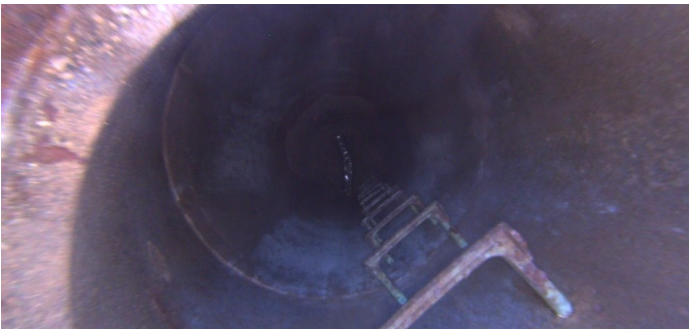
Code: **MGP**
Description: **General Photo**

Distance (ft): **.0**
Structural Grade: **0**
O&M Grade: **0**
Clock Start/From:
Clock To:
1st Value:
2nd Value:
Value Percent:
Step: **NO**
Remarks:

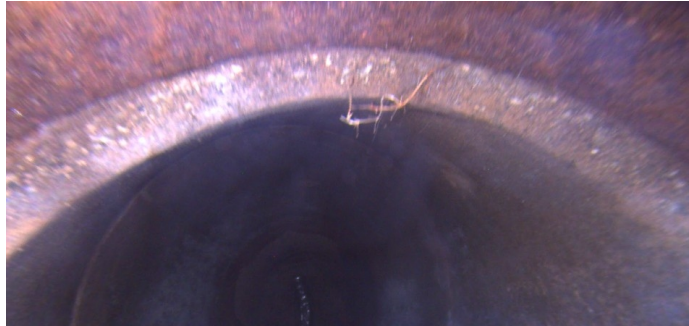
Code: **RFJ**
Description: **Roots Fine Joint**

Distance (ft): **.0**
Structural Grade: **0**
O&M Grade: **1**
Clock Start/From: **1**
Clock To:
1st Value:
2nd Value:
Value Percent:
Step: **NO**
Remarks:

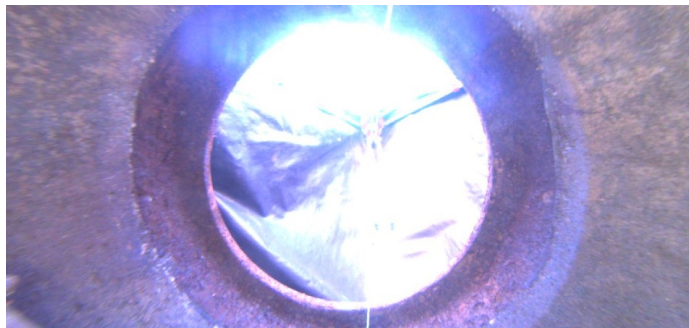
Code: **MGP**
Description: **General Photo**

Distance (ft): **2.0**
Structural Grade: **0**
O&M Grade: **0**
Clock Start/From:
Clock To:
1st Value:
2nd Value:
Value Percent:
Step: **NO**
Remarks:

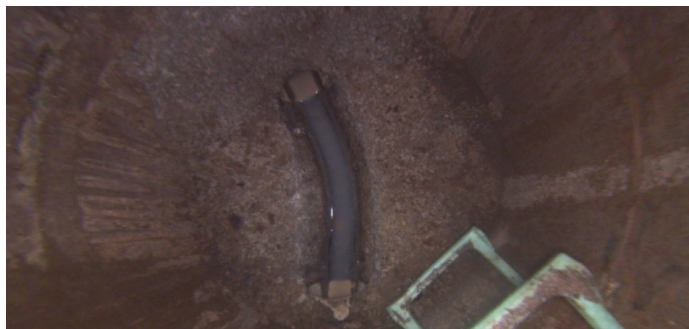
Code: **DAZ**
Description: **Deposits Attached Other**

Distance (ft): **11.5**
Structural Grade: **0**
O&M Grade: **2**
Clock Start/From: **12**
Clock To: **12**
1st Value:
2nd Value:
Value Percent: **10.000**
Step: **NO**
Remarks: **Mixed materials**

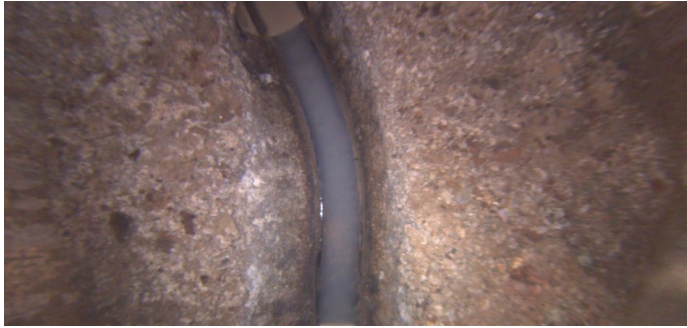
Code:	MGO
Description:	General Observation
Distance (ft):	13.4
Structural Grade:	0
O&M Grade:	0
Clock Start/From:	
Clock To:	
1st Value:	
2nd Value:	
Value Percent:	
Step:	NO
Remarks:	Ins. Comp.
