# Manhole Inspection Report

Date:	<b>03/24/2018</b>	Weather:		Coding:	<b>RZMACP</b>
MH#:	<b>M-308-011</b>	Owner:	<b>NA</b>	Len. Surveyed:	<b>12.5</b>
P.O.#:		Surveyor:	<b>John Kuglmaier</b>	Rim to Invert:	<b>13.1</b>
Customer:		Cert. #:	<b>U-1215-07002349</b>	Wall Material:	<b>Concrete (reinforced)</b>

Street:	<b>Diamond Dr. and Amber Dr.</b>	Project:	<b>Hobart, IN</b>
City:	<b>Hobart, IN</b>	GPS Northing:	<b>0.0</b>
Location:		GPS Easting:	<b>0.0</b>
Drain Area:	<b>Southwest</b>	GPS Accuracy:	<b>Nearest Meter</b>
Cover Shape:	<b>Circular</b>	Evidence of Surcharge:	<b>No</b>
Cover Size:	<b>22.5</b>	Potential for Runoff:	<b>None</b>
Comments:

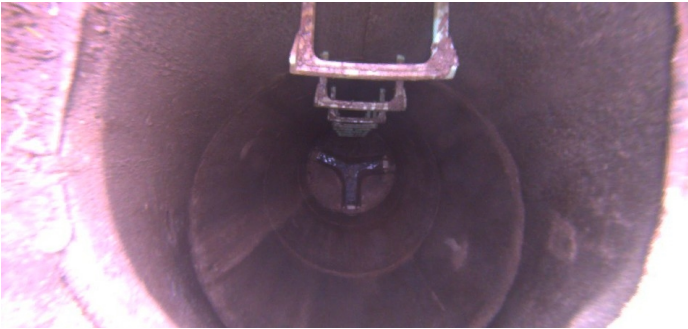
MGP

General Photo

.0

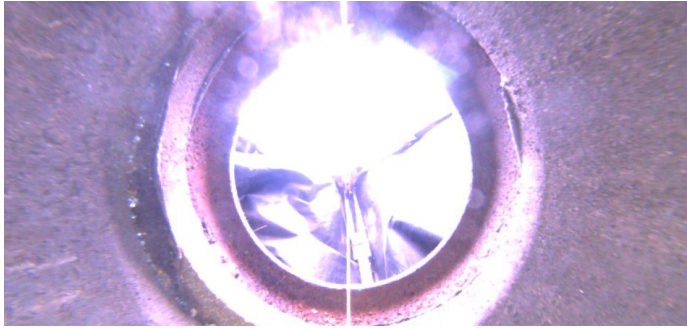
Code: **MGP**  
Description: **General Photo**

Distance (ft): **2.6**  
Structural Grade: **0**  
O&M Grade: **0**  
Clock Start/From:  
Clock To:  
1st Value:  
2nd Value:  
Value Percent:  
Step: **NO**  
Remarks:

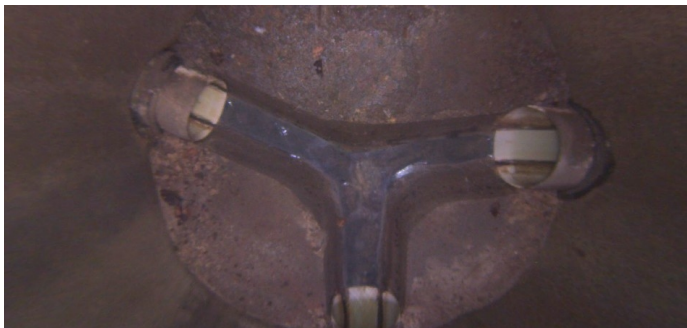
Code: **MGO**  
Description: **General Observation**

Distance (ft): **10.4**  
Structural Grade: **0**  
O&M Grade: **0**  
Clock Start/From:  
Clock To:  
1st Value:  
2nd Value:  
Value Percent:  
Step: **NO**  
Remarks: **Ins. Comp.**
