Manhole Inspection Report

Date:	03/24/2018	Weather:		Coding:	RZMACP
MH#:	M-308-013	Owner:	NA	Len. Surveyed:	12.1
P.O.#:		Surveyor:	John Kuglmaier	Rim to Invert:	12.9
Customer:		Cert. #:	U-1215-07002349	Wall Material:	Concrete (reinforced)

Street:	Amber Dr. 211' Northeast of Diamo	Project:	Hobart, IN
City:	Hobart, IN	GPS Northing:	0.0
Location:		GPS Easting:	0.0
Drain Area:	Southwest	GPS Accuracy:	Nearest Meter
Cover Shape:	Circular	Evidence of Surcharge:	No
Cover Size:	22.5	Potential for Runoff:	None
Comments:

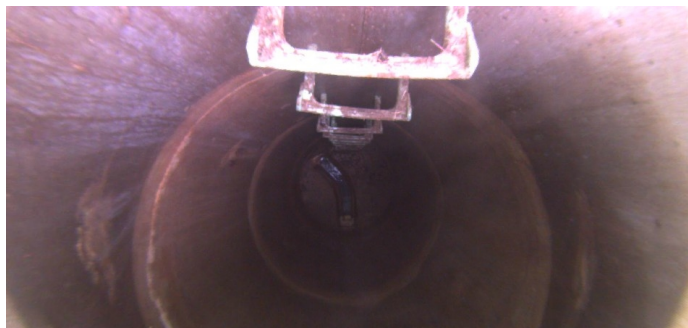
Code: **MGP**
Description: **General Photo**

Distance (ft): **.0**
Structural Grade: **0**
O&M Grade: **0**
Clock Start/From:
Clock To:
1st Value:
2nd Value:
Value Percent:
Step: **NO**
Remarks:

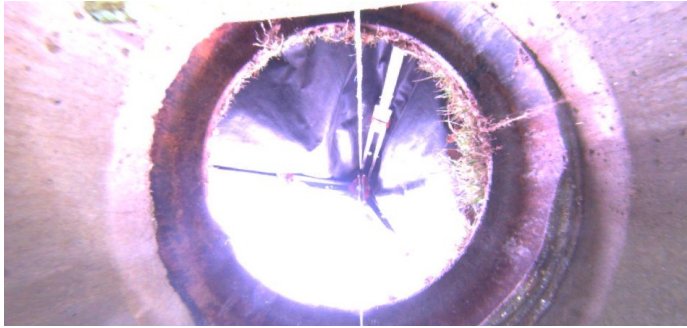
Code: **MGP**
Description: **General Photo**

Distance (ft): **2.1**
Structural Grade: **0**
O&M Grade: **0**
Clock Start/From:
Clock To:
1st Value:
2nd Value:
Value Percent:
Step: **NO**
Remarks:

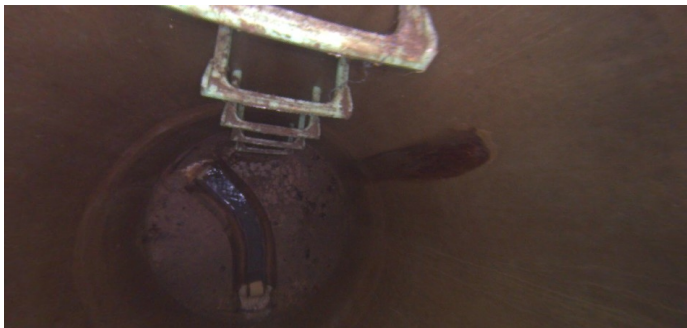
Code: **IS**
Description: **Infil Stain**

Distance (ft): **6.0**
Structural Grade: **0**
O&M Grade: **0**
Clock Start/From: **2**
Clock To:
1st Value:
2nd Value:
Value Percent:
Step: **NO**
Remarks:

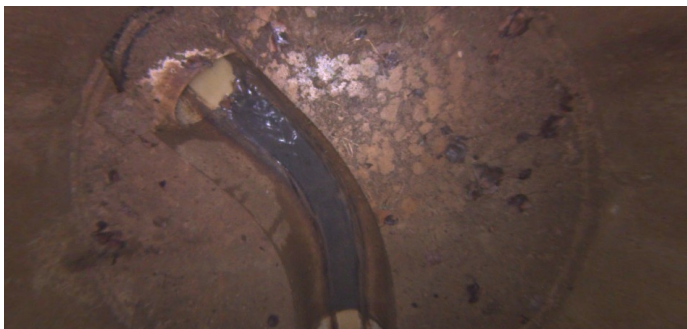
Code: **MGO**
Description: **General Observation**

Distance (ft): **10.1**
Structural Grade: **0**
O&M Grade: **0**
Clock Start/From:
Clock To:
1st Value:
2nd Value:
Value Percent:
Step: **NO**
Remarks: **Ins. Comp.**
