Manhole Inspection Report

Date:	03/24/2018	Weather:		Coding:	RZMACP
MH#:	M-308-015	Owner:	NA	Len. Surveyed:	7.1
P.O.#:		Surveyor:	John Kuglmaier	Rim to Invert:	9.9
Customer:		Cert. #:	U-1215-07002349	Wall Material:	Concrete (reinforced)

Street:	Emerald Dr. Amber Dr. to the East.	Project:	Hobart, IN
City:	Hobart, IN	GPS Northing:	0.0
Location:		GPS Easting:	0.0
Drain Area:	Southwest	GPS Accuracy:	Nearest Meter
Cover Shape:	Circular	Evidence of Surcharge:	No
Cover Size:	22.5	Potential for Runoff:	None
Comments:

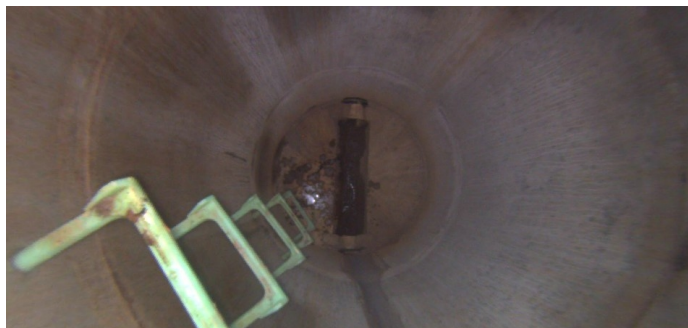
Code: **MGP**
Description: **General Photo**

Distance (ft): **.0**
Structural Grade: **0**
O&M Grade: **0**
Clock Start/From:
Clock To:
1st Value:
2nd Value:
Value Percent:
Step: **NO**
Remarks:

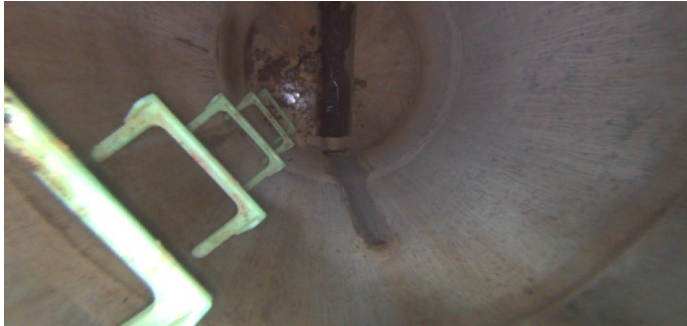
Code: **IS**
Description: **Infil Stain**

Distance (ft): **.5**
Structural Grade: **0**
O&M Grade: **0**
Clock Start/From: **6**
Clock To:
1st Value:
2nd Value:
Value Percent:
Step: **NO**
Remarks:

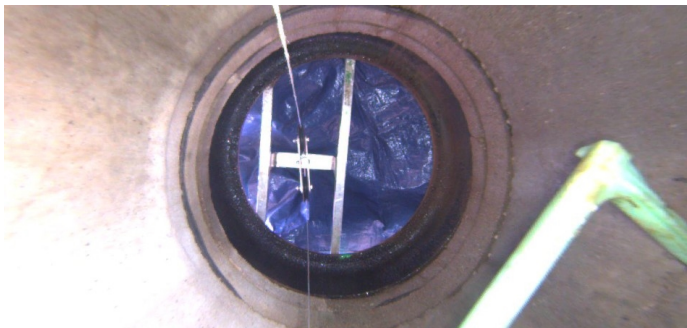
Code: **MGP**
Description: **General Photo**

Distance (ft): **.9**
Structural Grade: **0**
O&M Grade: **0**
Clock Start/From:
Clock To:
1st Value:
2nd Value:
Value Percent:
Step: **NO**
Remarks:

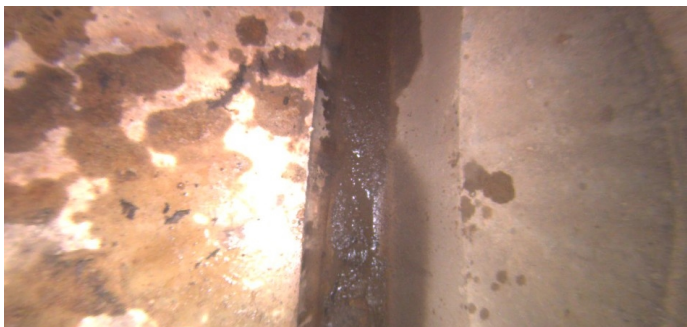
Code: **MGO**
Description: **General Observation**

Distance (ft): **6.0**
Structural Grade: **0**
O&M Grade: **0**
Clock Start/From:
Clock To:
1st Value:
2nd Value:
Value Percent:
Step: **NO**
Remarks: **Ins. Comp.**
