Manhole Inspection Report

Date:	03/27/2018	Weather:		Coding:	RZMACP
MH#:	M-308-018	Owner:	NA	Len. Surveyed:	7.8
P.O.#:		Surveyor:	John Kuglmaier	Rim to Invert:	8.7
Customer:		Cert. #:	U-1215-07002349	Wall Material:	Concrete (reinforced)

Street:	Ruby Ct. Emerald Dr.	Project:	Hobart, IN
City:	Hobart, IN	GPS Northing:	0.0
Location:		GPS Easting:	0.0
Drain Area:	Southwest	GPS Accuracy:	Nearest Meter
Cover Shape:	Circular	Evidence of Surcharge:	No
Cover Size:	22.5	Potential for Runoff:	None
Comments:

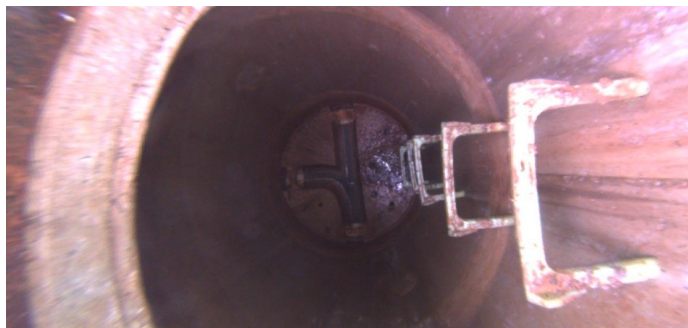
Code: **MGP**
Description: **General Photo**

Distance (ft): **.0**
Structural Grade: **0**
O&M Grade: **0**
Clock Start/From:
Clock To:
1st Value:
2nd Value:
Value Percent:
Step: **NO**
Remarks:

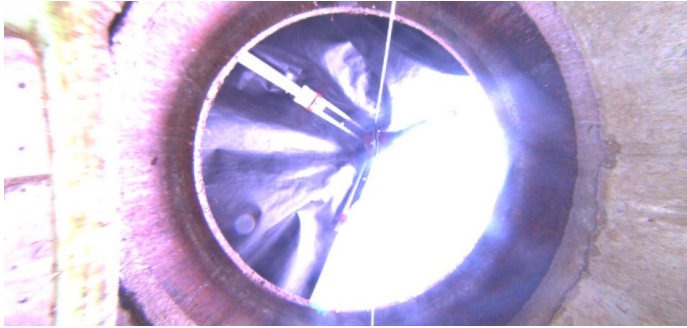
Code: **MGP**
Description: **General Photo**

Distance (ft): **2.1**
Structural Grade: **0**
O&M Grade: **0**
Clock Start/From:
Clock To:
1st Value:
2nd Value:
Value Percent:
Step: **NO**
Remarks:

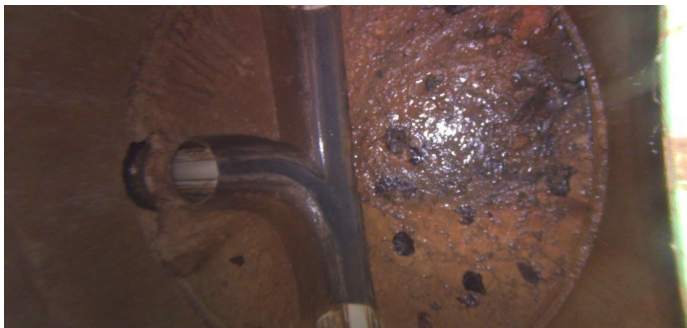
Code: **MGO**
Description: **General Observation**

Distance (ft): **6.1**
Structural Grade: **0**
O&M Grade: **0**
Clock Start/From:
Clock To:
1st Value:
2nd Value:
Value Percent:
Step: **NO**
Remarks: **Ins. Comp.**
