Manhole Inspection Report

Date:	03/27/2018	Weather:		Coding:	RZMACP
MH#:	M-308-019	Owner:	NA	Len. Surveyed:	11.5
P.O.#:		Surveyor:	John Kuglmaier	Rim to Invert:	12.2
Customer:		Cert. #:	U-1215-07002349	Wall Material:	Concrete (reinforced)

Street:	Diamond Dr. 298' West of Amber Dr.	Project:	Hobart, IN
City:	Hobart, IN	GPS Northing:	0.0
Location:		GPS Easting:	0.0
Drain Area:	Southwest	GPS Accuracy:	Nearest Meter
Cover Shape:	Circular	Evidence of Surcharge:	No
Cover Size:	22.5	Potential for Runoff:	None
Comments:

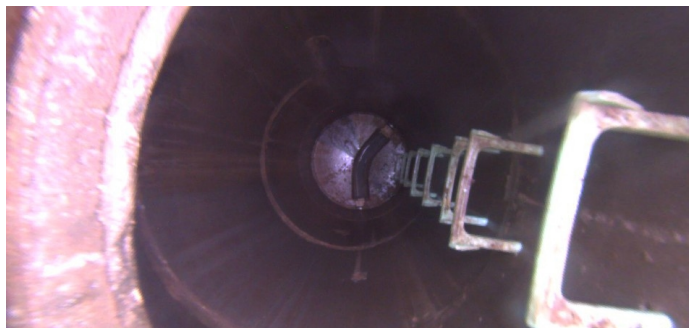
Code: **MGP**
Description: **General Photo**

Distance (ft): **.0**
Structural Grade: **0**
O&M Grade: **0**
Clock Start/From:
Clock To:
1st Value:
2nd Value:
Value Percent:
Step: **NO**
Remarks:

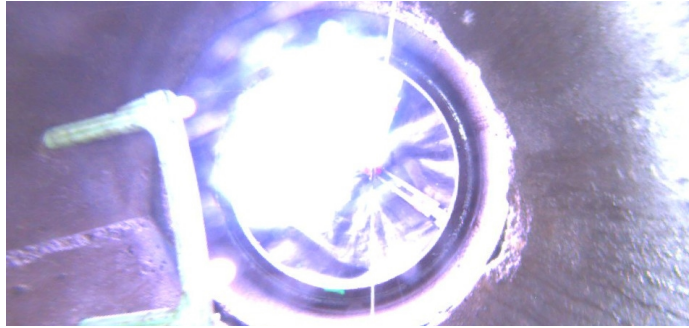
Code:	MGP
Description:	General Photo
Distance (ft):	2.4
Structural Grade:	0
O&M Grade:	0
Clock Start/From:	
Clock To:	
1st Value:	
2nd Value:	
Value Percent:	
Step:	NO
Remarks:

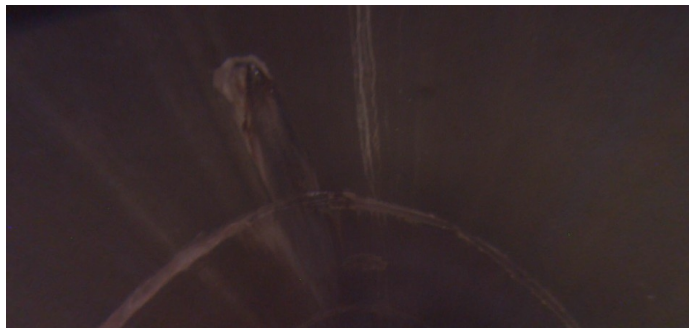
Code:	IS
Description:	Infil Stain
Distance (ft):	4.1
Structural Grade:	0
O&M Grade:	0
Clock Start/From:	11
Clock To:	
1st Value:	
2nd Value:	
Value Percent:	
Step:	NO
Remarks:

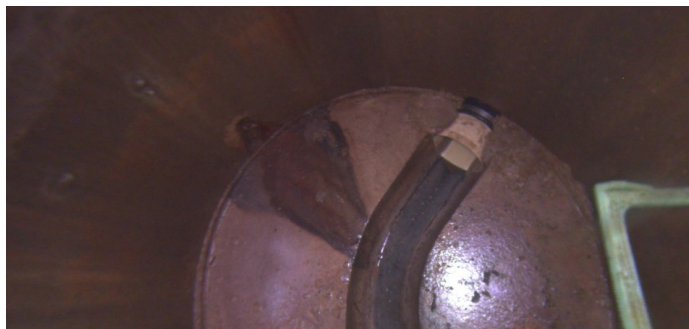
Code:	IS
Description:	Infil Stain
Distance (ft):	9.1
Structural Grade:	0
O&M Grade:	0
Clock Start/From:	10
Clock To:	
1st Value:	
2nd Value:	
Value Percent:	
Step:	NO
Remarks:

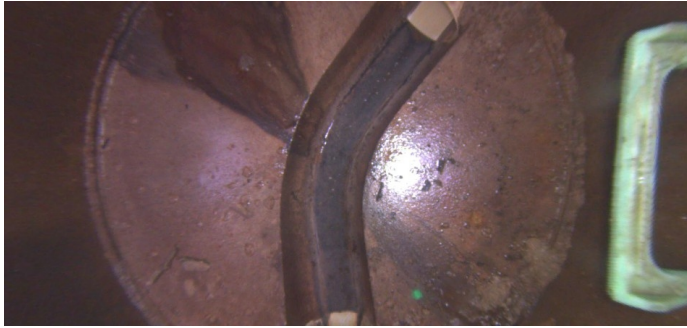
Code:	MGO
Description:	General Observation
Distance (ft):	9.6
Structural Grade:	0
O&M Grade:	0
Clock Start/From:	
Clock To:	
1st Value:	
2nd Value:	
Value Percent:	
Step:	NO
Remarks:	Ins. Comp.
